# **Final Report No. 1965 by the Aircraft Accident Investigation Bureau**

to the Bell 206B Jet Ranger III helicopter, HB-XQO

on 26 March 2005

Sustenlimi, Steingletscher, municipality of Gadmen/BE

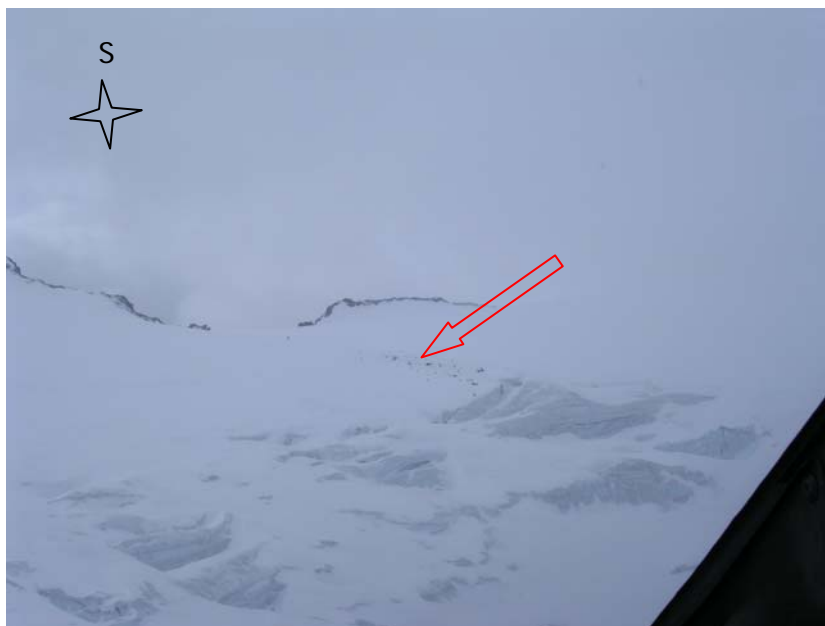
Debris field from a distance of 800 m, 10:17 on the day of the accident

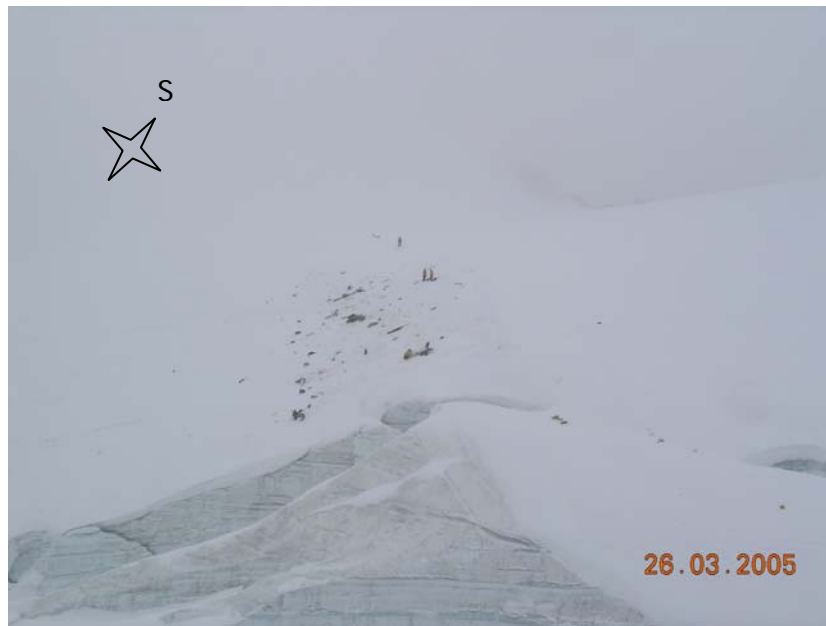
**Debris field 3 hours after the accident, direction of view SSE**

The helicopter collided with the terrain. All the occupants died immediately. The aircraft was destroyed.

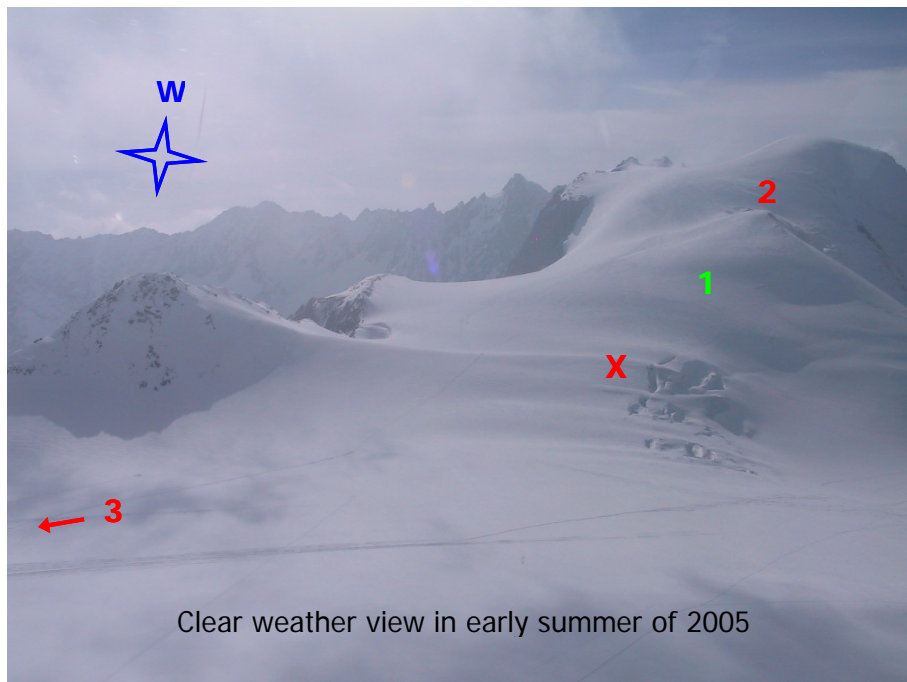
The site of the accident was located approximately 450 m east of the official "Sustenlimi 675575/171425, 3170 m AMSL" mountain landing area. The debris was approximately 650 m east of the planned original landing site (2) at point 3225. In relation to the first landing area approached (3) at the Sustenlimi Pt 3089 intersection, where the first three passengers had disembarked, the site of the accident (X) was about 750 m to the west (see Annex 1 Overview map).

The debris field lay on the open, snow-covered glacier which rises gently towards the west, along an indistinct, broad ridge of snow. This ridge begins below Pt 3183 on the southern crest of rock adjacent to the glacier and runs in a direction of approx. 330°, gently descending towards the end, into the transverse crevasses below the plateau of the glacier. The ridge is topographically recognisable on the national map.

From the first detectable point of impact of the helicopter onto the snow-covered glacier terrain, falling off to the right or the east at 15°-25° in the direction of flight, the debris was scattered in a conical pattern in the NNW direction. Individual parts, such as the fuel tank or the rear section of the turbine, were found in the large transverse crevasses visible in the photo (see Annex 3, Accident site).

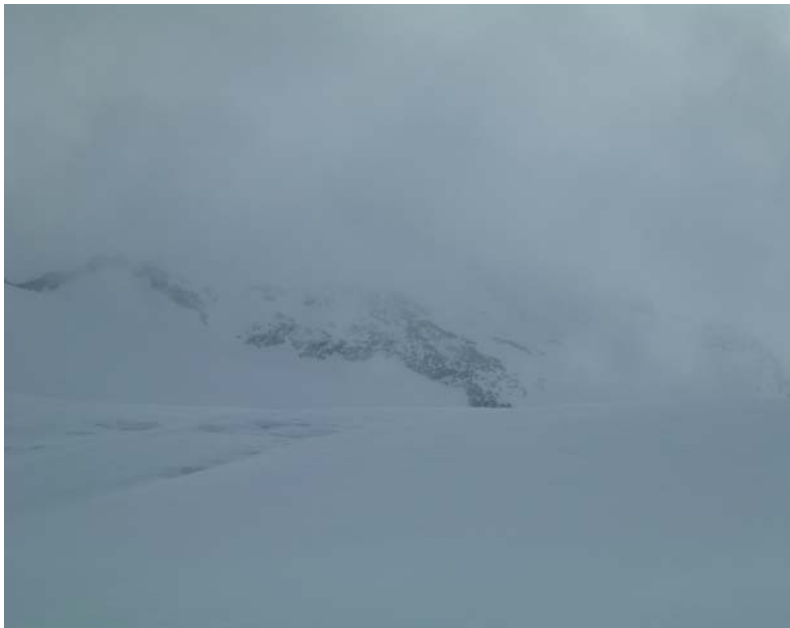
**direction of sight F1**

**26.03.05 at 08:50**

**11 minutes before the accident**

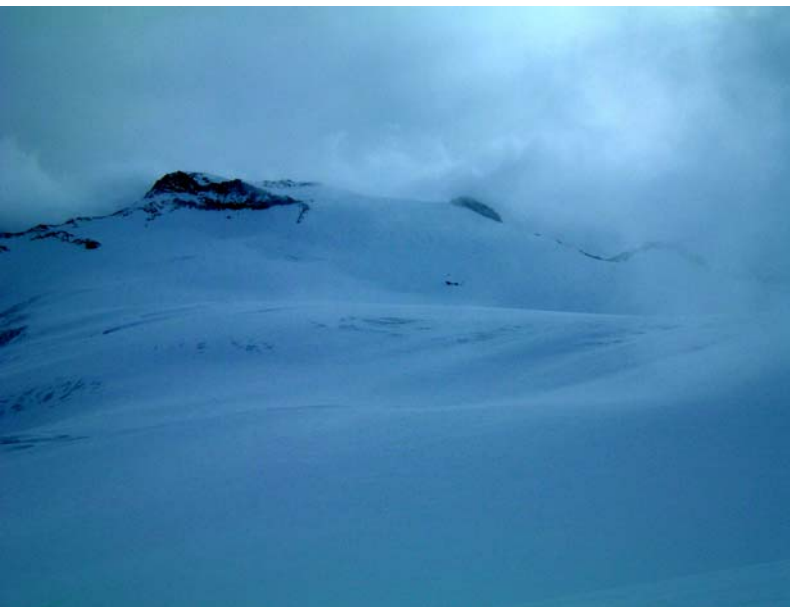
**direction of sight F2**

**26.03.05 at 08:52**

**9 minutes before the accident**

contrast and sharpness have been increased to show the dynamics of the clouds

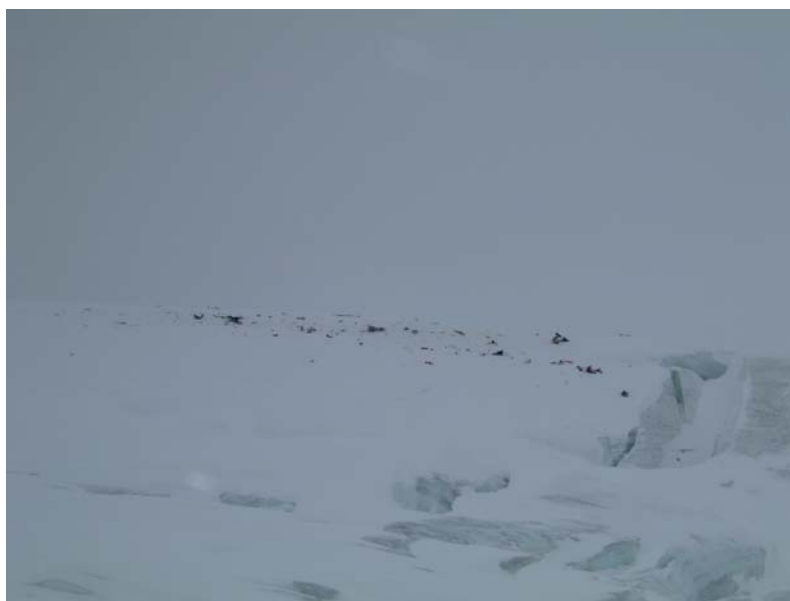
**direction of sight F3**

**26.03.06 at 09:09**

**8 minutes after the accident**

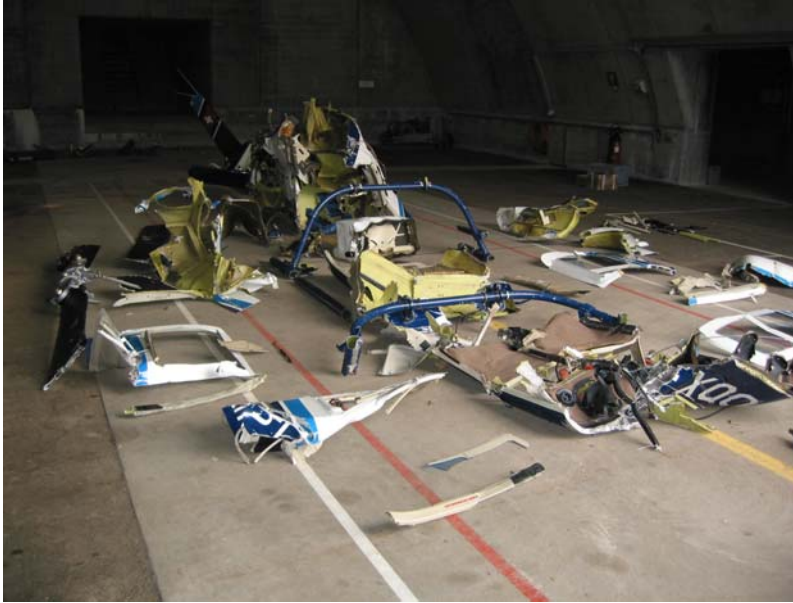
picture 1

All the damage found, such as fractures, cracks, buckling, paint marks, scratches and contact marks gave the same picture. On the basis of specific characteristics such the direction of fracture or buckling, location of the damage or reciprocal traces on individual parts of the wreckage it was possible to build up a plausible dynamic picture of the destruction from the initial impact.

The damage indicates high initial deceleration forces. The braking must have resulted in a rotation about the transverse axis and a roll-over.

layout of wreckage parts as per their position

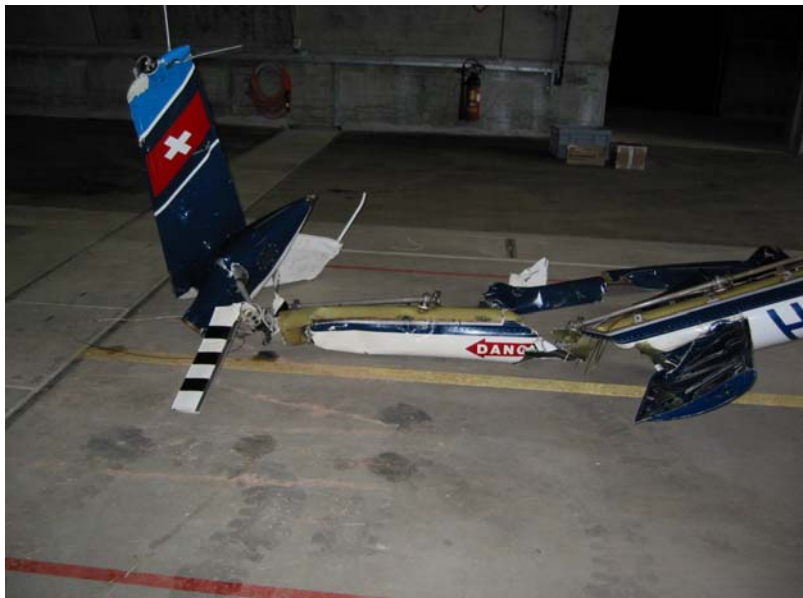
picture 2

layout of tail with tailrotor, vertical fin and horizontal stabilizer

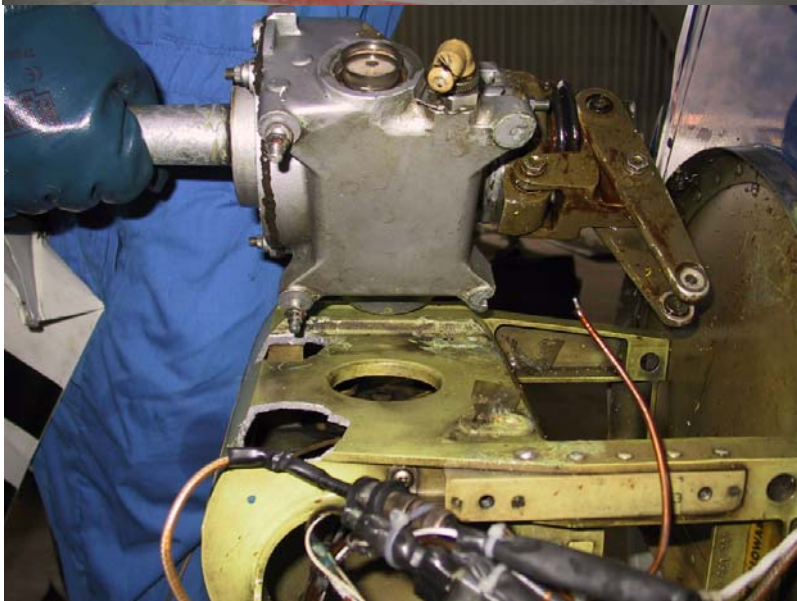
picture 3

torn off tailrotor-gearbox
