# **Final Report No. 1966 by the Swedish Accident Investigation Board**

concerning the accident  
to the aircraft Cessna 210, HB-CXF  
on 11 December 2004  
at Ängelholm Helsingborg airport, Sweden

## ***Report RL 2007:07e***

**Aircraft accident to HB-CXF  
at Ängelholm Helsingborg airport, M county,  
Sweden, on 11 December 2004**

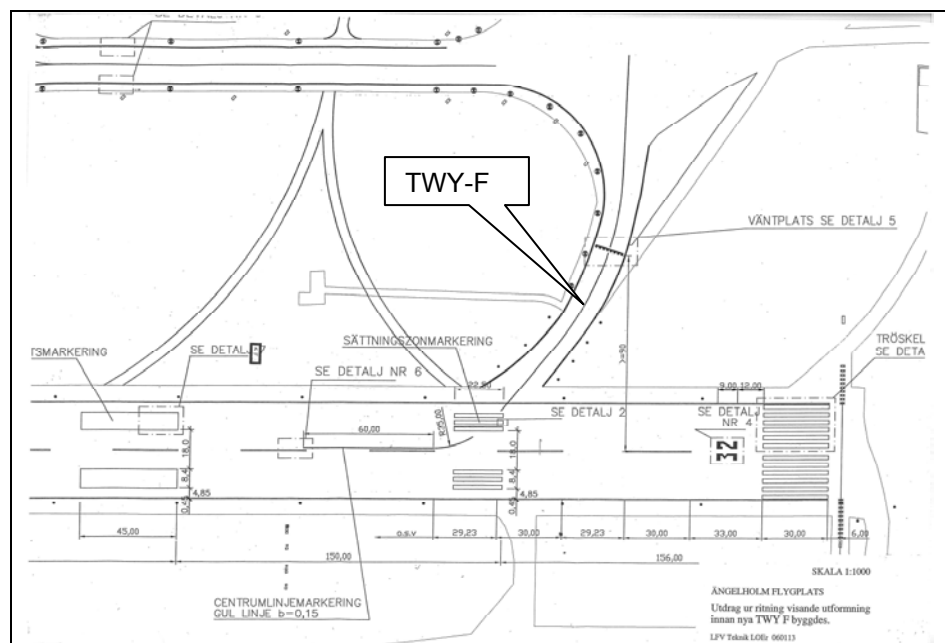
Before reconstruction

So that commercial aircraft could more easily be able to use the whole length of the runway, during the autumn of 2004 a taxiway called TWY-F was moved about 60 m closer to the threshold of runway 32. The connection angle to the runway was at the same time rebuilt from about 45° to 90°. (See below.)

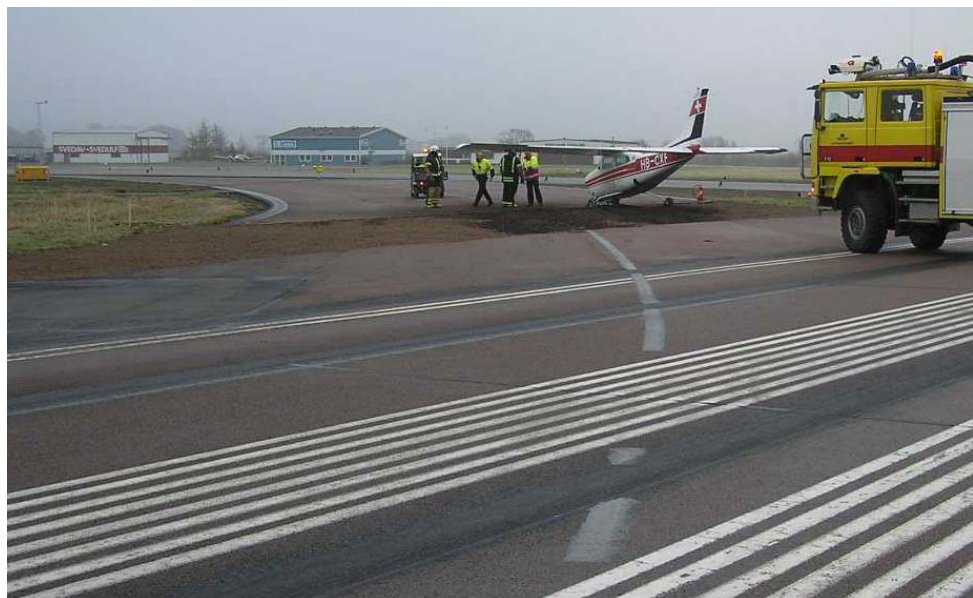
At the time of the accident, about seven metres of the black asphalt layer of the old TWY-F had been removed and replaced by dark-coloured earth. The old centreline had been overpainted with gray paint, but was still clearly visible. (See photograph below.)

Both the sign that indicated the original run-off to the taxiway and its centreline were still there. The old centreline had certainly been over-painted with gray paint, but was still clearly visible. The asphalt surface for the original run-off had been replaced by earth, which had approximately the same colour as the asphalt on the runway and taxi system. There was no suitable edge marking or other visual warning to show the pilot that the original run-off was unusable.

After the accident the edge of the runway at the location of the removed taxiway was marked by fluorescent poles and tape until the new sign could
