Final Report No. 1967 by the Aircraft Accident Investigation Bureau

to the Robin HR200/160 aircraft, registration HB-KFA

on 23 September 2005

municipality of Collombey-Muraz, hamlet of Peutet

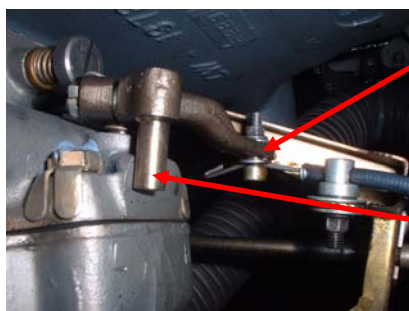
Mixture control on a carburetor of type Precision MA-4SPA

In section 7-6-2, the maintenance manual states: "*Réglage de la commande de mixture: Amener la tirette à 2 mm de la console et fixer le câble sur l'équerre du carburateur. La butée "pauvre" est réalisée par le téton dépassant sous l'équerre et ne nécessite par conséquent aucun réglage.*", that is: Adjustment of the mixture control: bring the pull-out knob 2 mm from the console and fix the cable onto the corner plate of the carburettor. The "lean" stop is constituted by the lug passing under the lever (set square) and therefore does not need any adjustment.

Fixing of the mixture control cable on the carburetor lever

Lug in the "lean" stop position

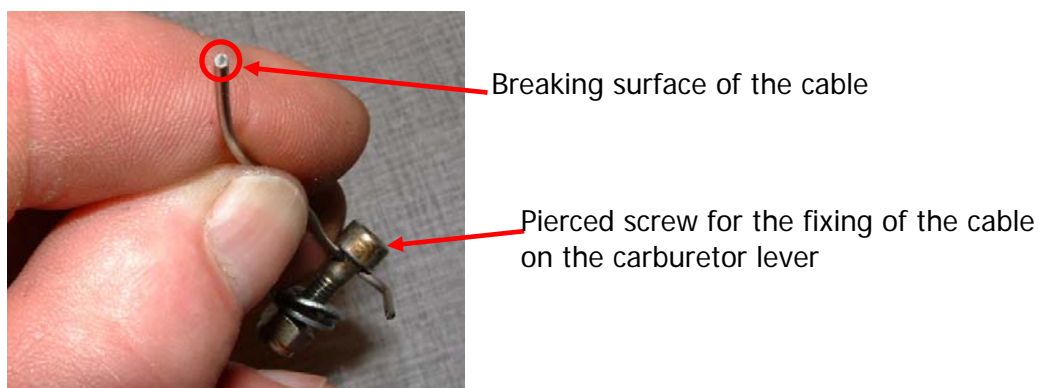
- The break in the "piano wire" control cable is due to fatigue. The analysis report states that the break presents normally on the surface, without any macroscopically identifiable deformation. The areas of the edges have suffered secondary damage in places. From the macroscopic viewpoint, the typical characteristics of a fatigue break in the form of streaks can be recognised; these occur over approximately 40%. Given the orientation of the break, one can suppose that the force causing this break is the result of a unilateral bending stress superimposed on a slight torque effect. Despite the secondary damage observable on the surface of the break, streak marks due to vibration can be seen in places. The break due to the residual force exhibits the typical characteristics of a ductile break, in the form of fine pitting.

Mixture control, breaking surface

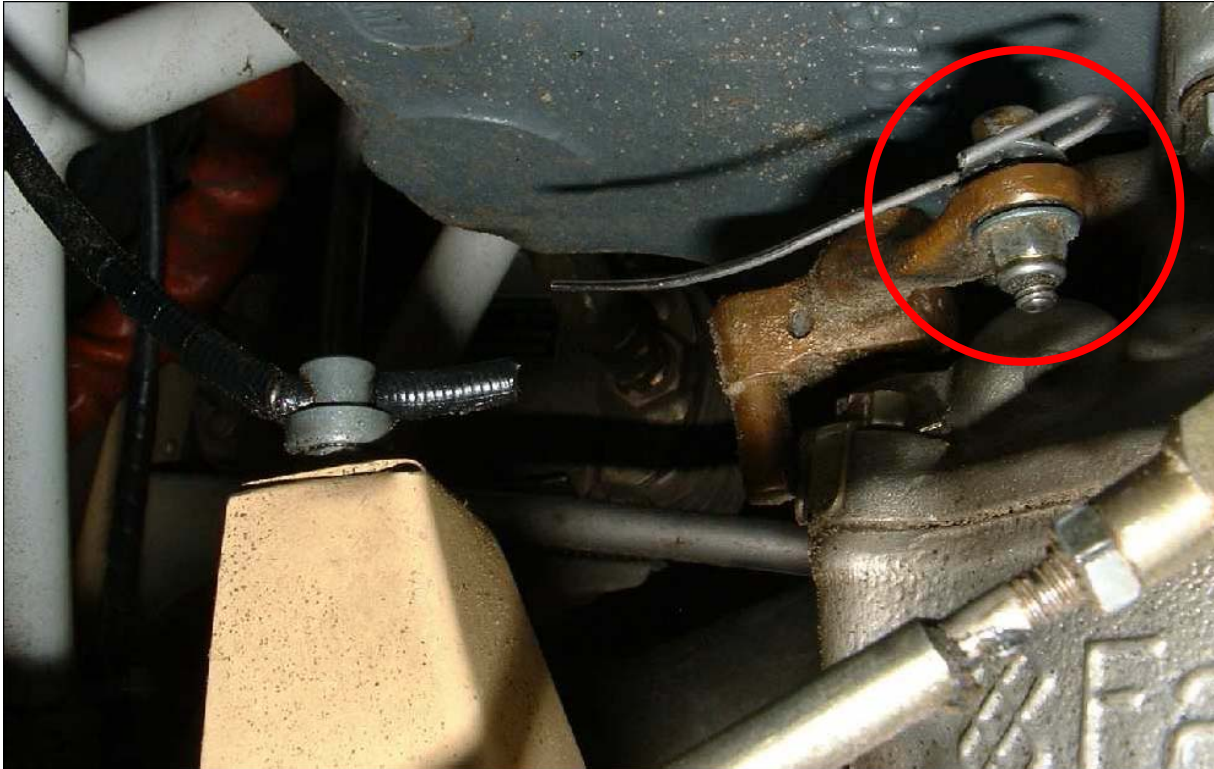
- The travel of the mixture lever was measured on the carburettor during the examination; a clearance of 45 mm was found.
- On the carburettor mixture lever, the perforated screw of the cable clamp was mounted vertically, with the head at the top. This assembly was inverted 180° compared with the manufacturer's instructions. These specify that the perforated screw of the control's cable clamp on the mixture lever must be positioned from bottom to top. Hence, given this inverted assembly, the cable was offset upward by about 10 mm in relation to its normal operating position, and this accentuated the bend in the cable and increased its resistance when it moved inside the sheath. This assembly configuration certainly increased the fatigue effect on the material (Annex 1).

The inadequate assembly configuration, which raised a segment of cable in excess of 15 mm, together with the misalignment, may explain the way the mixture control broke.

The break in the mixture control cable may be explained by the conjunction of two factors: on the one hand the inadequate assembly of the cable clamp on the carburettor mixture lever and on the other hand the incorrect adjustment of the mixture control (Annex 1).

Fig. 1 Mixture control, incorrect assembly

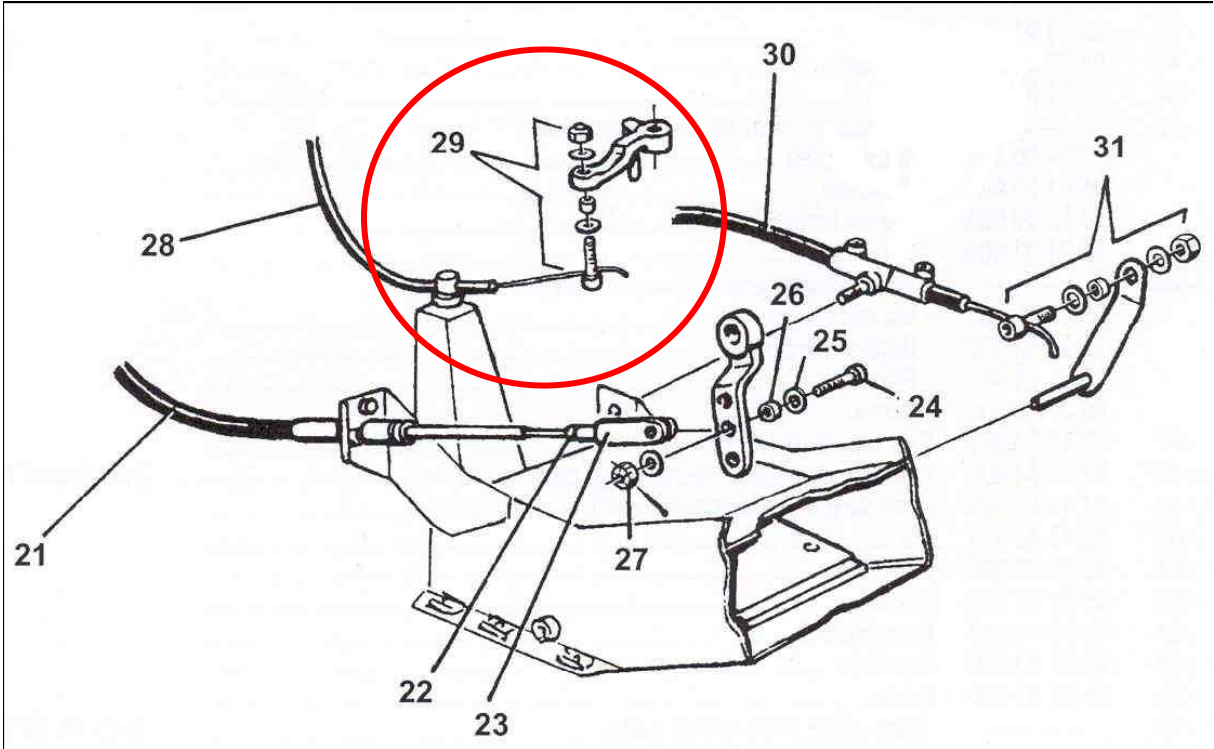
Fig. 2 Mixture control, assembly according to the manufacturer's manual
