# **Final Report No. 1972 by the Aircraft Accident Investigation Bureau**

concerning the serious incident  
to the Piper PA-34-200T Seneca II aircraft, HB-LOG  
on 2 March 2006  
between Egelsbach EDFE (Hessen, Germany)  
and Locarno LSZL (Switzerland)

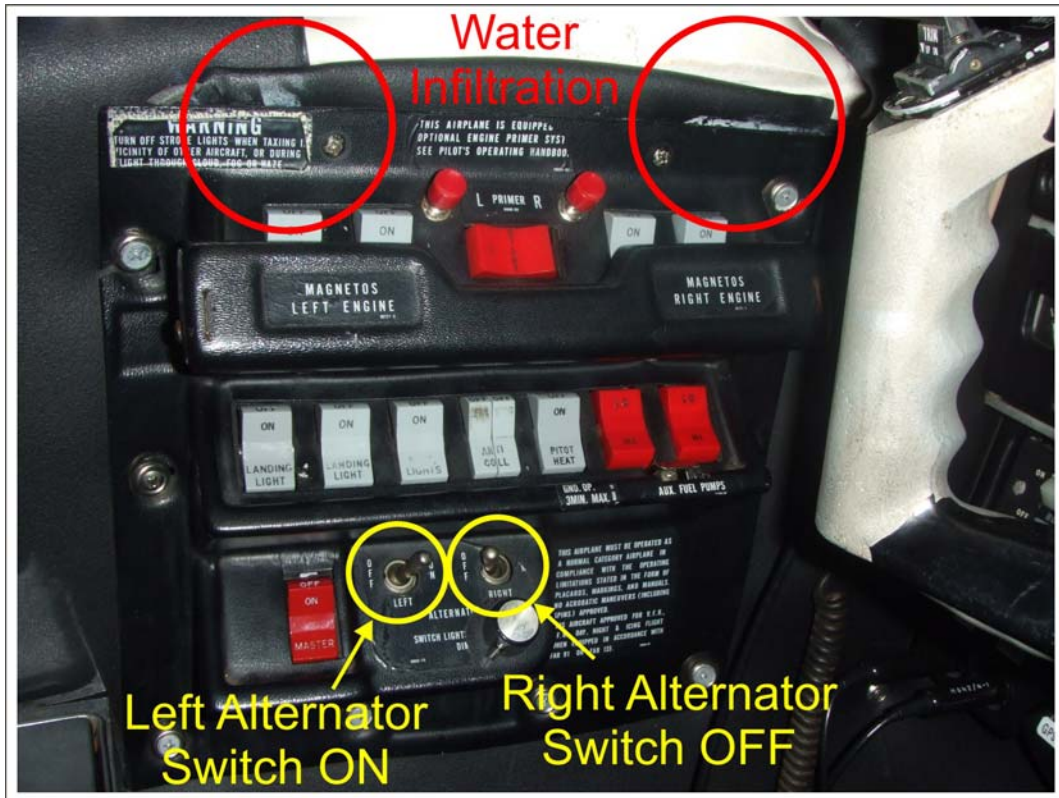
Although he did not assume a total failure of the left generator, he operated the alternator switches. It can be concluded that these switches were not placed in the correct position. This applies in particular to the right alternator switch, which was found to be in the “OFF” position after the incident.

- According to his statement, the pilot of HB-LOG did not realize the intercepting manoeuvres as such.
- After landing in Locarno, the right alternator switch was found in the OFF position.

Fig. 1 Electrical switches on the left side of the cockpit of HB-LOG

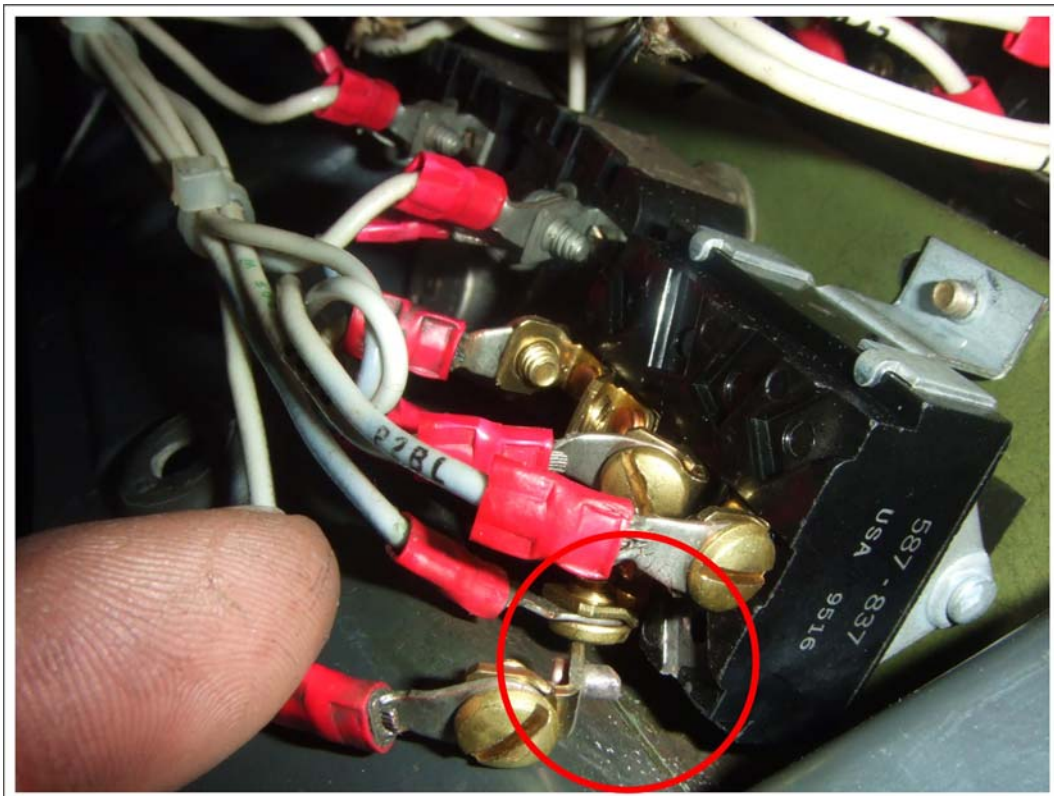
- The connection at the master switch for the cable leading to the left alternator switch was broken. There were traces of oxidation and arcing inside the master switch between the contacts (cf. Annex 1 Fig. 4). The terminal was correctly screwed onto the broken part of the connection (cf. Annex 1 Fig. 2).

- The terminal on the master switch for the wire leading to the left alternator switch was broken off.
- No VHF/COM hand-held radio was carried on board.

Fig. 2 Broken connection on master switch

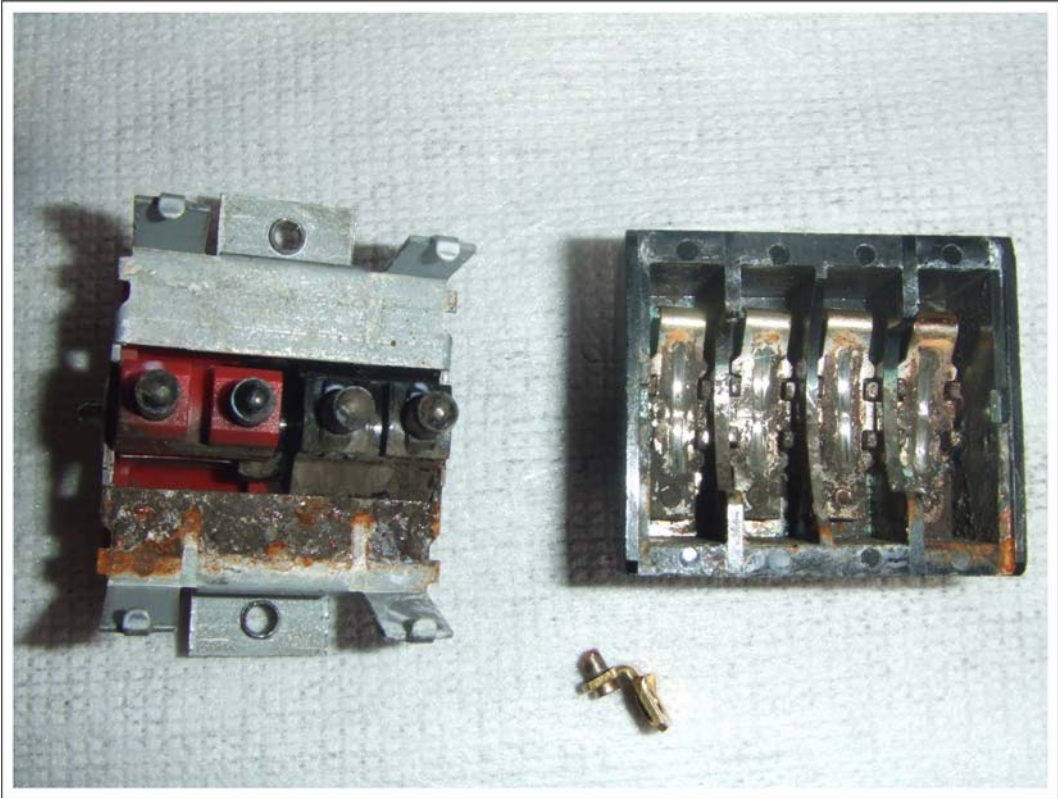
Fig. 4 Internal view of master switch
