Final Report No. 1973 by the Aircraft Accident Investigation Bureau

concerning the serious incident
to the Embraer 145LR aircraft, HB-JAD
operated by Crossair under flight number LX 500
on 24 December 2001
at Basle Airport

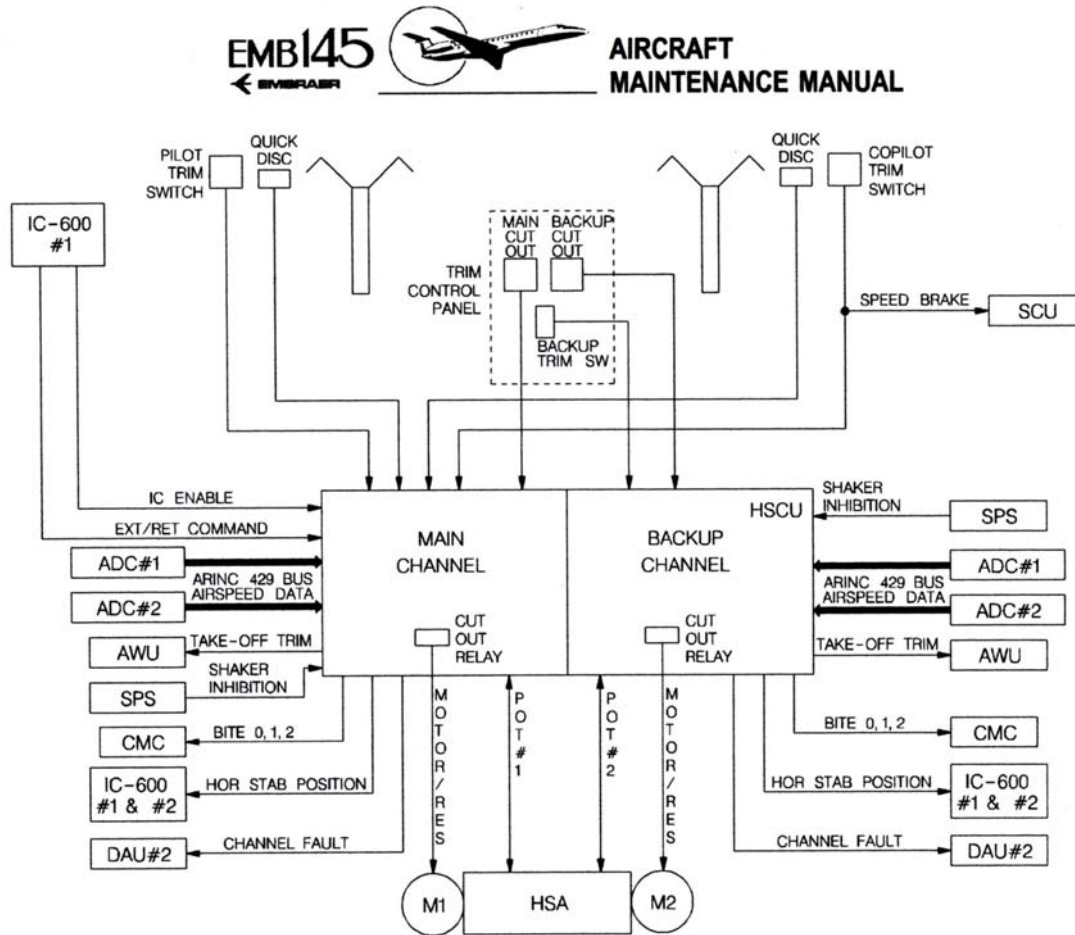
Annex 1: Horizontal Stabilizer Control System Schematic

Movement of the horizontal stabilizer is performed by means of the Horizontal Stabilizer Actuator – HSA. This in turn is controlled by the Horizontal Stabilizer Control Unit – HSCU. The HSCU has two channels, in order to ensure the primary and backup operating modes (see Annex 1).

In primary operating mode, the HSCU controls HSA motor M1 and in back-up operating mode it controls HSA motor M2. Both are identical electric motors.

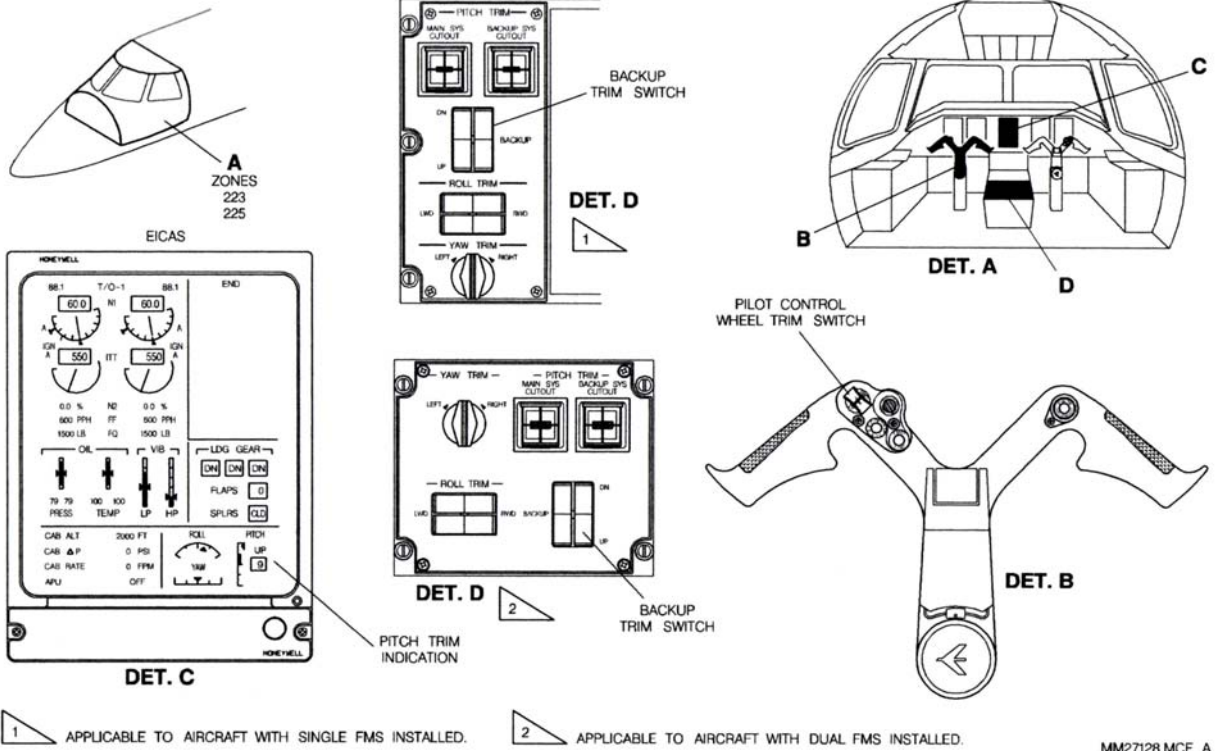
Annex 2: Pitch Trim Control and Indication

During trimming, the stabilizer is adjusted on the one hand automatically by the autopilot or by actuation of the speed brakes and on the other hand by the manual trim using trim switches on both pilots' control column or by means of the back-up trim switch on the centre console (see Annex 2).
