# Schlussbericht Nr. 1982

# Flugunfalluntersuchungen

über den schweren Vorfall (Fastkollision/AIRPROX)  
zwischen dem Flugzeug Boeing 737-86J, D-ABAP  
betrieben durch Air Berlin GmbH & Co unter Flugnummer BER 1315  
und dem Flugzeug Fokker 100, D-AGPP  
betrieben durch Hapag-Lloyd Express GmbH unter  
Flugnummer HLX 3680  
vom 17. Juni 2006  
Zürich, 10 NM östlich KLO/DVOR

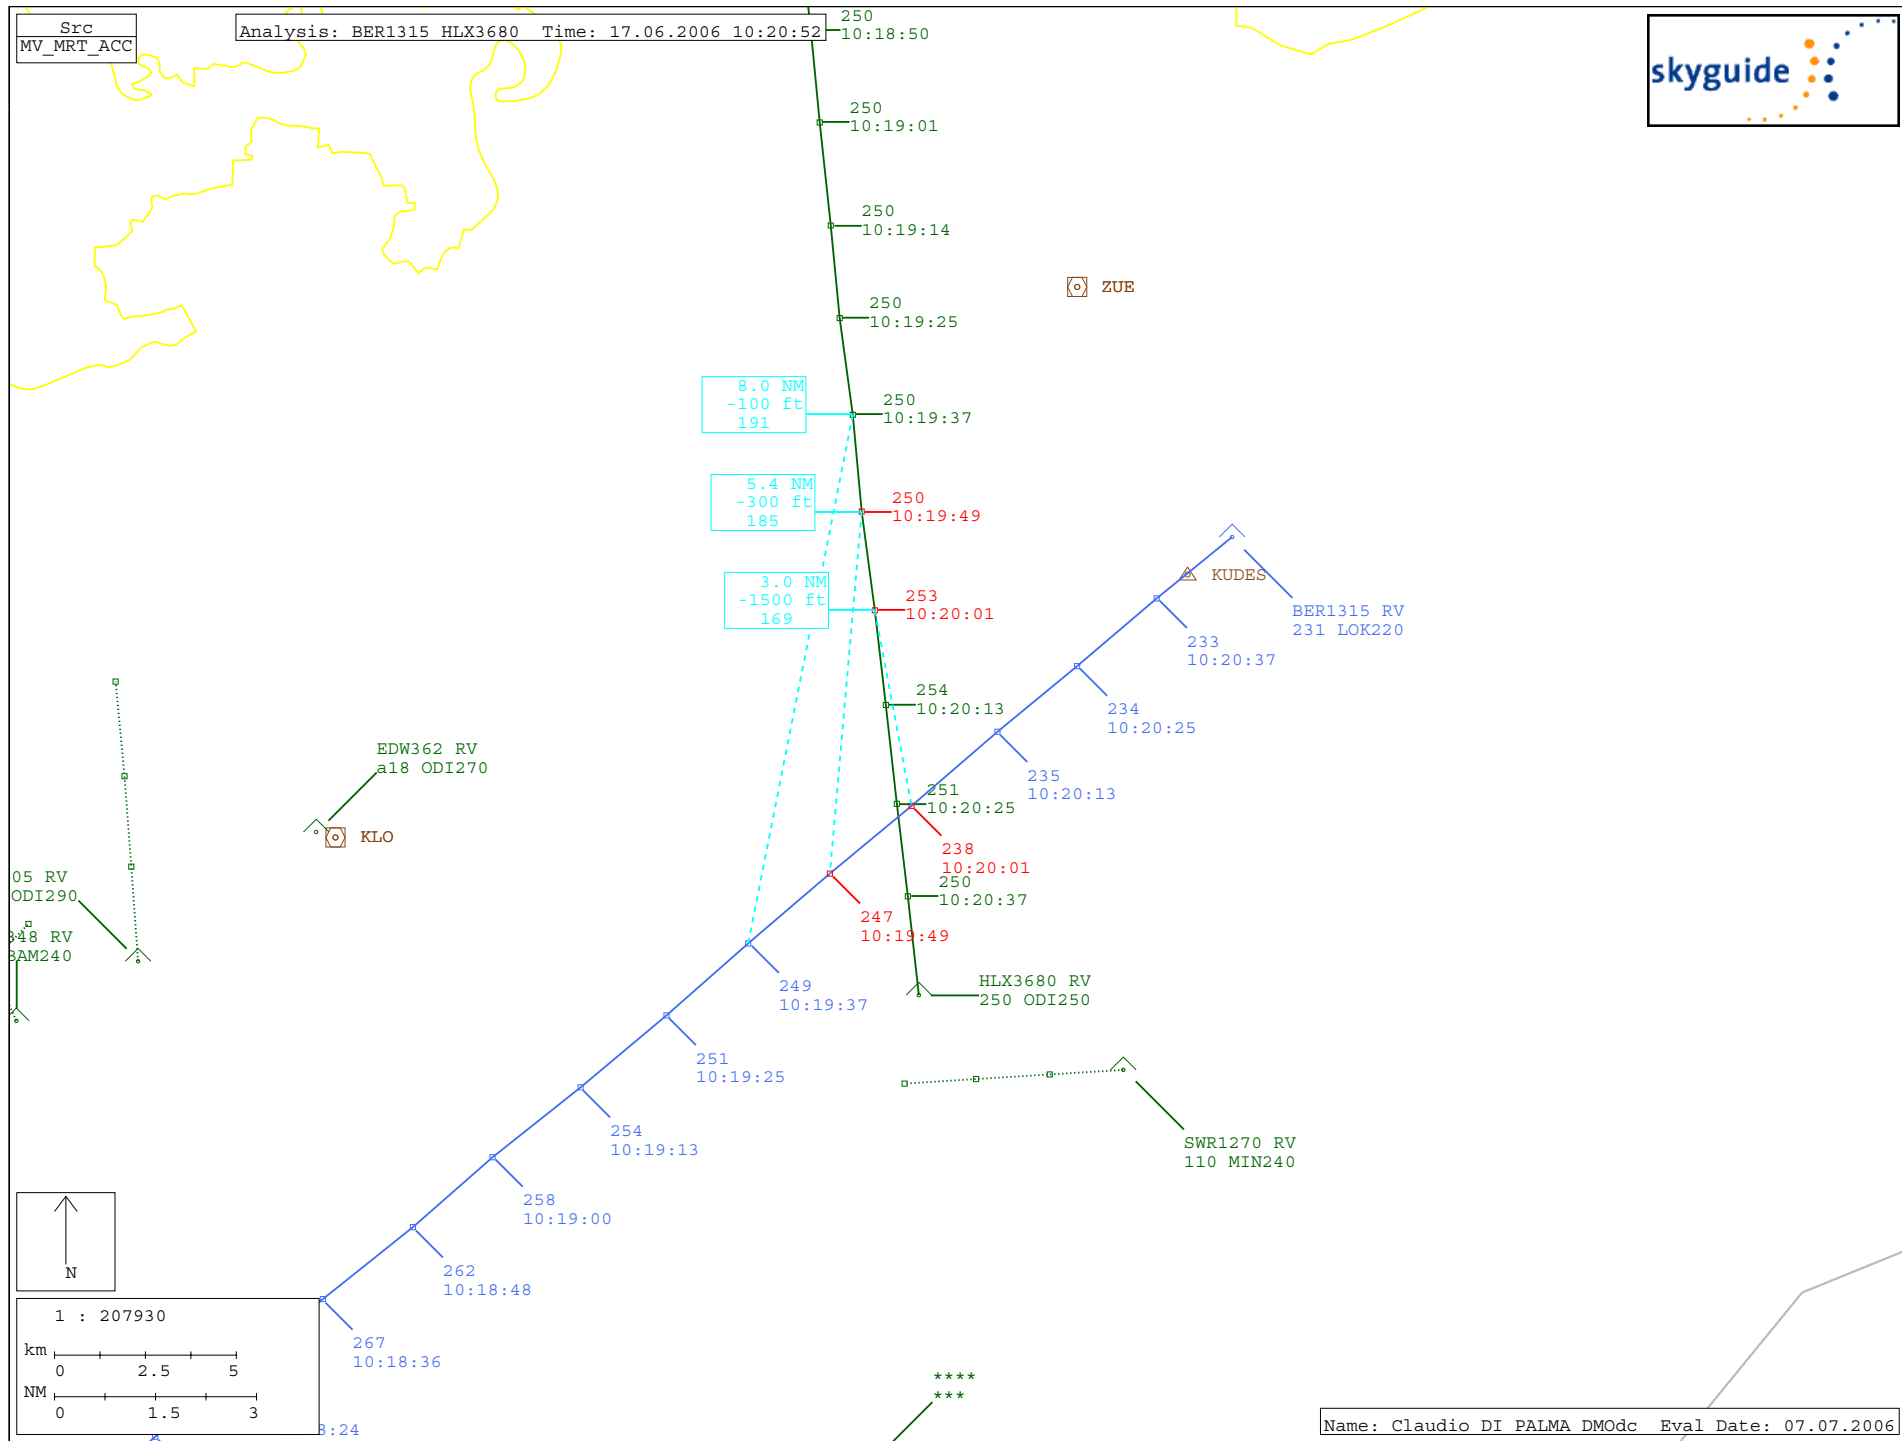
Analysis: BER1315 HLX3680 Time: 17.06.2006 10:20:52

- Um 10:19:59 UTC kreuzte die BER 1315 gemäss Radaraufzeichnung den Flugweg der HLX 3680. Beide Besatzungen folgten den ACAS Anweisungen. Die BER 1315 passierte FL 238 im Sinkflug. Die HLX 3680 befand sich im Steigflug und durchflog FL 253.
