# **Final Report No. 1984 by the Aircraft Accident Investigation Bureau**

to the Bell 206 B helicopter, registration HB-XXN

on 14 April 2005

Valletta di San Gottardo, Airolo/TI

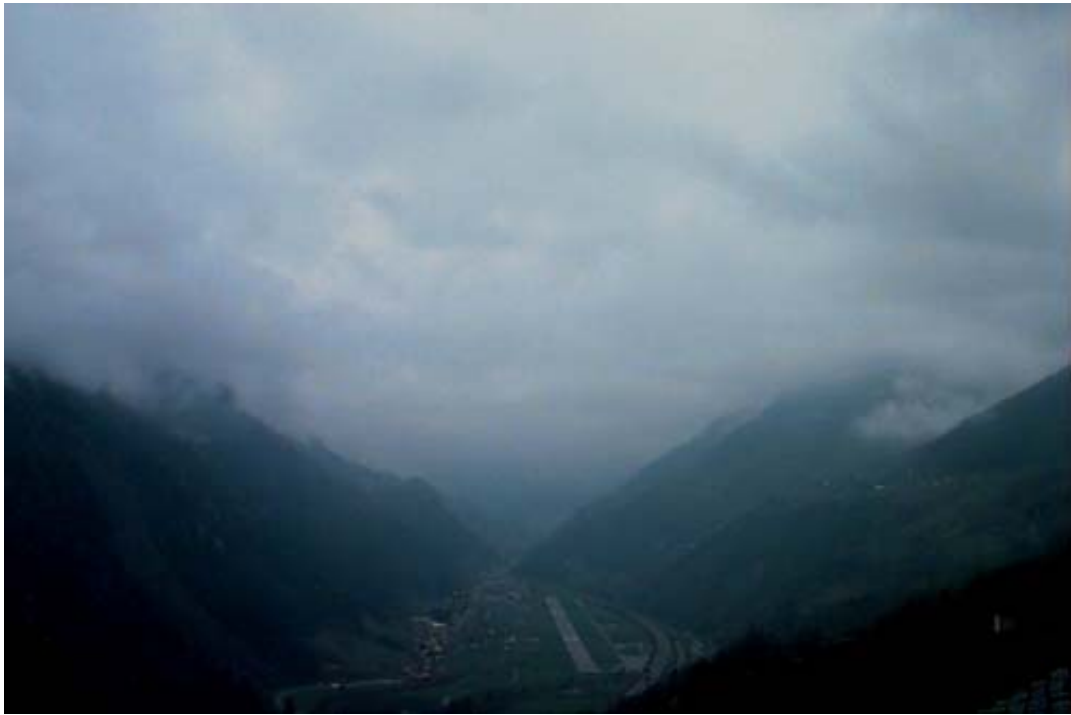
Since webcam images are generally archived only for a short time, after the accident it was only possible to obtain an image of an area to the south of the region of the accident, showing the weather conditions in the upper Leventina shortly before the presumed time of the accident (see Figure 1).

Figure 1 – webcam image: Image from Catto, looking towards Piotta and Airolo on 14 April 2005 at 11:01 LT. Ambri aerodrome can be seen in the foreground.

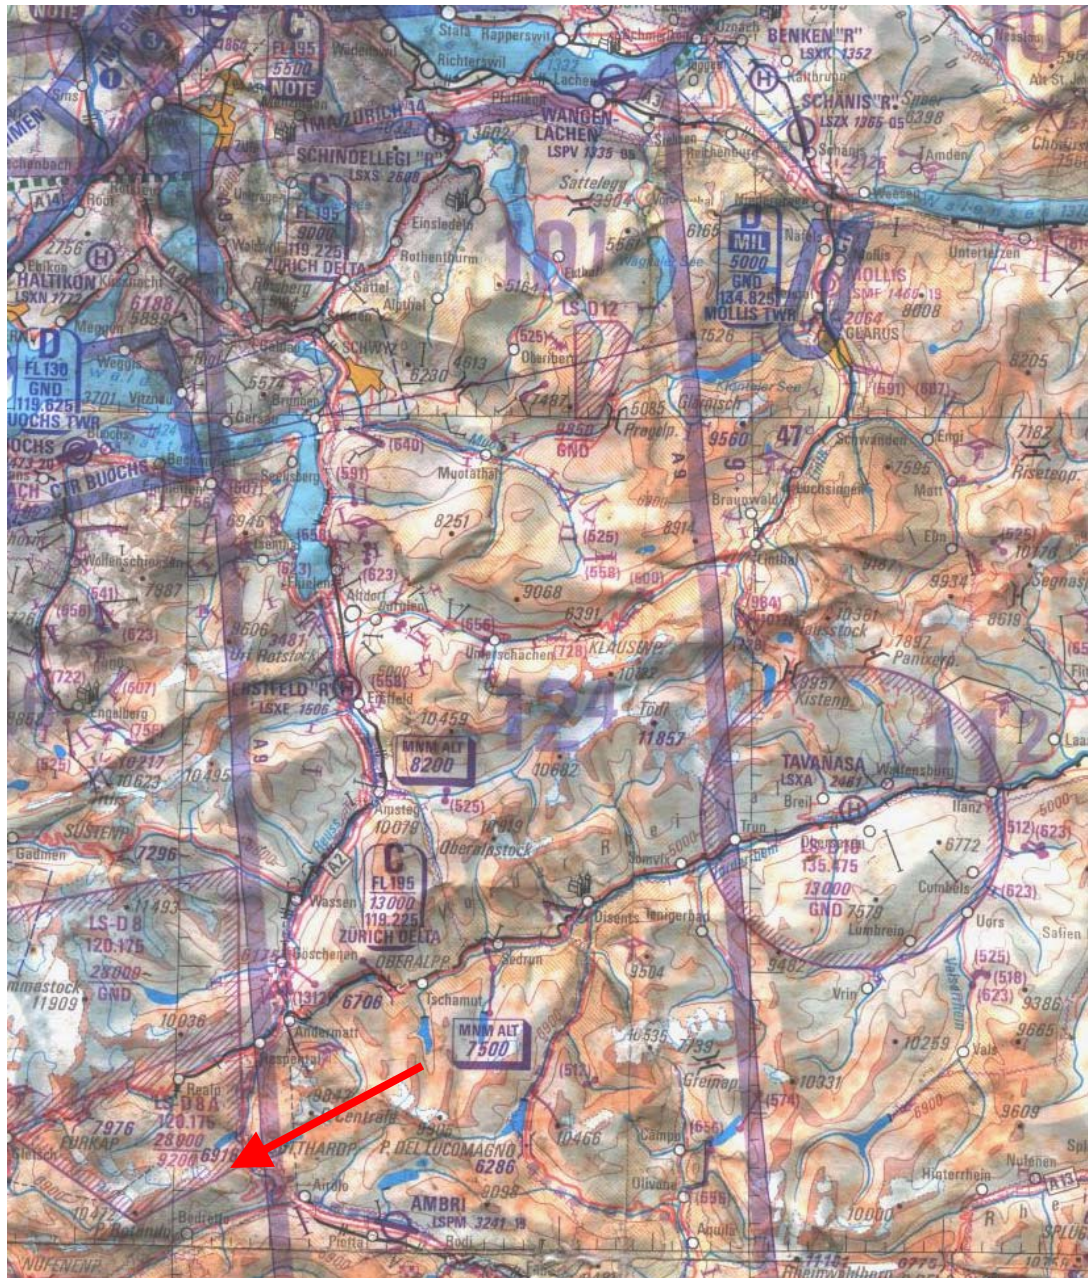
Figure 3 - Section of the ICAO chart: This chart, scale 1:500 000 was being carried on the flight involved in the accident. The section shows the area of the Gotthard Pass. The red arrow indicates the site of the accident.
