Final Report No. 1985 by the Aircraft Accident Investigation Bureau

concerning the accident
to the Gulfstream G-V aircraft, HB-IMJ
operated by the G5 Executive AG company
under flight number EXH 152
on 1 June 2007
at Zurich Airport

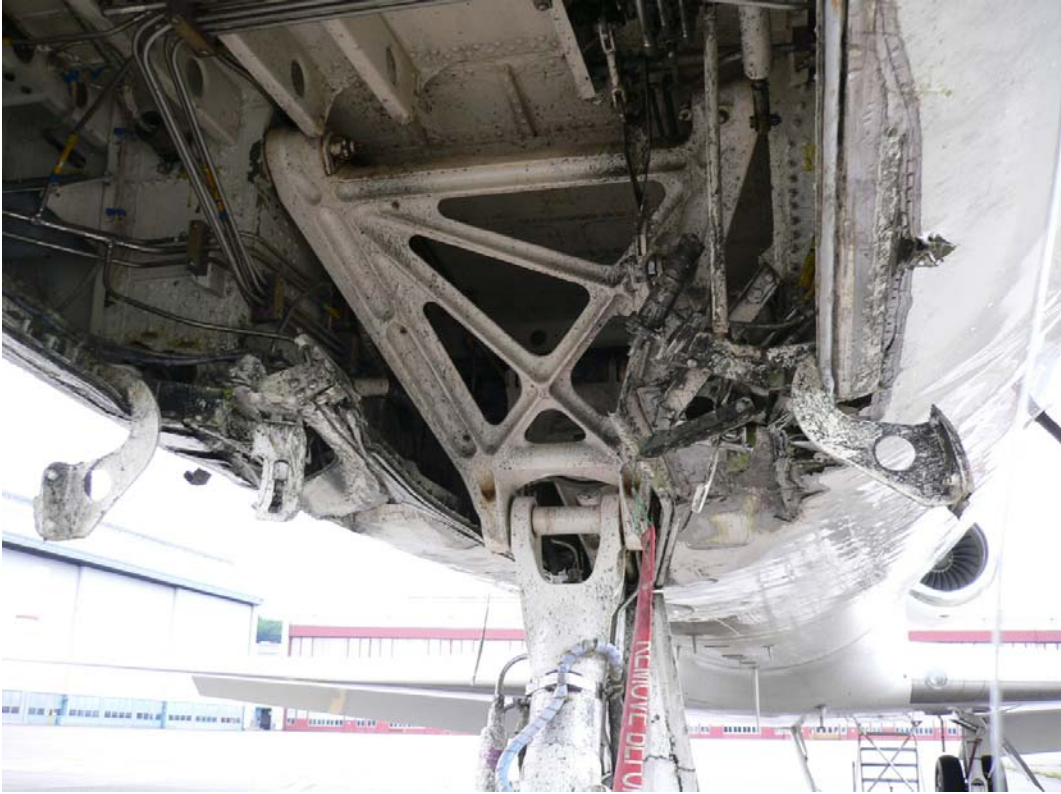
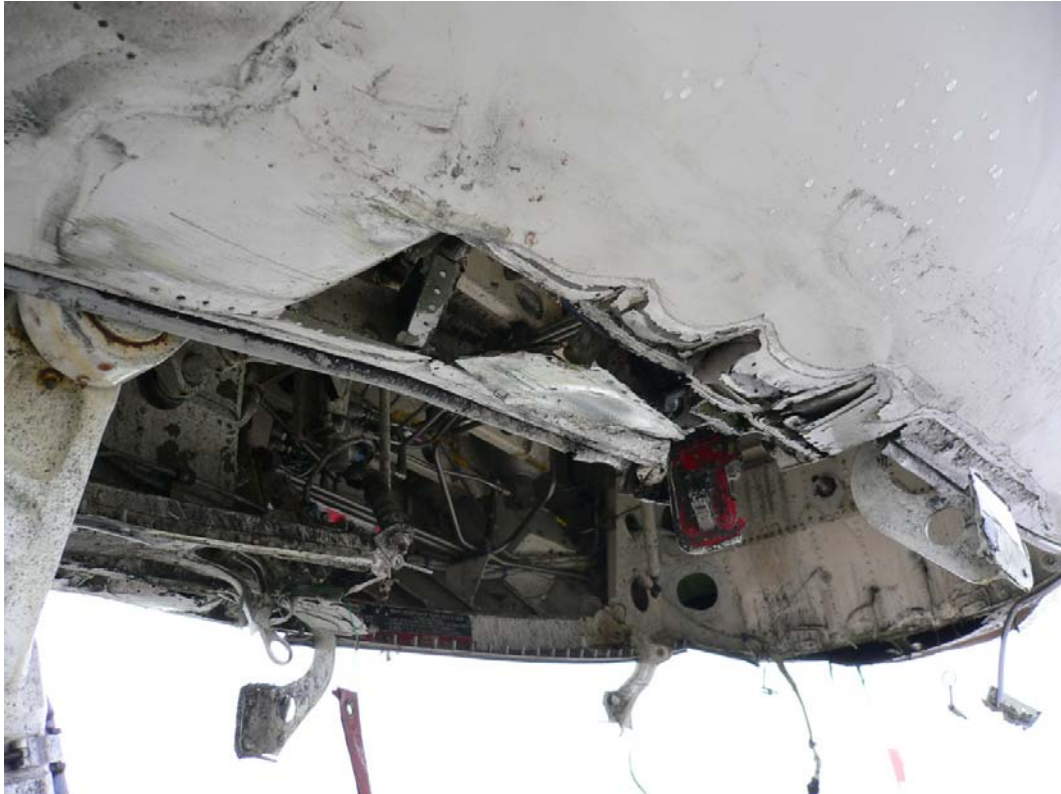
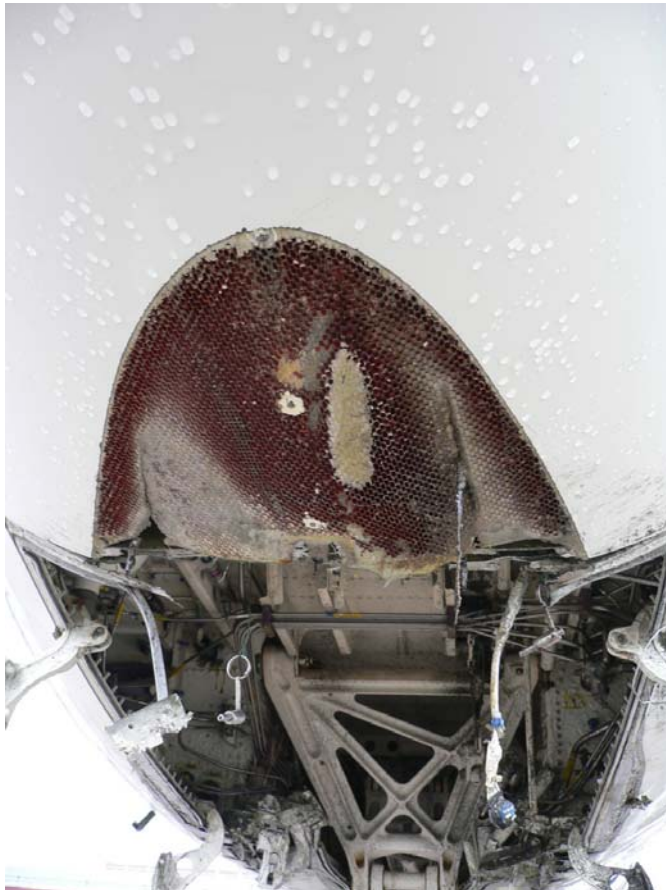
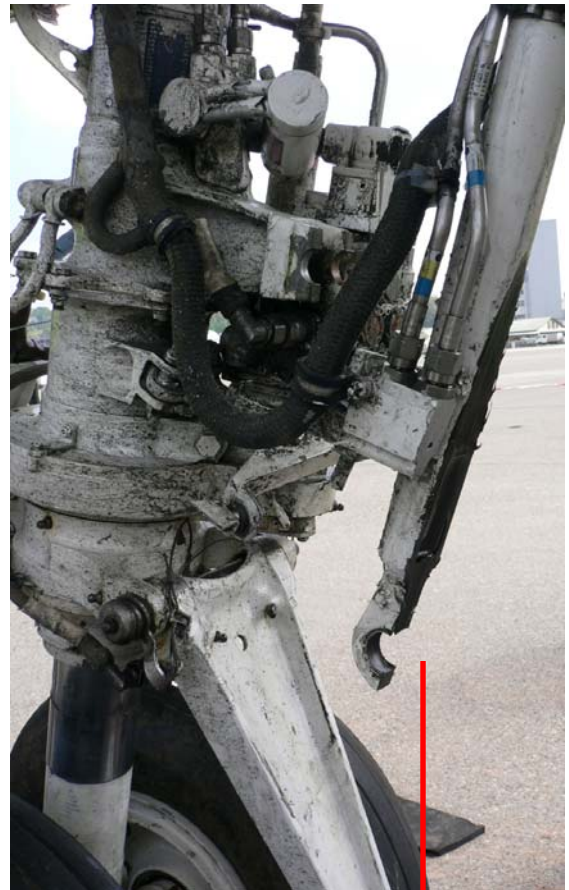
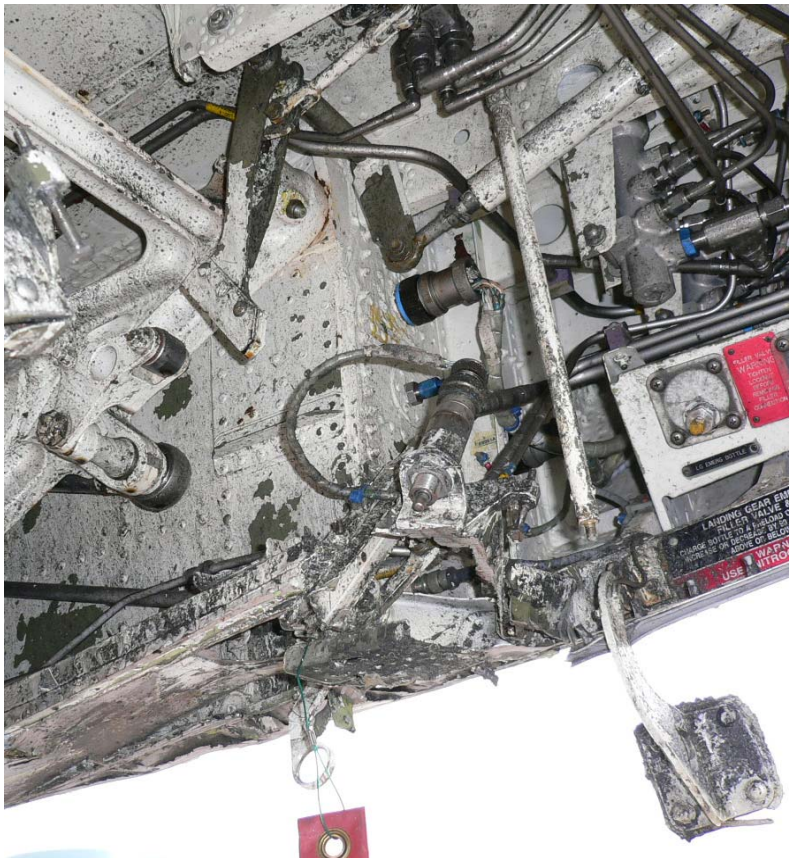
Annex 1: Damage to the aircraft

There was considerable damage to the aircraft (see Annex 1). The individual items of damage could be reconstructed using the maintenance company's repair report (Work Report W.O. No. BHIMJ067). The listing below is a summary of the damage which occurred.

In the area of fuselage stations FS 44 – FS 145, the lower fuselage sheeting was replaced. In the area of fuselage stations FS 44 – FS 119 a fairly large number of bulkheads, frames and stringers were replaced. In the area of fuselage stations FS 95 – FS 114, stiffeners were installed. This work was performed in accordance with special instructions from the aircraft manufacturer.

A wide strap was placed around the front part of the fuselage and the nose of the aircraft was lifted with the aid of a hydraulic crane. The intention was to extend the nose gear manually, lock it and tow the aircraft away. When the badly damaged gear door was opened, it was apparent that the drag brace had been considerably abraded (see Annex 1). This meant that the nose gear could no longer be locked.

Damaged radome and nose gear bay

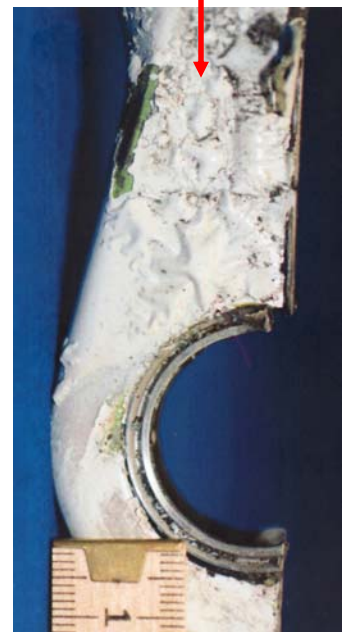
Drag brace

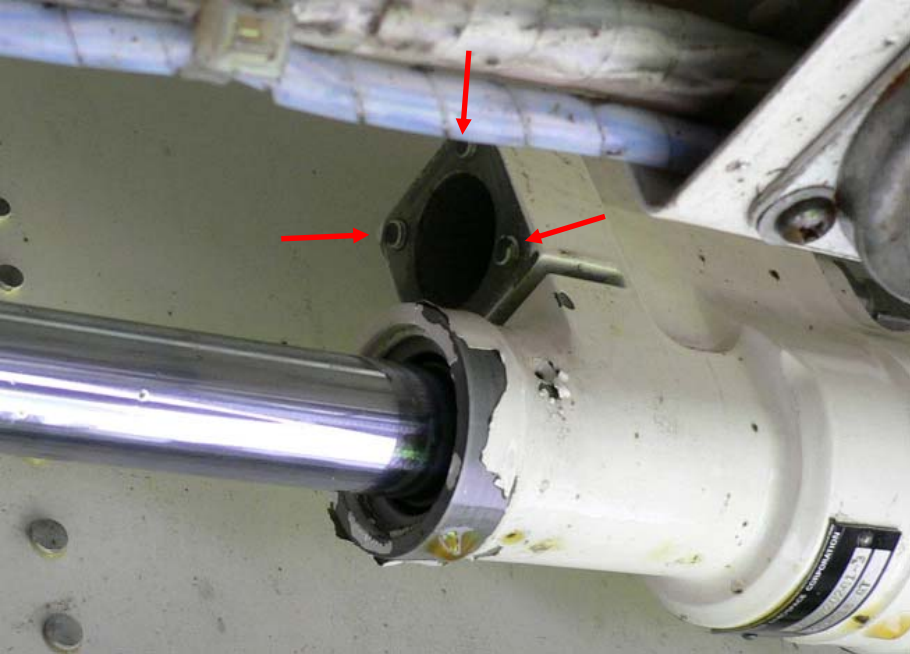
On the door actuator it was evident that the four screw heads securing the end gland on the shuttle valve had ripped off. The end gland was broken and hanging from the hydraulic line (see Annex 3).

Ripped off end gland retaining screws (arrows)

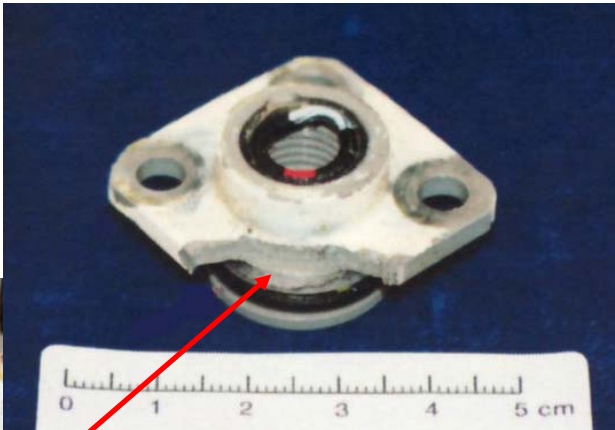
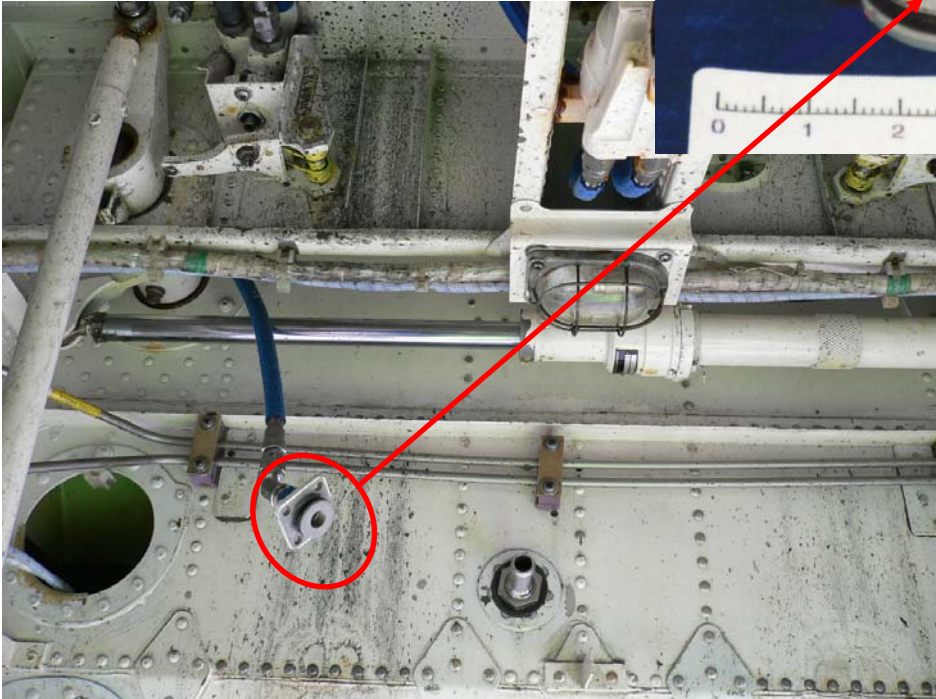
Broken-off shuttle valve end gland

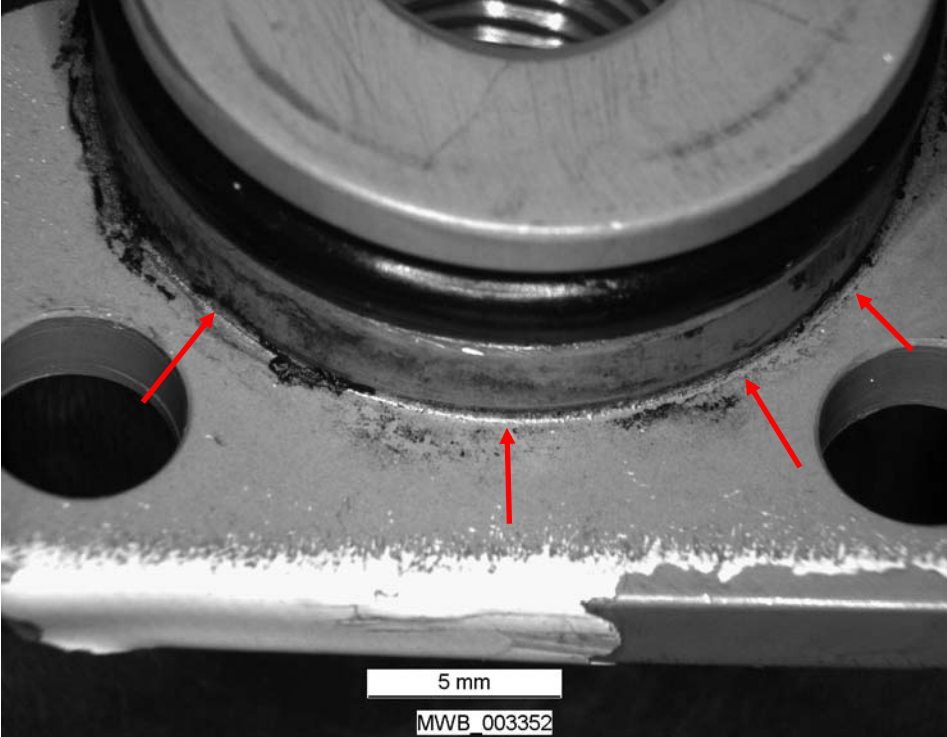
Fractographic examination of the end gland showed that the fracture occurred on the inner radius at the transition from the lug to the flange. At the origin point of the fracture, impressions could be detected on the surface of the inner radius, which were very probably caused by a washer. Other incipient cracks were present over virtually the entire extent of the inner radius (see Annex 5, figure 1 and 2).

An incipient crack was also present on the opposite side of the flange over the entire extent of the inner radius.

Figure 1:
Incipient crack along inner radius on the opposite side of the flange

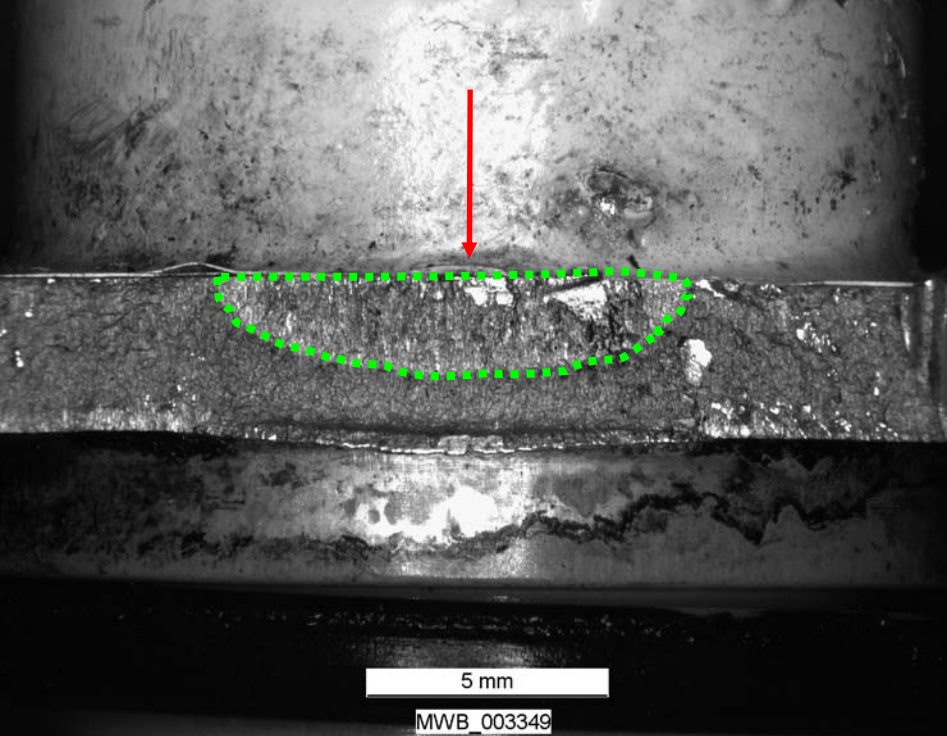
Part of the surface of the fracture was mechanically damaged (secondary damage). Macrofractographically, the origin of the fracture was located in the area of the indentation point of the washer.

The primary fracture of the end gland was initiated by a fatigue fracture, starting from the inner radius at the transition from the flange to the lug. The fracture starts in the area of a nick which was presumably caused by the impression of the washer lying on it. The question arises whether the choice of diameter of the washer was appropriate.

Figure 2:
Fracture surface with secondary damage (shiny). Origin of fracture (arrow) at flange/lug transition. Edged in green: fatigue fracture surface

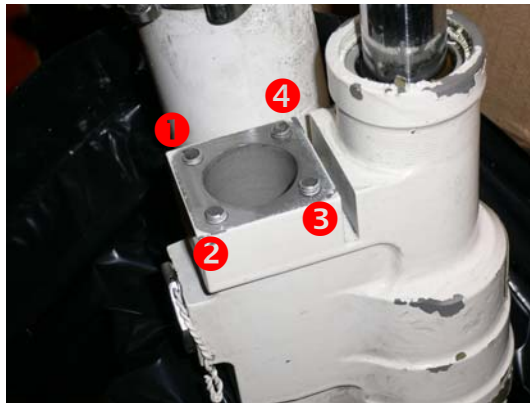
Fractographic examination of the retaining screws indicated the typical characteristics of a fatigue fracture. With approximately 85%, screw 1 exhibits the highest fatigue fracture area (see Annex 6, figure 1 and 2). Screws 2, 3 and 4 show fatigue fracture area of approximately 70%. There are numerous steps, which indicate a high level of notch effect. The residual surfaces of the forceful fracture show the typical characteristics of a ductile fracture (honeycombs). No abrasion is evident on the thread flanks, as is normally present when adequate tension force is applied to screws.

Figure 1: Broken-off end gland retaining screw

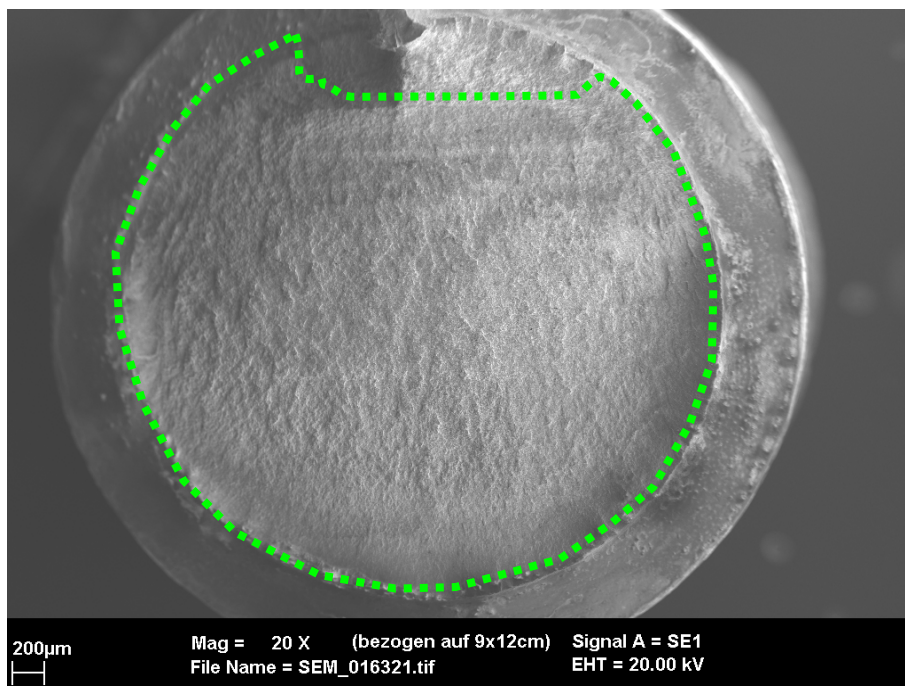
All four retaining screws exhibited a high area of fatigue fracture (pulsating/flexural loading), finally leading to failure (forceful fracture). Numerous production-related incipient cracks were present on the thread flanks of the retaining screws. The applied coating is virtually undamaged, indicating that the screws were insufficiently tightened.

Figure 2: Fracture surface of screw No. 1. Fatigue fracture area edged in green. Numerous steps along the thread base.

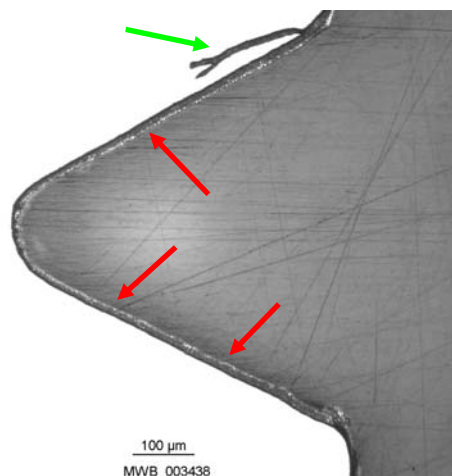
A metallographic cross-section was then produced in the axial direction on screw 1. The screw is coated; the coating is undamaged along the thread flanks. Incipient cracks, presumably caused during manufacture, were present over virtually the entire length of the screw on the thread flanks. In the groove of the further threads, fine incipient cracks were also present (see Annex 6, figure 3).

Figure 3: Undamaged coating (red arrows) and incipient cracks (green arrow) on the thread flanks.

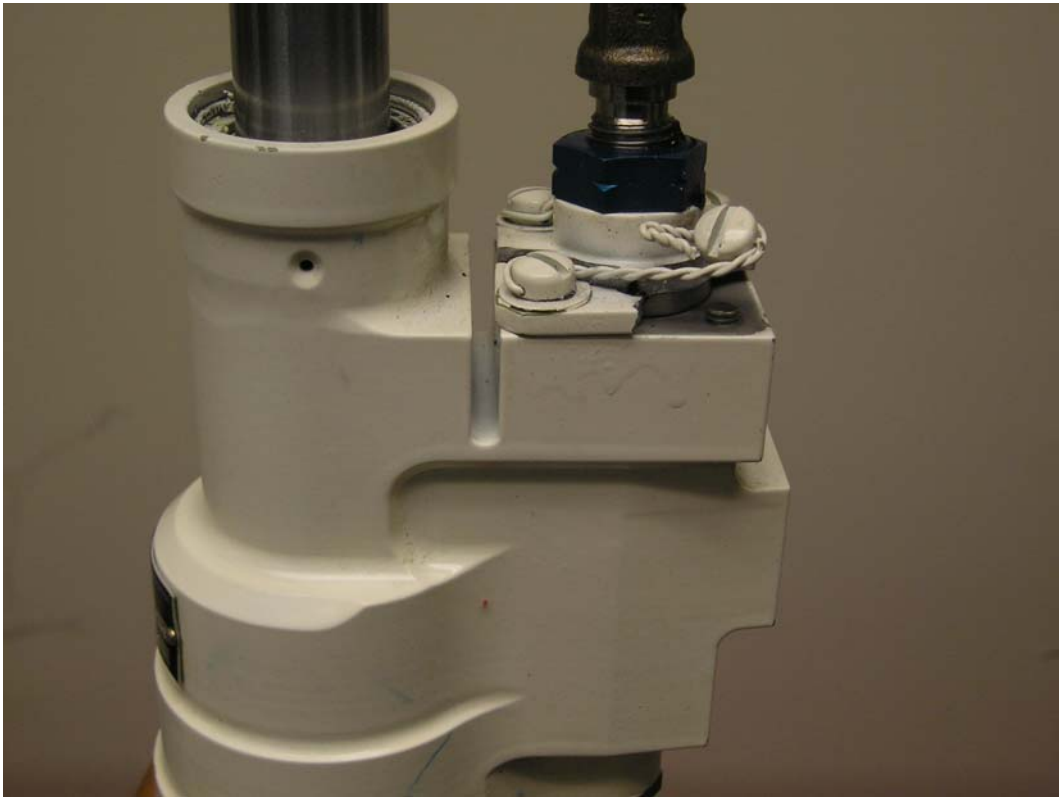
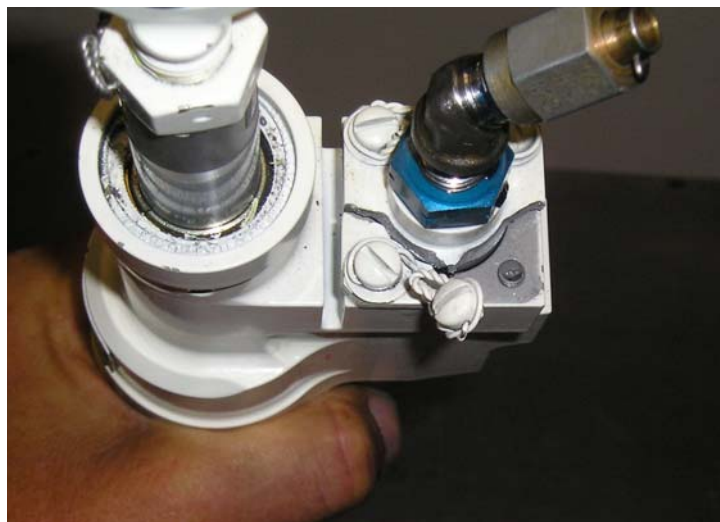
Annex 9: Evidence of damage in another incident

The aircraft manufacturer's investigations after the incident showed that a retaining screw for the end gland of the nose landing gear door actuator shuttle valve had ripped off and that parts of the gland had broken off (see Annex 9).

Another incident on a Gulfstream G-V occurred on 22 June 2007 (see chapter 1.18). The aircraft manufacturer subsequently arranged for the replacement of the type AN502-10-8 retaining screws which were in use.
