# **Final Report No. 1986 by the Aircraft Accident Investigation Bureau**

to the Robinson R22 Beta II helicopter, registration HB-ZGH

on 27 February 2006

Neumatt, municipality of Bätterkinden/BE

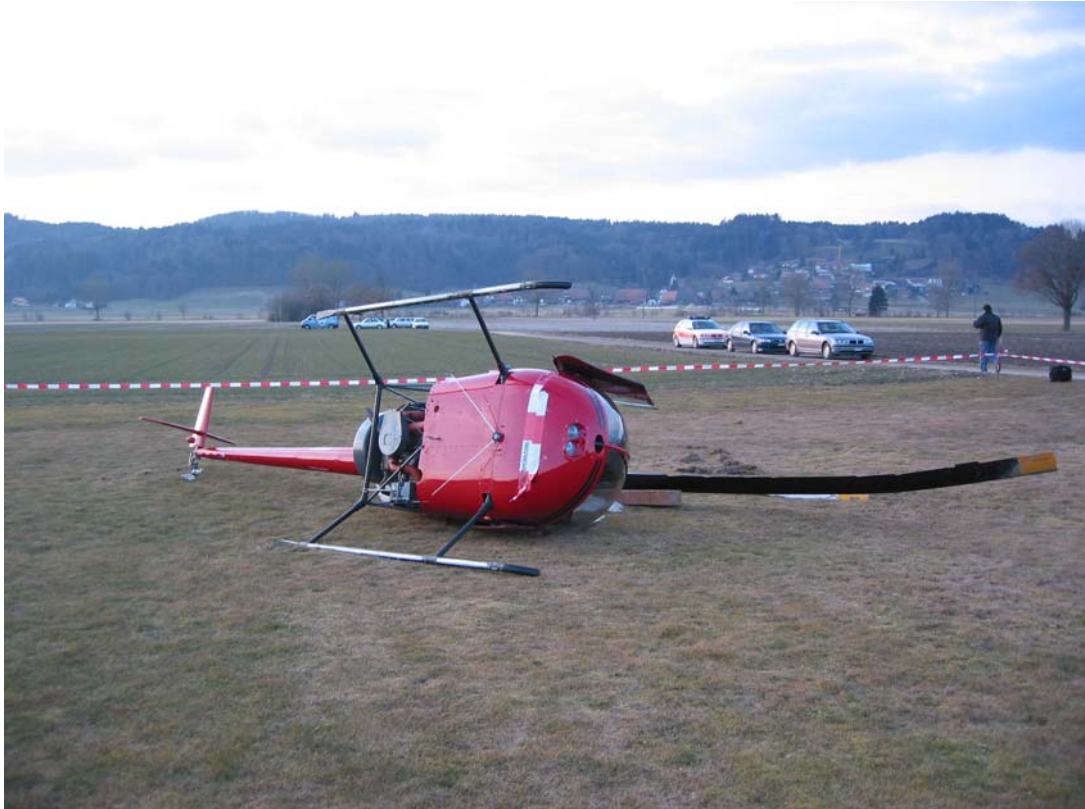
The pilot pressed the right pedal to prevent rotation around the yaw axis. At the same time he lowered the collective pitch and immediately pulled it up again, in order to stop the helicopter's vertical movement. In this phase, the crew noticed that HB-ZGH shifted laterally to the left, the left skid made contact with the ground and the helicopter began to tip over to the left. Although both of them immediately pushed the collective pitch full down, as they say, it was no longer possible to prevent the helicopter from tipping over to the left.

**Figure 1:** Final position of the helicopter after the accident

- Part of the left skid dug into the grass.
- The helicopter tipped over to the left.
- The nose of the helicopter was pointing approximately in the 080° direction.

The accident is attributable to the fact that during touchdown following a simulated engine failure while hovering, control over the helicopter was lost and it tipped over.
