Final Report No. 1987

Federal Aircraft Accident Board

to the aircraft model VAN'S RV-9, HB-YML

on 10 October 2007

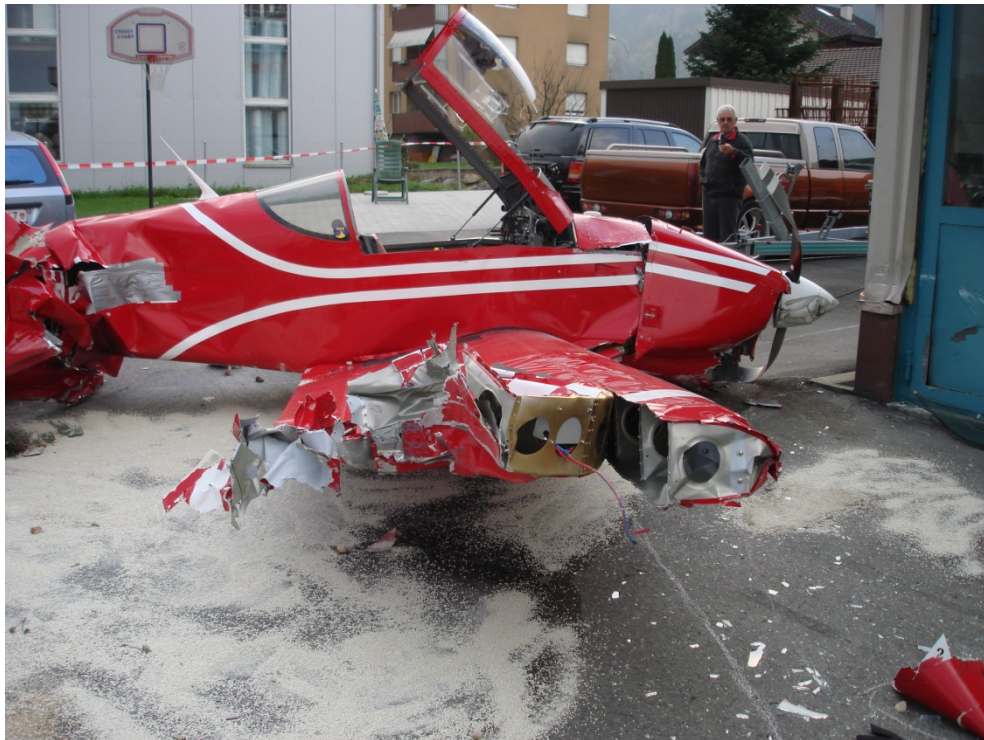
The aircraft was destroyed.

The damage to the propeller indicated low rpm at the time of impact.

The engine and ignition system suffered minor damage.

Fig. 2: The wreck of the aircraft

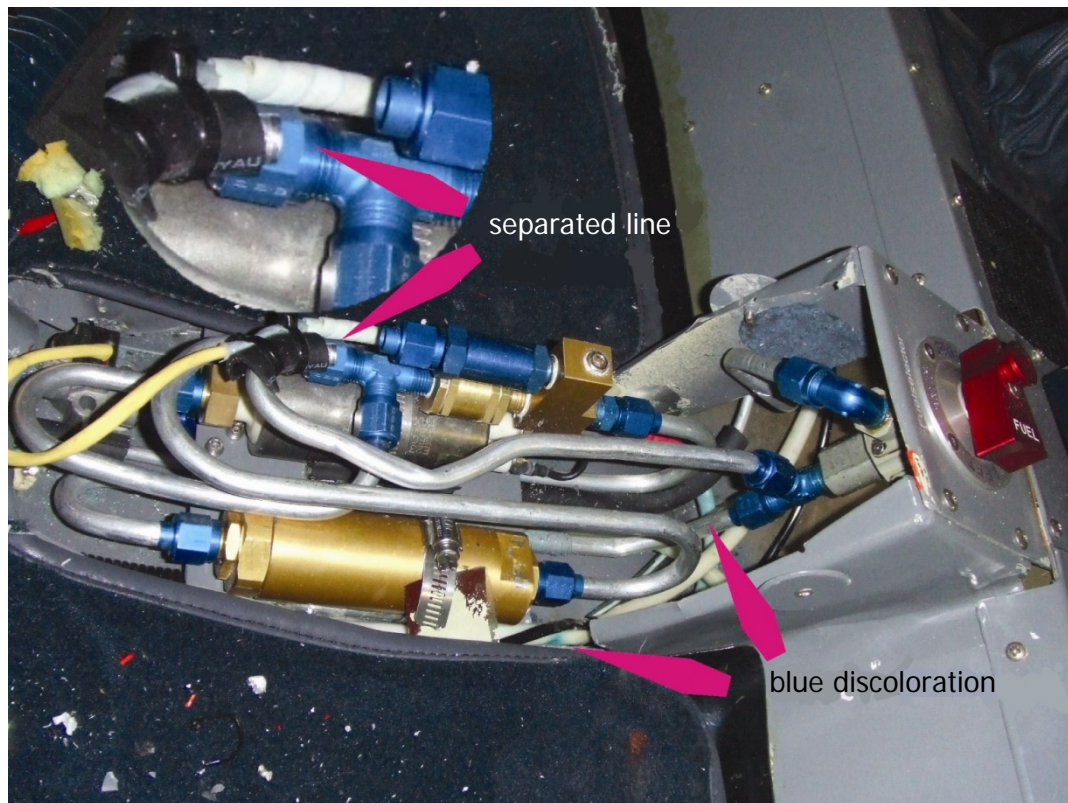
Once the only slightly damaged casing had been opened, it was found that the booster pump return line to the fuel selector was separated.

Fig. 3: Separated return line

No traces of an external violent force could be found either on the fuel selector casing or on the separated line.

Abnormal force had to be applied to separate the other fuel lines in this area when the locknuts were loosened. Individual ends of lines were jammed firmly in the locknuts; this was attributable to excessive tightening of the unions. Examination of the torn-out end of the return line and the corresponding locknut showed that the wall thickness of the tube at the flare was greatly reduced and as a result had torn around its circumference. This damage, as well as the end of the fuel line jammed in the locknut, indicated that the lines had been fabricated incorrectly. Upon examination it was found that the fissured line had been pushed out of the locknut. This condition can be explained as the result of the high deceleration forces on impact.

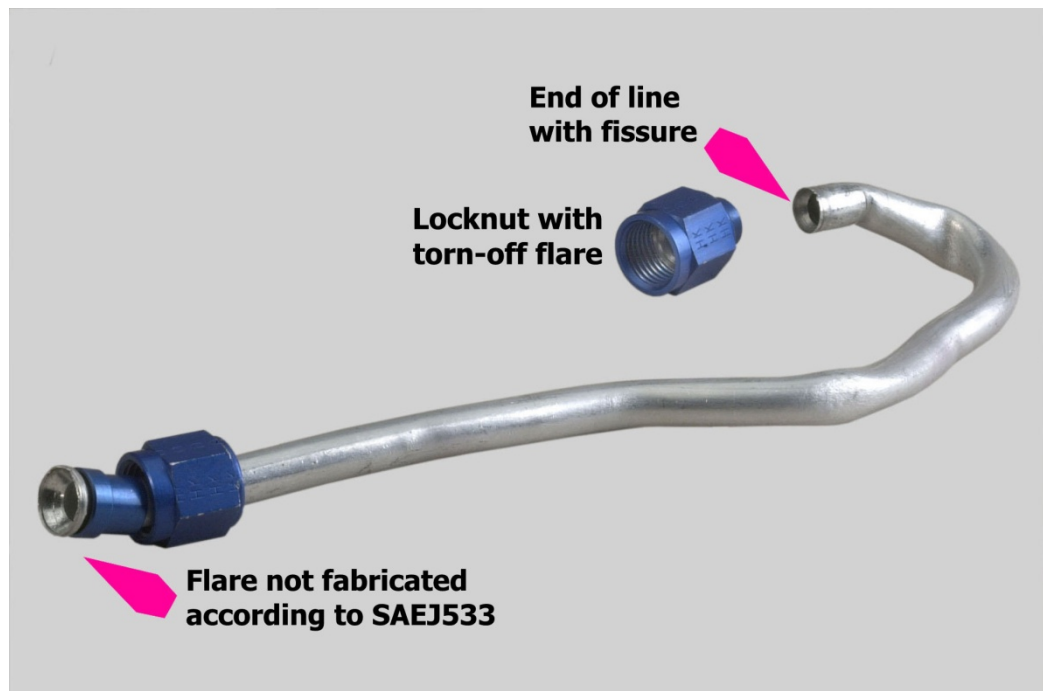
Fig. 5: Fissured fuel line

On the basis of the measurements and tests carried out, it can be assumed that at full power on take-off, with the booster pump switched on, air found its way into the injection system through an opening in the fissured return line and consequently the engine first delivered reduced power and then shut down completely.

- Examinations of the torn-out end of the return line and the corresponding locknut showed that the wall thickness of the tube at the flare was greatly reduced and as a result had torn around its circumference.

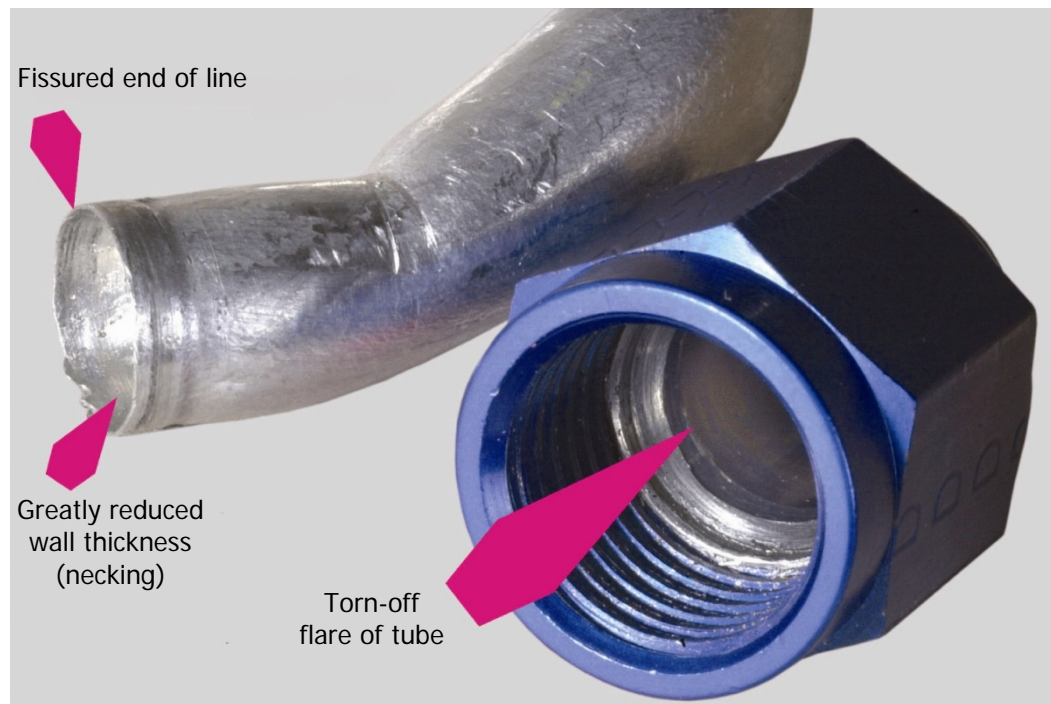
Fig. 6: Details of the fissure in the line and the torn-off flare in the locknut

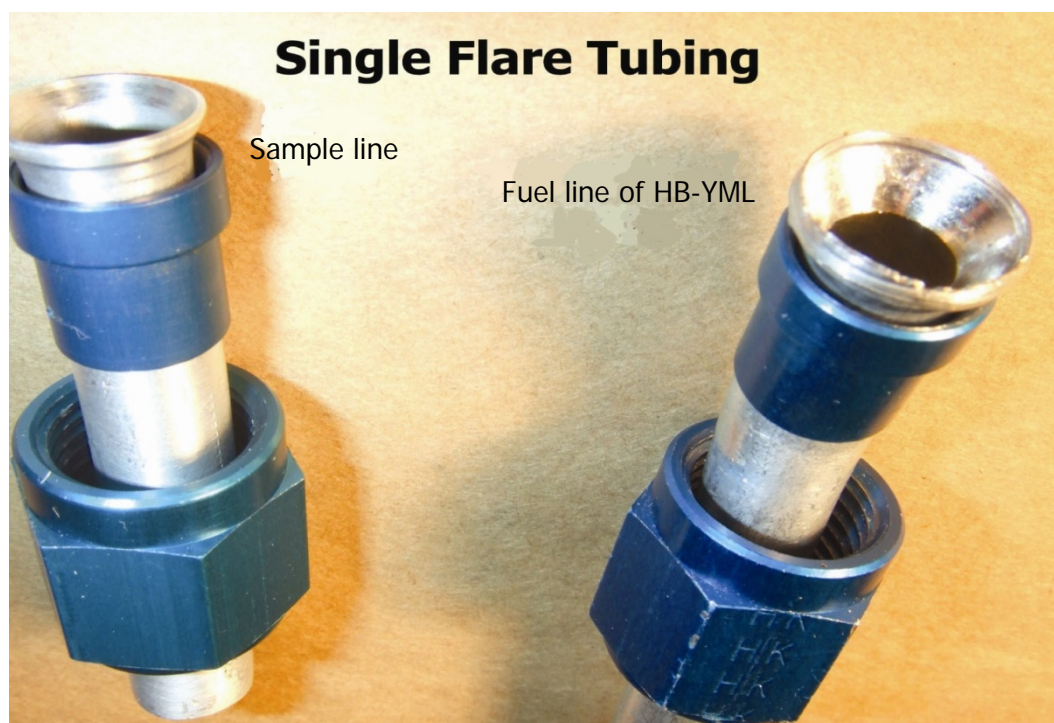
Fig. 7: Left: line with correctly fabricated flare, right: line from aircraft HB-YML with a flare not fabricated according to norm SAEJ533

An assessment plus geometric measurements of the flares on all aluminium fuel lines showed that they had not been fabricated professionally and that the dimensions did not comply with the norm SAEJ533.

- Geometric measurements of the flares on all aluminium fuel lines showed that they had not been fabricated professionally and that the dimensions did not comply with the norm SAEJ533.

The engine failure is attributable to a fuel line which was not fabricated professionally.
