Final Report No. 1994 by the Aircraft Accident Investigation Bureau

to the Schweizer Aircraft Corp. Helicopter 300C Model 269C

registration HB-XQF

on 10 July 2003

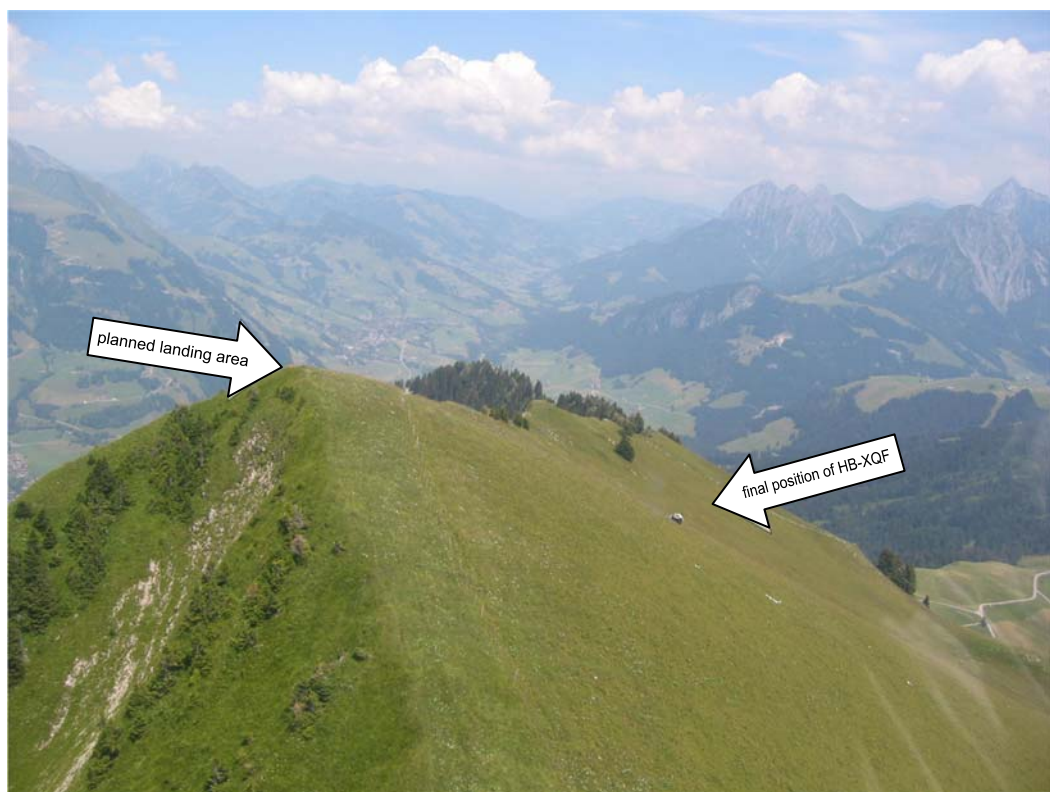
The landing area was a barbeque area, approximately 2 m in diameter at the north-east end of the ridge.

Figure 1: view of the planned landing area on the ridge from the approach direction and the final position of the helicopter

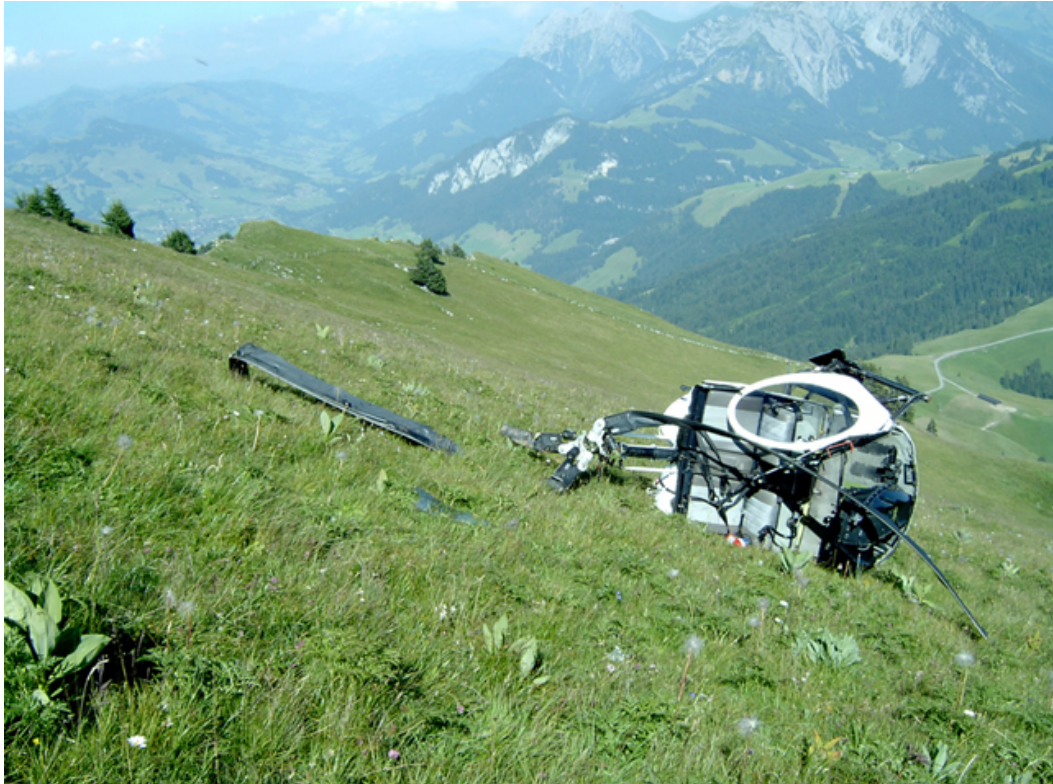
The third approach was rather short. In the course of the increased power demand that was necessary in this phase, the engine speed dropped first to 3000 rpm and then shortly afterwards to 2800 rpm. A landing at this place was not possible. In this phase, the flying instructor took over the controls and attempted to turn away from the peak to the south, towards the sloping terrain. Despite a slightly decreased load on the collective, it was not possible to bring the main rotor speed back up again. The helicopter touched down at a low forward speed with its nose pointing down the slope. In the process the skids caught in a cattle fence. The helicopter then rolled several times around its transverse axis. The tailboom was torn off. After rolling twice, the trainee pilot released the buckle of his belt and leapt out of the cabin to the left. The flying instructor remained strapped in the cabin. After rolling two more times, the helicopter came to a standstill lying on its right side on the steep terrain.

Figure 2: Final position of the helicopter
