Final Report No. 1995 by the Aircraft Accident Investigation Bureau

to the Kamov KA-32A12 helicopter, registration HB-XKE

on 26 March 2002

“Ufem Schoren” municipality of Neuenegg/BE

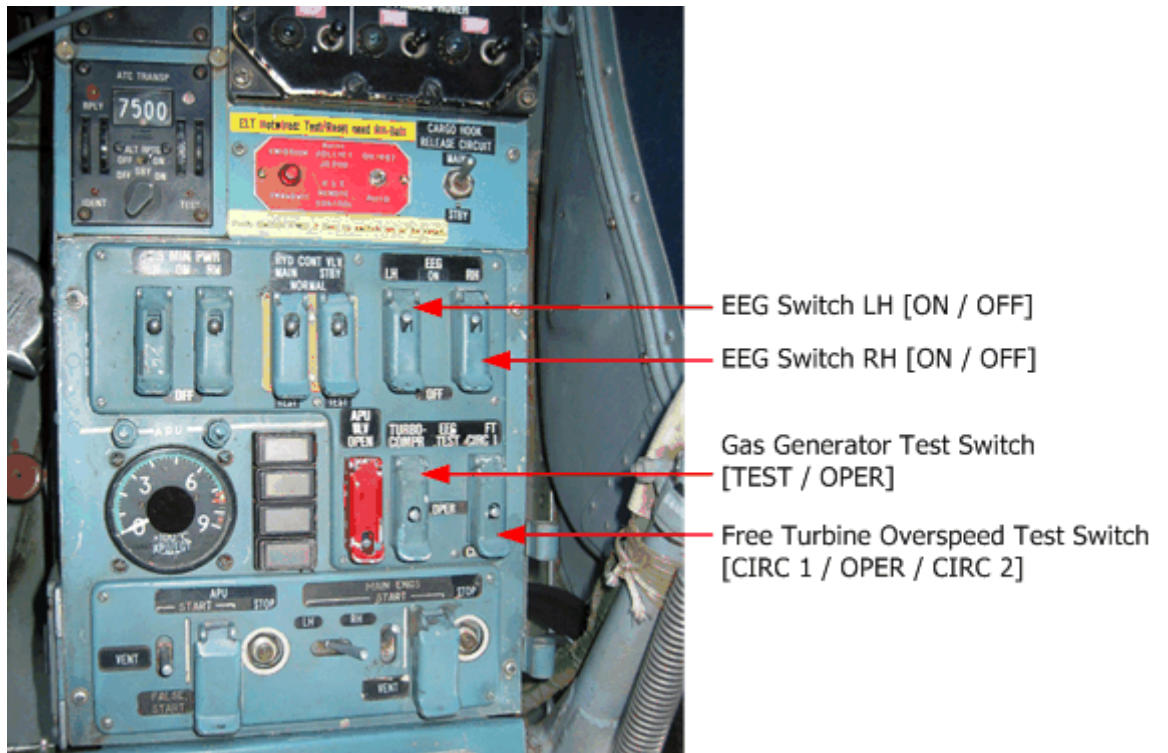
Fig. 3: Lower section of the centre console – layout of switches and their identification

The switches for operation of the EEG are located in the centre console. The hinged flaps are light blue and exhibit no special identification or safeguards. In the closed position, the switches are in the normal position.

The two engines each have an FCU and an EEG. The free turbine overspeed test switch acts simultaneously on both EEGs.

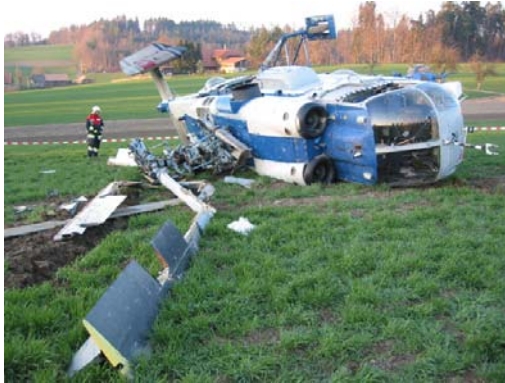
Fig. 4: HB-XKE in its final position

During the landing after autorotation, the helicopter initially came into contact with the terrain with its rear landing gear. Just before it came to a halt, the helicopter tipped to the right and came to rest on its side. The rotor blades hit the ground with high kinetic energy and were destroyed. Externally, the airframe remained largely intact. The front right landing gear was displaced.

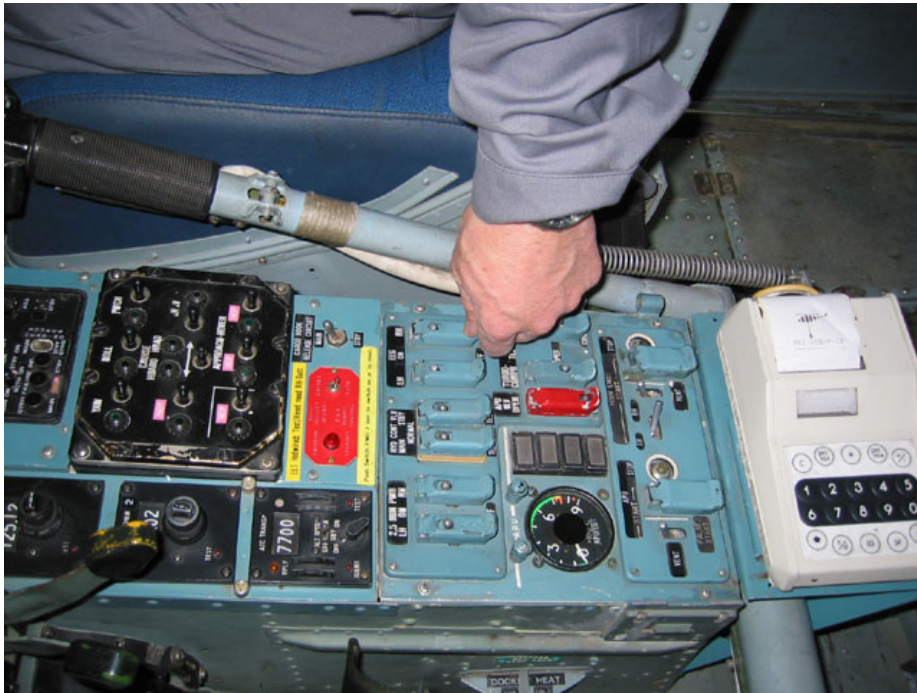
In order to be able to test the right engine hydromechanical controller, the flight instructor intended to operate the EEG RH switch, thereby switching off the electronic controller. Because of confusion, the free turbine overspeed test switch, which is located in the same column of switches but one row further back, was operated.

The photo shows the intended operation of the EEG RH switch.

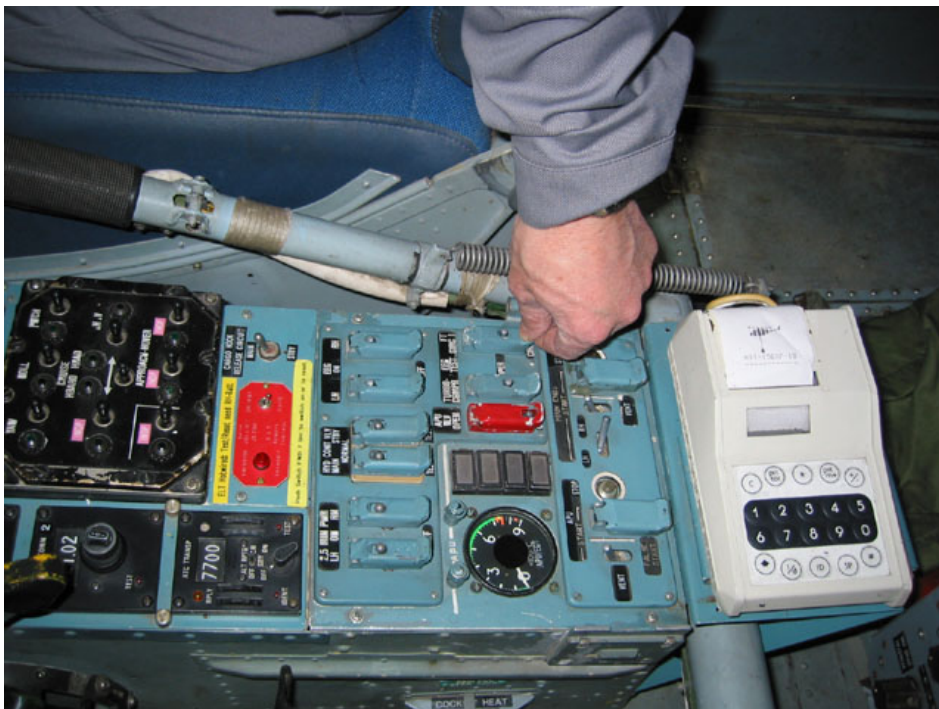
The photo shows the operation of the free turbine overspeed test switch which was actually carried out.

It could not be established whether the switch was initially brought to the CIRC 1 or CIRC 2 position. By analogy, as this position corresponds to the OFF position on the EEG RH switch, it can be assumed that the test sequence for CIRC 2 was activated first. When this was done, the test logic reduced the threshold for the power turbine speed N_{tttest} to 86.4 % on channel 2. At this time, the helicopter was cruising at a rotor speed, or power turbine speed respectively, of approxi-

mately 90%. Thus the condition for a power turbine overspeed was fulfilled for channel 2. The L ENG FT OVERSPEED and R ENG FT OVERSPEED warning lamps and the associated audio warning were activated. The effective rotor speed was not yet changing at this point in time.

Evidently the audio warning and warning lamps alarmed the flying instructor upon which, as an immediate reaction, he brought the free turbine overspeed test switch to the CIRC 1 position via the OPER position. This procedure took less than 0.2 seconds. Subsequently, the automatic test logic reduced the threshold for the power turbine speed N_{fttest} to 86.4 % on channel 1. At this moment, on both channels of the right and left EEG, the conditions for an assumed power turbine overspeed were met and the corresponding signals were generated to the engine shutdown actuator of the left and right engines. Both engines cut out immediately.

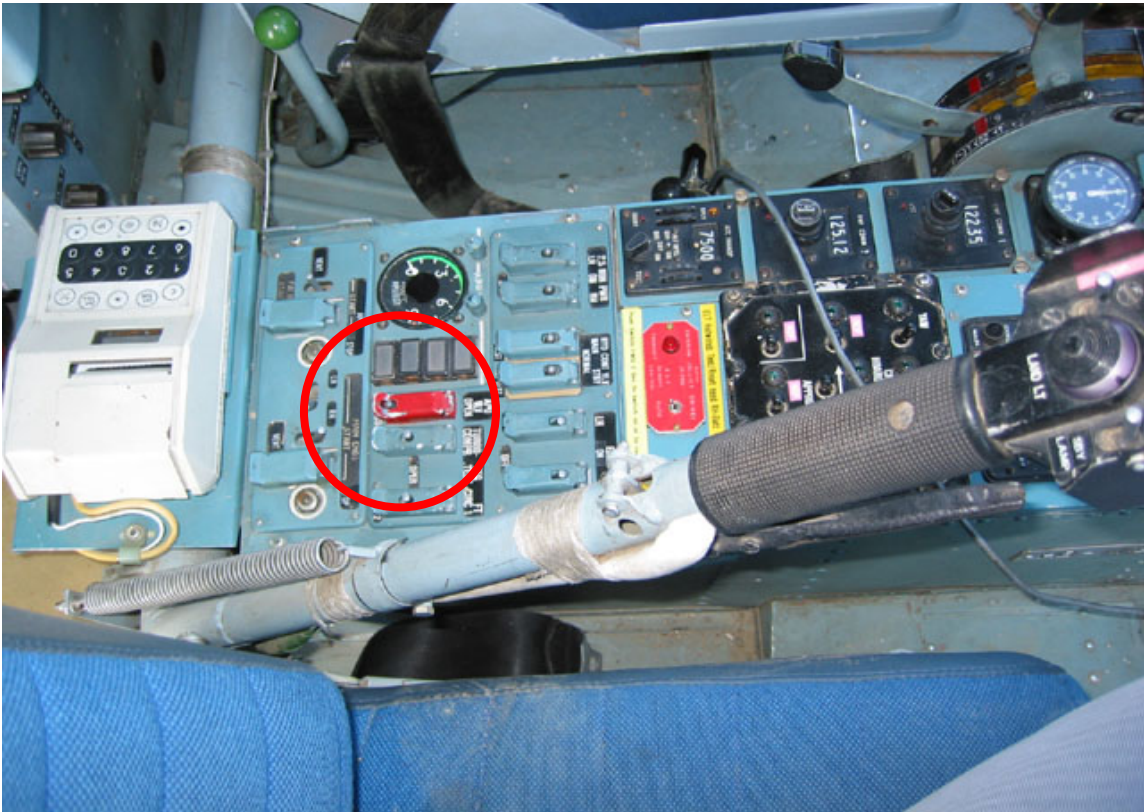
Centre console before the modification from the viewpoint of the pilot in the right-hand seat.
