Büro für Flugunfalluntersuchungen BFU
Bureau d'enquête sur les accidents d'aviation BEAA
Ufficio d'inchiesta sugli infortuni aeronautici UIIA
Uffizi d'inquisiziun per accidents d'aviatica UIAA
Aircraft Accident Investigation Bureau AAIB

Final Report No. 1998 by the Aircraft Accident Investigation Bureau

concerning the serious incident (AIRPROX)
between flight AFR 563B, operated by the Régional company,
Embraer E145, registration F-GRGL
and
flight OHY 2451, operated by Onur Air
A321-231, registration TC-OAE
on 30 June 2005
at MEDAM, 71 NM south-west of Geneva

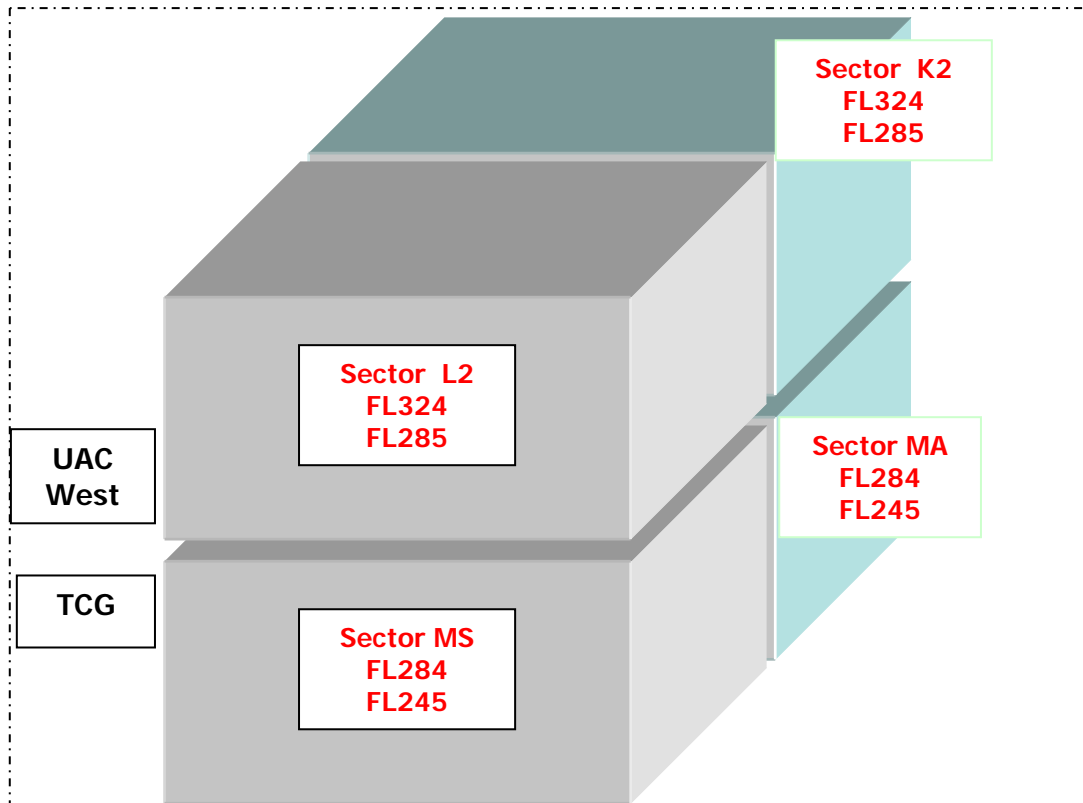
1.1 Sectorisation of the Geneva Control Centre at the time of the incident

Sectors K2 and L2 and sectors MA and MS were coupled.

In the vertical plane, sectors MA and MS are delimited from level FL 245 to level FL 284, within the Geneva CTA control region. The managed traffic consists of aircraft in transit, arrivals at and departures from Geneva and aircraft leaving or entering the Reims FIR and the adjacent TMAs (ref. ATM GE ACC). Essentially, therefore, these sectors handle traffic moving in the vertical plane.

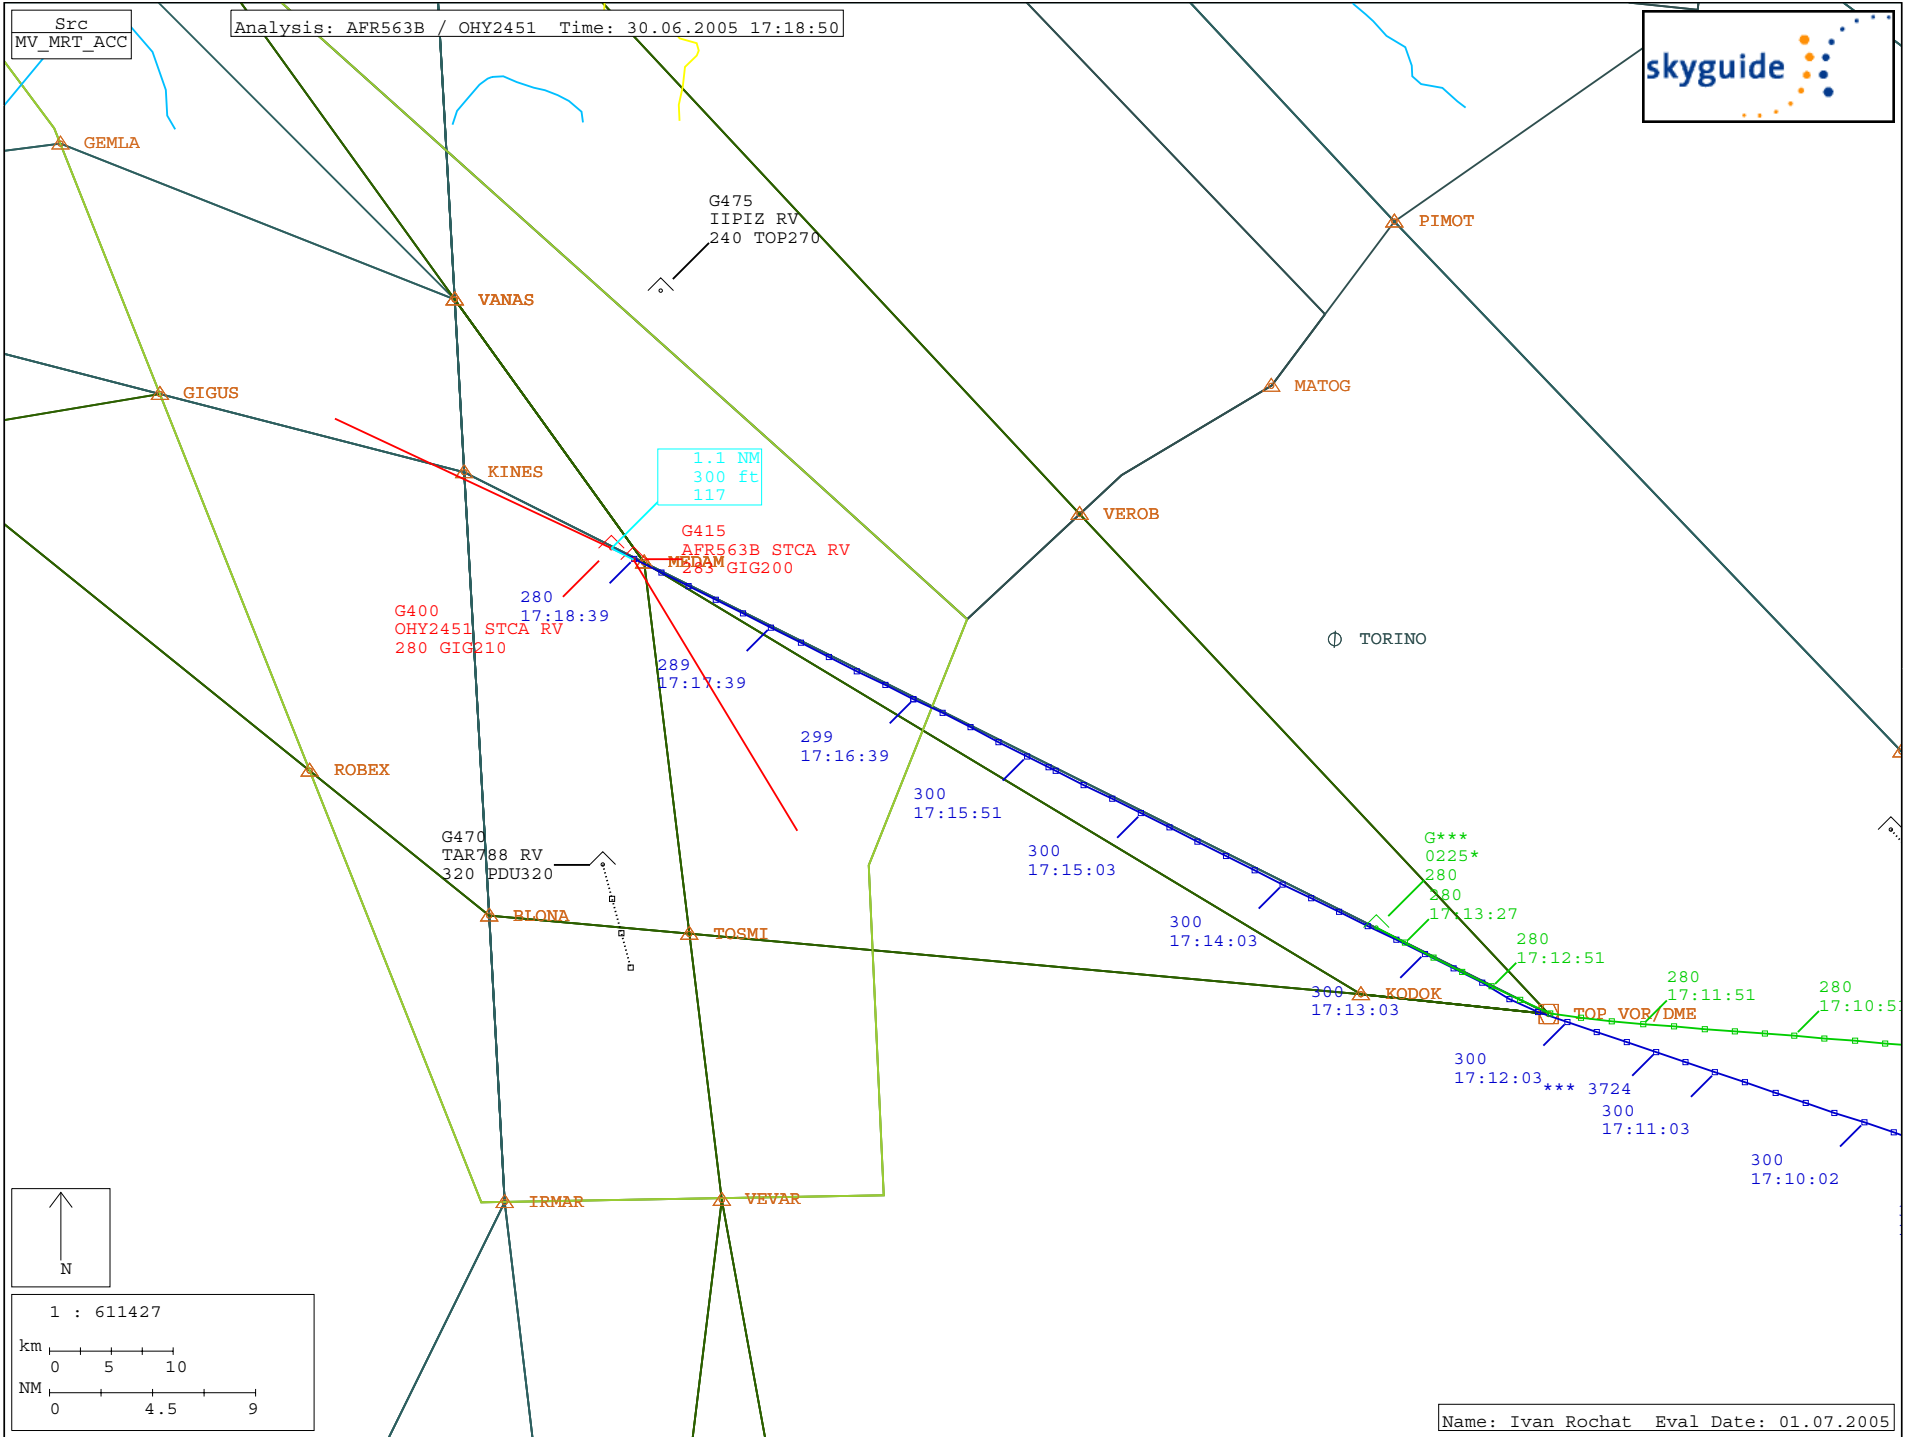
Analysis: AFR563B / OHY2451 Time: 30.06.2005 17:18:50

At the time of greatest proximity of the aircraft, the lateral separation and altitude difference determined by extrapolation of the radar plots was 1.1 NM and 0 ft.
