# **Final Report No. 2004 by the Aircraft Accident Investigation Bureau**

to the Ecolight, Eurostar EV 97 aircraft, registration HB-WAV

on 29 July 2006

on Lake Neuchâtel 900 m off the port,

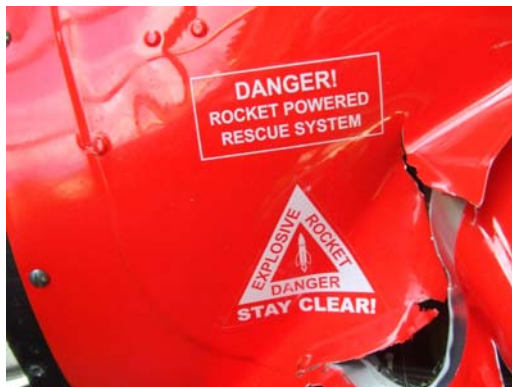
- On the instrument panel cover, two placards indicate the presence of a danger. The pyrotechnic cartridge of the parachute was slightly damaged by the impact.

Fig. 1: Identification of the BRS on the instrument panel cover

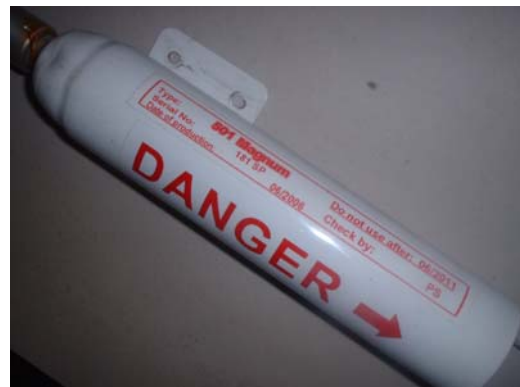
Fig. 2: Pyrotechnic cartridge of the BRS parachute system

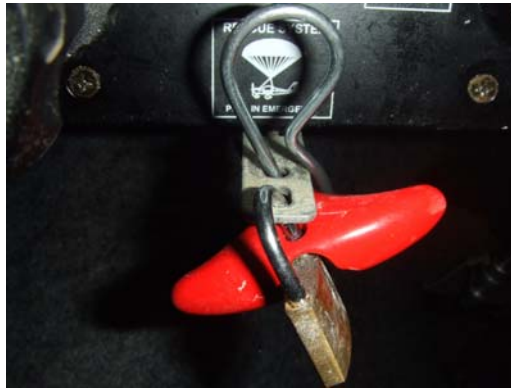
- A padlock locked the operating handle of the emergency parachute, the "BALLISTIC RECOVERY SYSTEM" (BRS) and prevented the system from being used immediately (see fig. 3).

A padlock fitted on the emergency parachute system activation handle prevented immediate operation of the system. The key to the padlock was fitted on the same key-holder as the magneto selector key. A second key was found in the left side pocket of the aircraft.

Fig. 3: Padlock fitted to the emergency parachute control

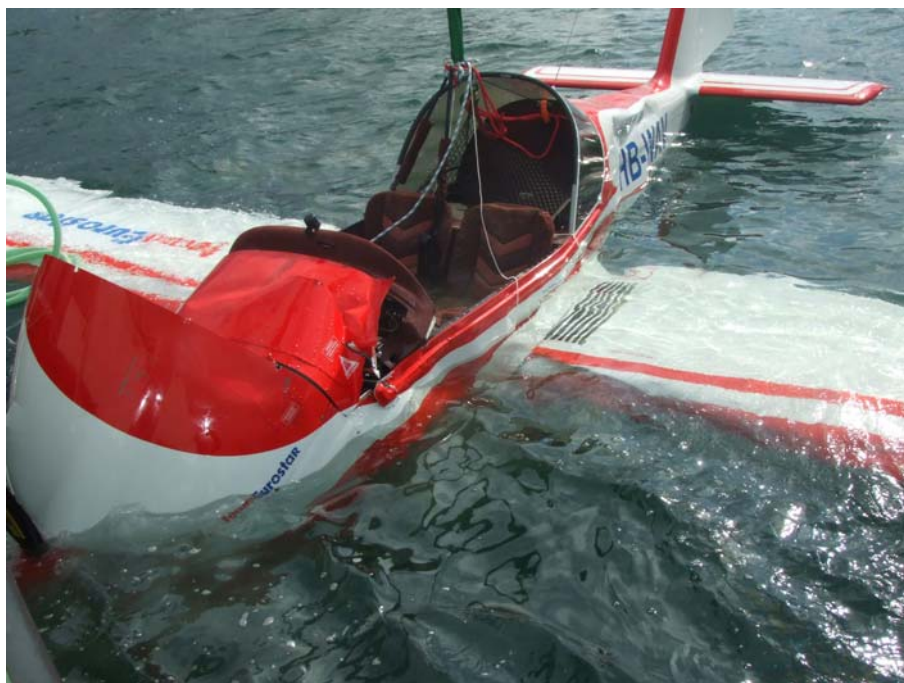
Fig. 4: Recovery of the wreck

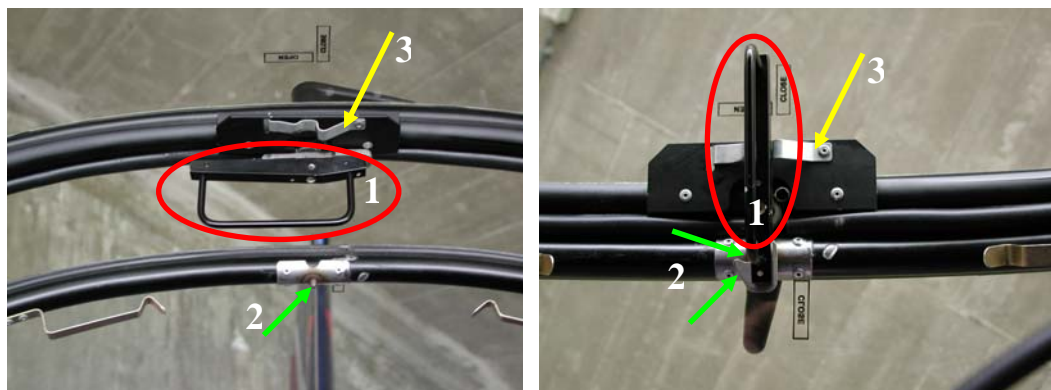
Fig. 5 and 6: 1) Locking handle. 2) Locking tab and hook. 3) Spring blade

The inspection of the locking system concluded that in the event of violent opening with the correctly locked canopy being torn off, specific traces would be visible on the rear of the tab and on its left side. However, the locking tab exhibited only traces of normal wear.

The analysis of the canopy locking system found that the locking hook was not in the locked position. Since the canopy was not locked, it was initially partially-open in flight and was then torn off during the impact. The experts' report on this system excludes the possibility that the locking hook was turned and opened following the frontal impact of the aircraft (fig. 5 and 6). The pilot probably closed the canopy before take-off but did not lock it.

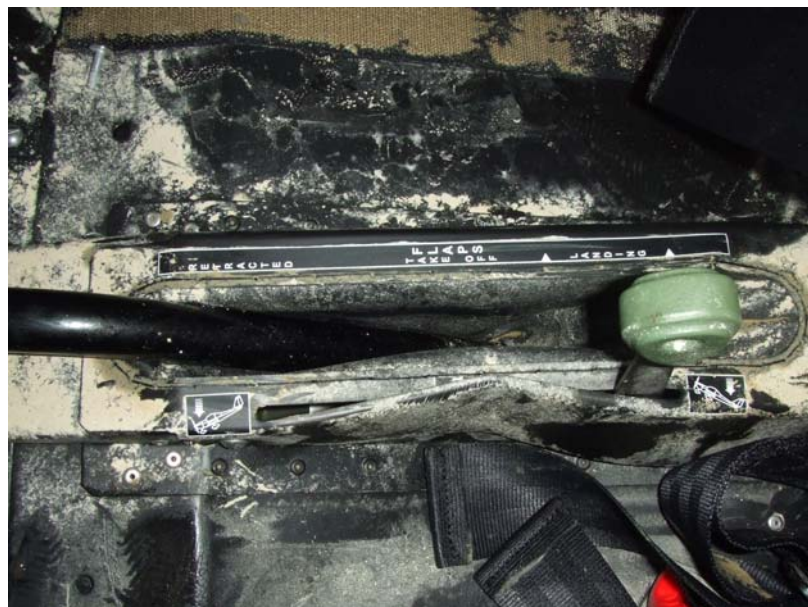
The left corner plate of the trim control slide system was damaged by buckling (fig. 7).

Fig. 7: Position of the trim control lever

With regard to the buckling of the left corner plate of the support of the trim slide system; the experts' report concludes that the deformation was caused by the impact on contact with the water.

The pilot stated that he positioned the trim control lever in the "neutral" position. However, upon the recovery of the aircraft, this control was found in "nose up" position, 8 mm from the rear stop (fig. 7). Technical analysis showed that this control lever could not have moved during the impact. The pilot also stated that he encountered abnormal conditions after retracting the flaps. He then tried to change the position of the trim control lever but could not find it.
