# **Final Report No. 2005 by the Aircraft Accident Investigation Bureau**

to the Beechcraft B90 King Air aircraft, registration G-OJRO

on 27 September 2007

at Zurich Airport

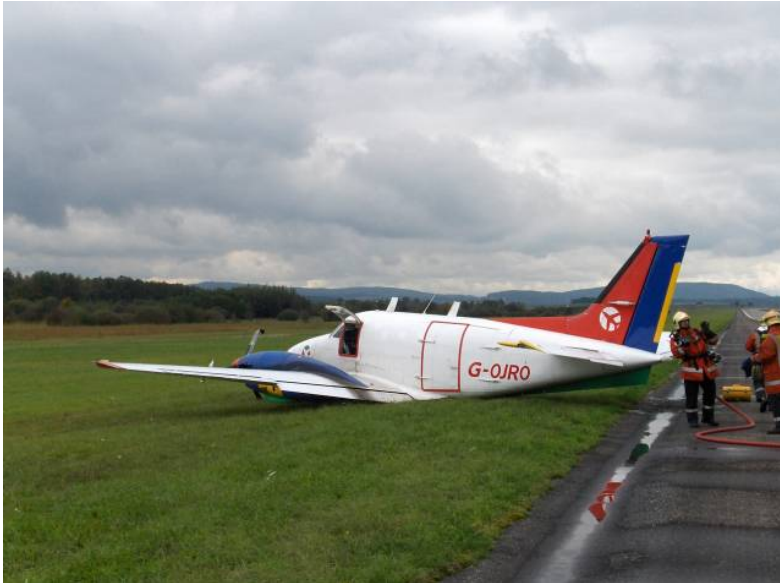
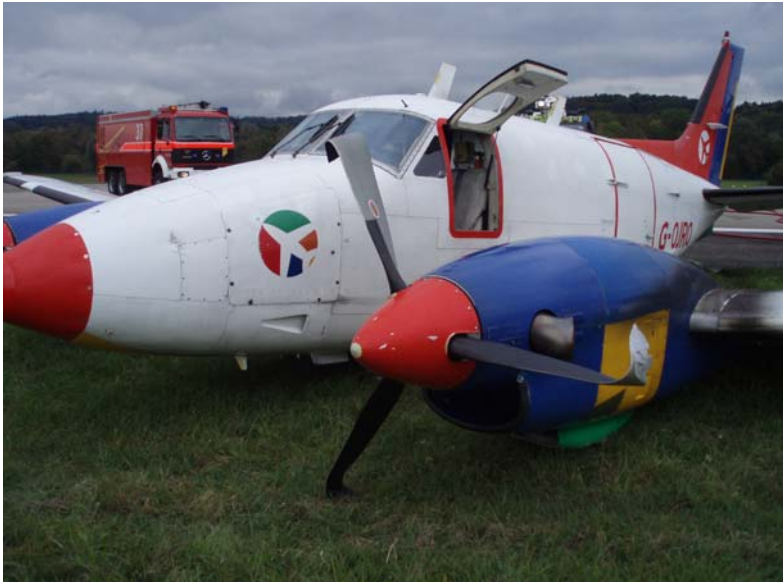
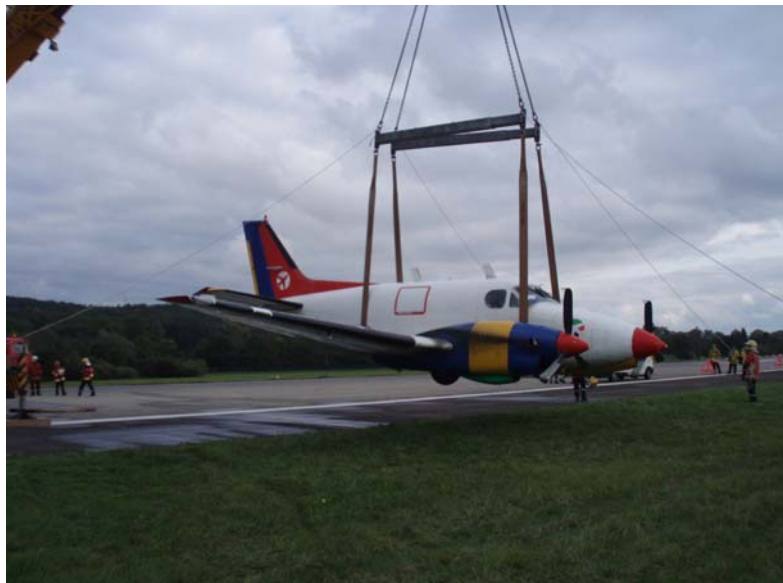
Annex 1

The aircraft then drifted slightly to the left and a little later to the right, before crossing the right edge of the runway after 615 metres. In the process, a runway lamp was torn off. The aircraft then rotated 90 degrees to the right about its vertical axis and came to a standstill five to six metres from the runway edge (see Annex 1).

Apart from the badly deformed propeller blades, the aircraft exhibited no major external damage. There was no leakage and about 600 l of kerosene were defuelled before further investigations.

The aircraft after landing

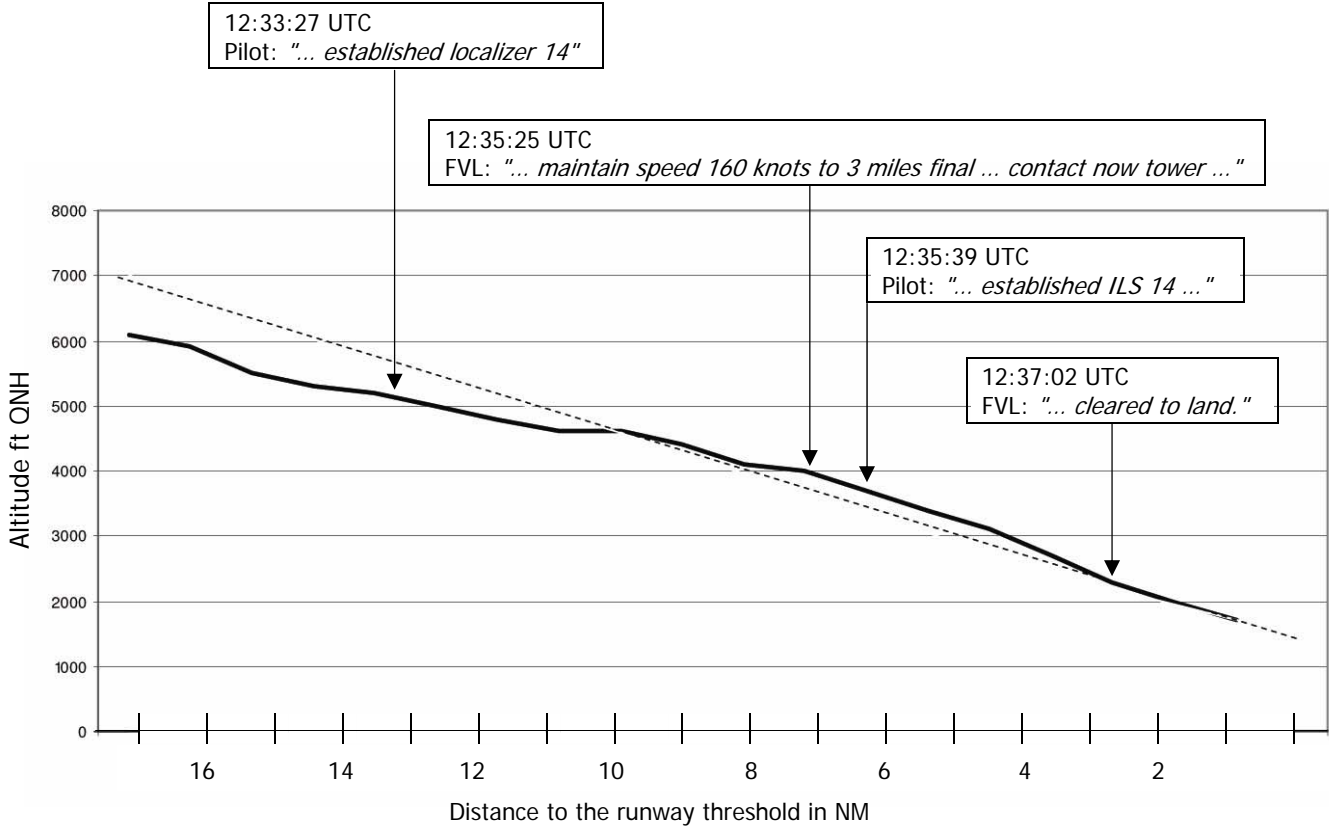
Approach profile G-OJRO

According to radar recordings, at approximately 3 NM the aircraft was on the glidepath at a speed of approximately 160 kt and at a height of approximately 1000 ft above the ground. The pilot then reduced speed for landing. He intended to make a so-called 'long landing'<sup>1</sup>, in order to be able to leave the runway without delay after landing. The pilot was unable to recall afterwards whether he had heard the acoustic warning for non-extended landing gear at any time during the approach.

The recording of the flight path based on the radar data allows the conclusion that the approach took place approximately on the nominal glidepath. In the given configuration of the aircraft, this would have required a power setting which should have caused the landing gear warning tone to sound, at least occasionally. The fact remains that this warning did not generate an adequate reaction from the pilot.

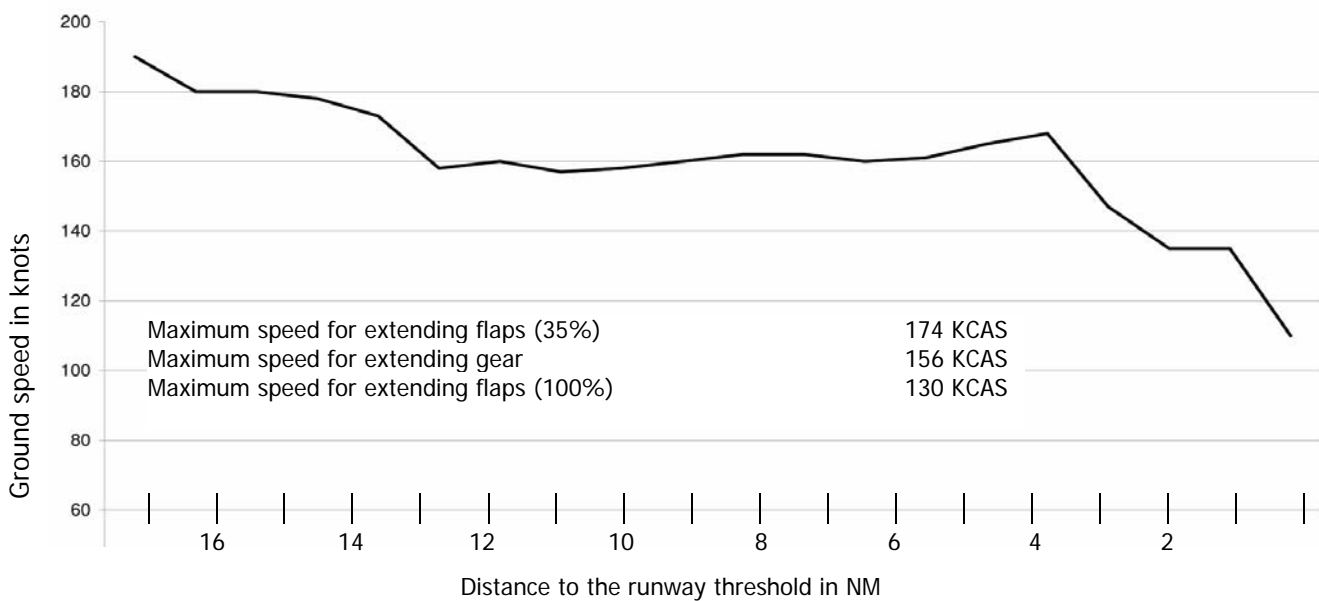
Speed during the approach (ground speed)<sup>1)</sup>

<sup>1)</sup> In the current prevailing wind, the speed indicated in the cockpit was 3 to 4 knots higher
