Final Report No. 2006 by the Aircraft Accident Investigation Bureau

to the aircraft Beechcraft BE 35-C33A Debonair, registration HB-KCK

on 1 April 2004

Lake of Geneva, between Les Moulins de Rivaz and Cully,
municipality of Puidoux/VD

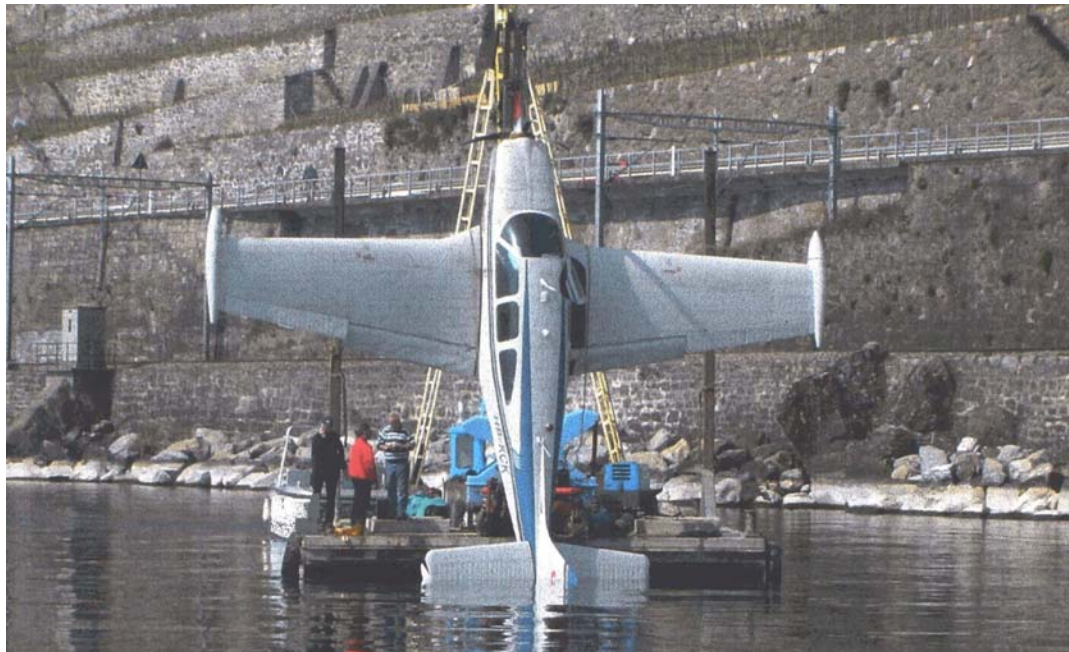
The wreckage was lying on its back in Lake Geneva, at a depth of approximately 25 metres. It could be located by air bubbles which appeared on the surface of the water.

Fig 1: Recovery of the wreckage on the day after the accident

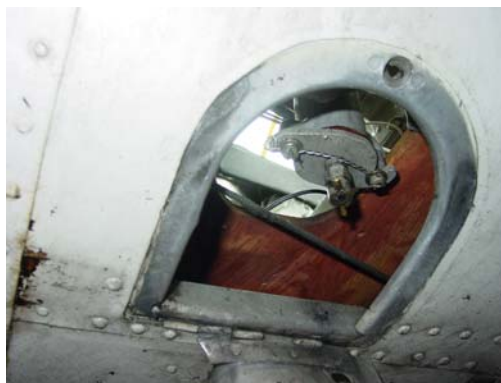
- One exhaust silencer was torn off on impact and was not found.
- The main drain located below the filter of the fuel selector valve was in the open position.

When the wreckage was examined, the main drain was found in the open position. This is why a measurement of fuel loss was carried out on ground on an aircraft of the same type in order to assess the quantity of fuel which might have leaked out through the main drain if it had been in the open position throughout the accident flight.

Fig 2: Main drain located under the floor of the cabin.

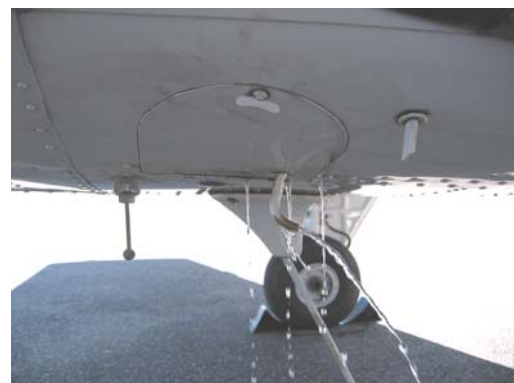
Configuration	Engine consumption	Fuel lost
Engine shut down	- - -	0.68 litre/min
Engine start-up sequence	- - -	0.22 litre
Idling	4 USG/hour	0.67 litre/min
Climbing power (2700 RPM)	21 USG/hour	0.41 litre/min
Cruising power (65%)	13.3 USG/hour	0.53 litre/min

- When the fuel selector is OFF, only the quantity of fuel in the selector filter flows out from the main drain.
- Engine operation is not affected at all by the opening of the main drain or by selection of the tank when the drain is open.
- The loss of fuel through the main drain decreases when the fuel flow to the engine increases.
- A strong smell of fuel occurs in the cabin immediately after the opening of the main drain, with the inspection hatch closed.

On the basis of the measurements which were taken, it is possible to evaluate the quantity of fuel which would have been lost during the accident flight if the main drain had remained opened after the check carried out before departure. The quantity of fuel lost can be estimated at between 28 l and 35 l.

Fig 3: Fuel leakage from the main drain with engine shut down

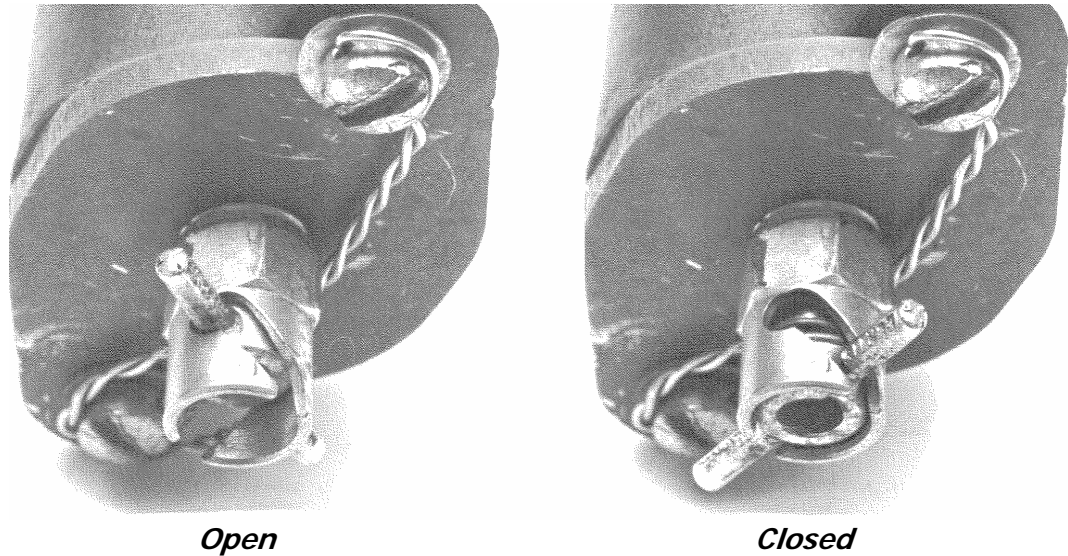
- That the shape of the bayonet which is fitted to the drain in question requires a rotary movement to open it, and to maintain it in the open position
- That during the external check on the aircraft, with the fuel selector closed, the drain might accidentally have stayed in the open position.

Fig 4: Main drain opening and closing system

- Following the finding that the main drain was open, an opening resistance test was carried out. A force of 1.8 kg is required to open the drain and 3.5 kg to lock it in the open position.

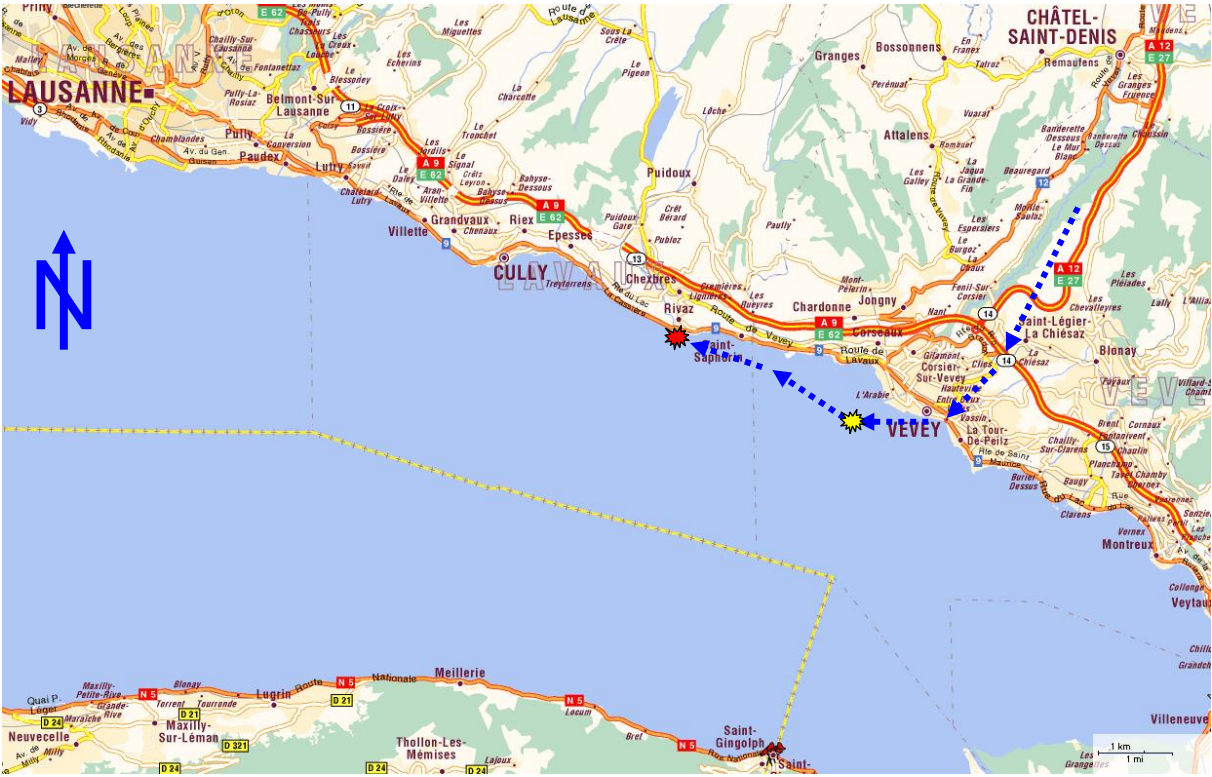
Annexe 1: Illustration of the HB-KCK final flight path

Engine stoppage

Landing on water
