Final Report No. 2007 by the Aircraft Accident Investigation Bureau

concerning the accident

to the Piper PA-28-181 Archer II aircraft, registration HB-PGC

on 16 September 2007

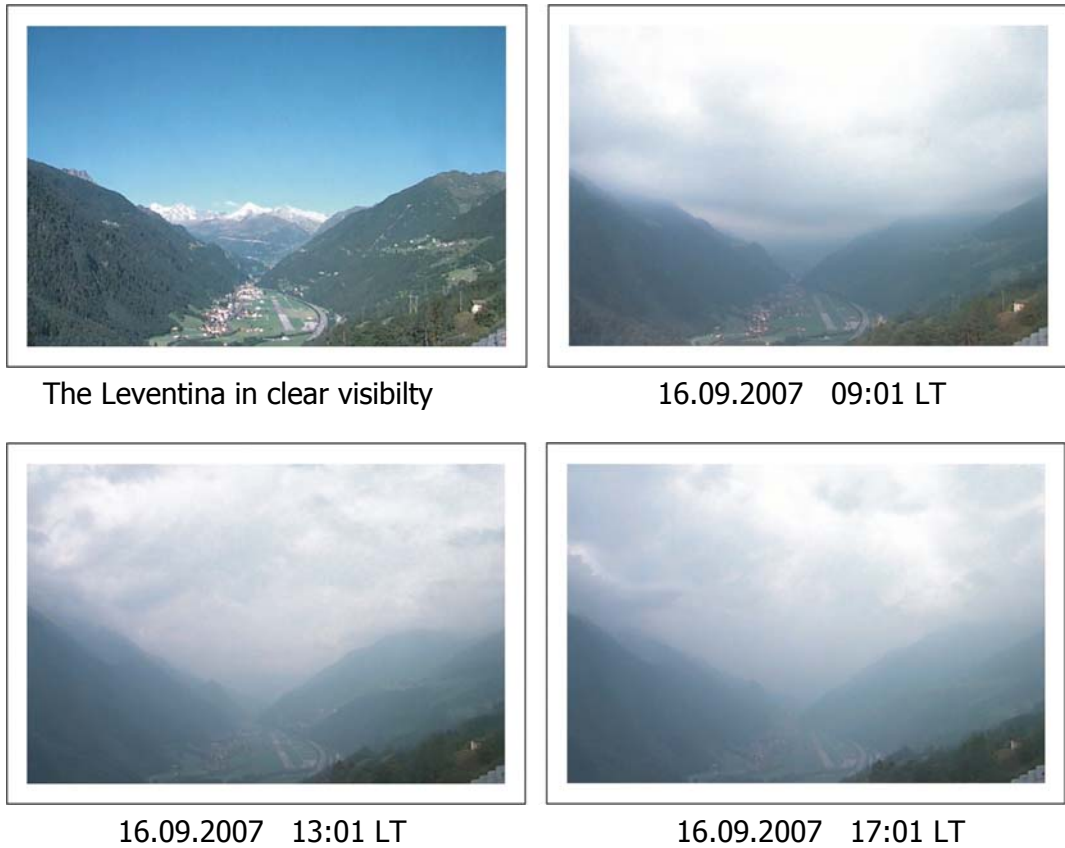
Figure 1 – Webcam images: Image from Catto, looking towards Piotta and Airolo on 16 September 2007. Ambri aerodrome can be seen in the foreground. For comparison, an image showing clear visibility conditions is shown top left.

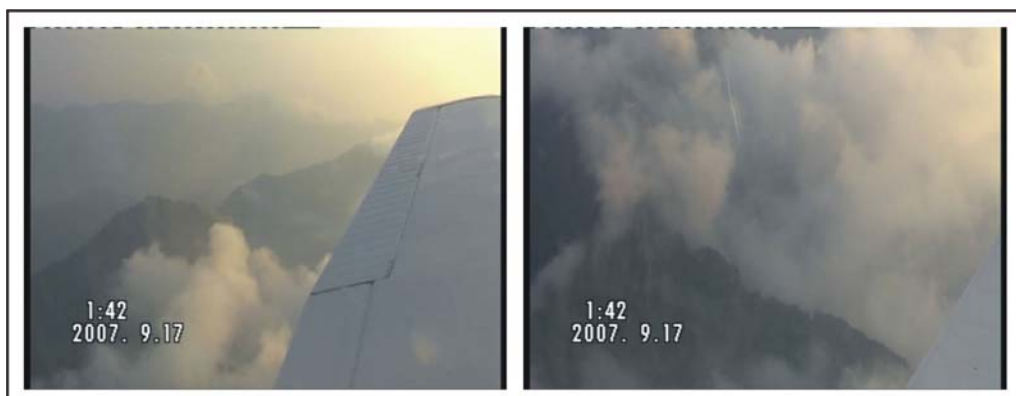
Figure 2 – Stills from a video camera onboard the aircraft involved in the accident: The photos were taken at approximately 18:48 LT and show the locality of the Val Treversagna/GR. As was established after the accident, the video camera's clock was 6:54 hours fast.

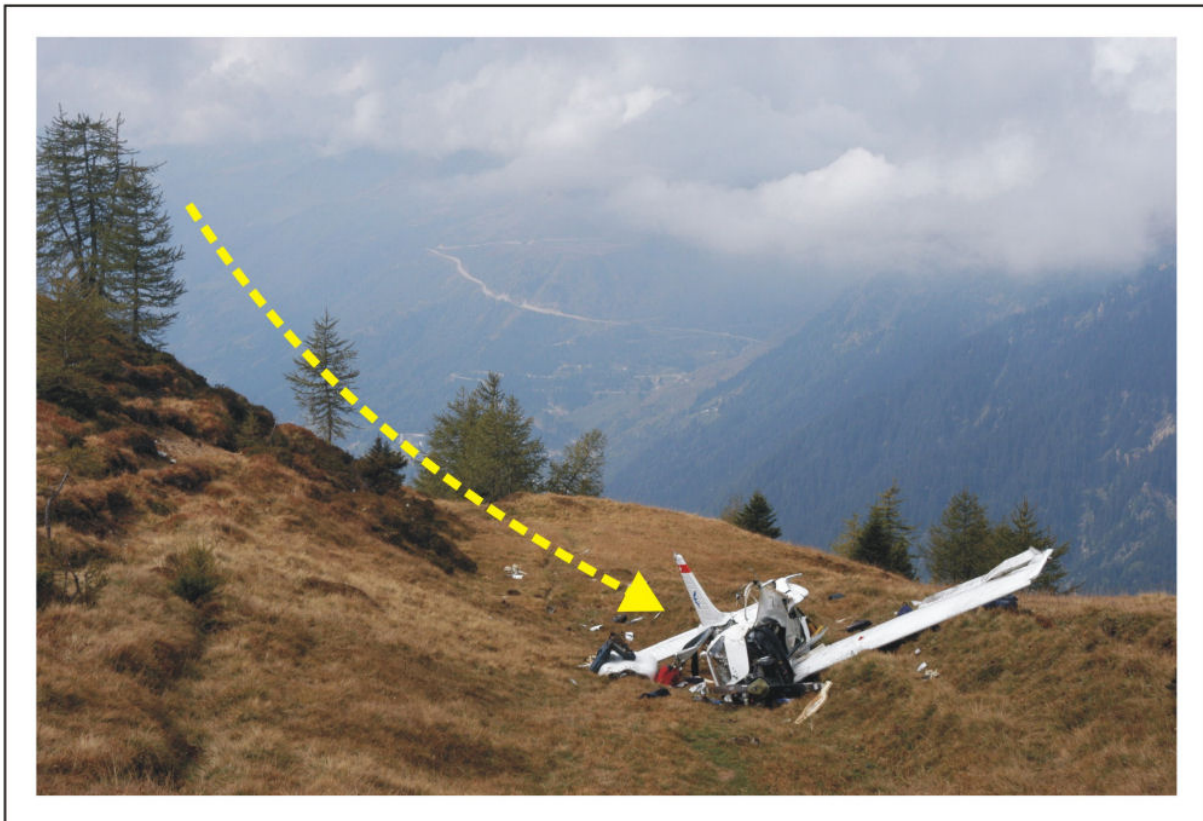
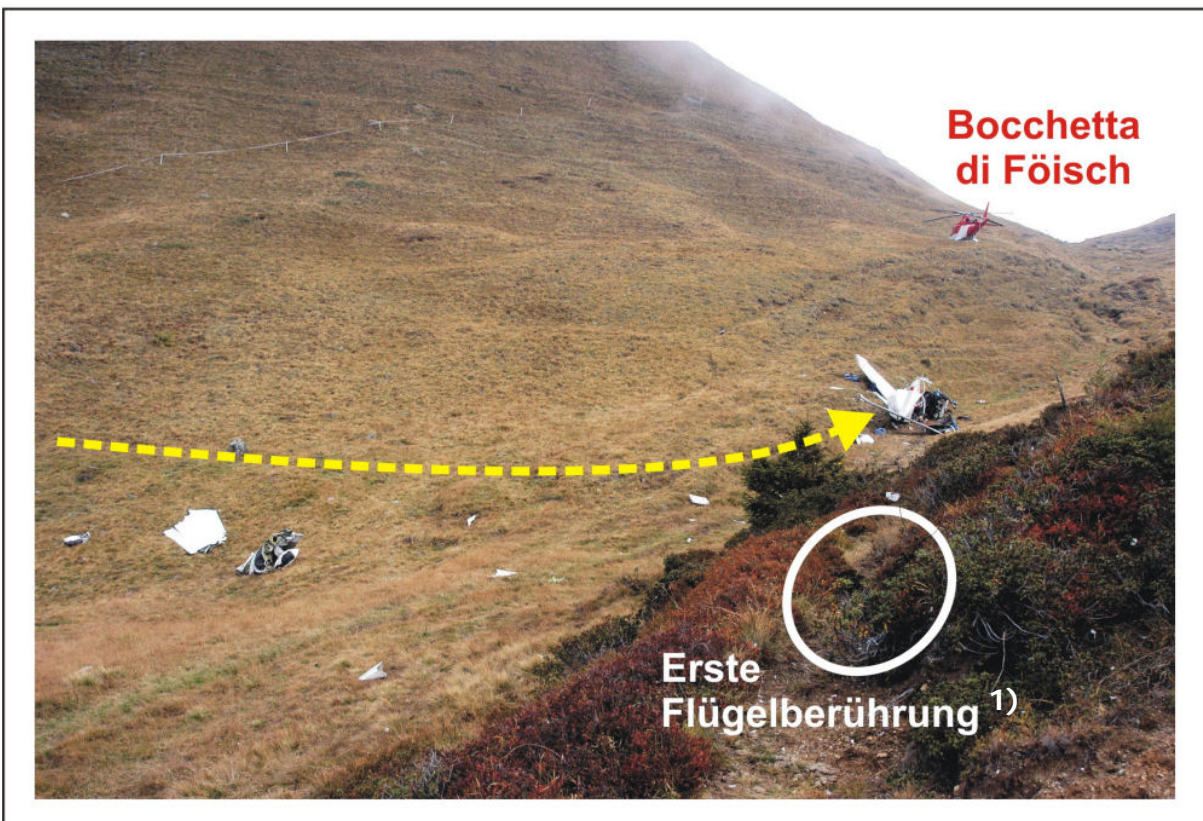
Presumed direction of approach and final position of the wreckage

1) Initial wing contact
