# **Final Report No. 2009**

to the aircraft type Opus 3 (experimental), registration OY-CYZ

on 23 August 2005

at Furkapass-Tällistock, above the municipality of Oberwald/VS

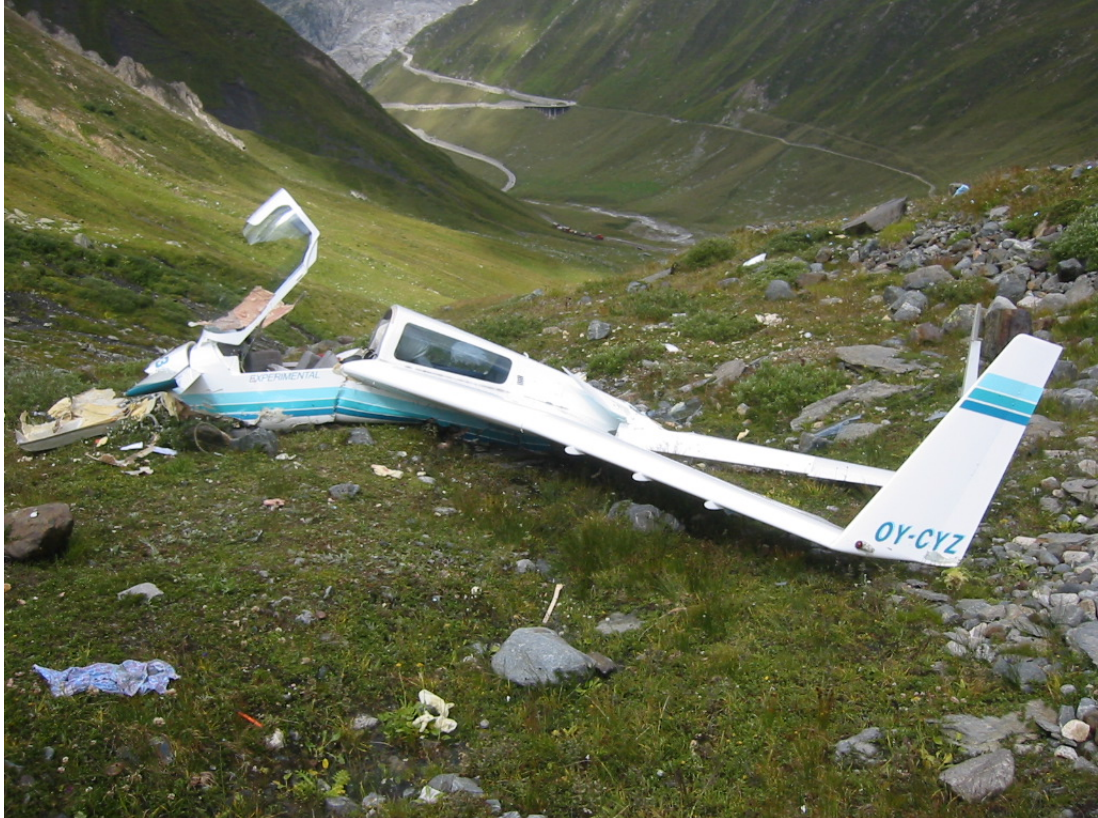
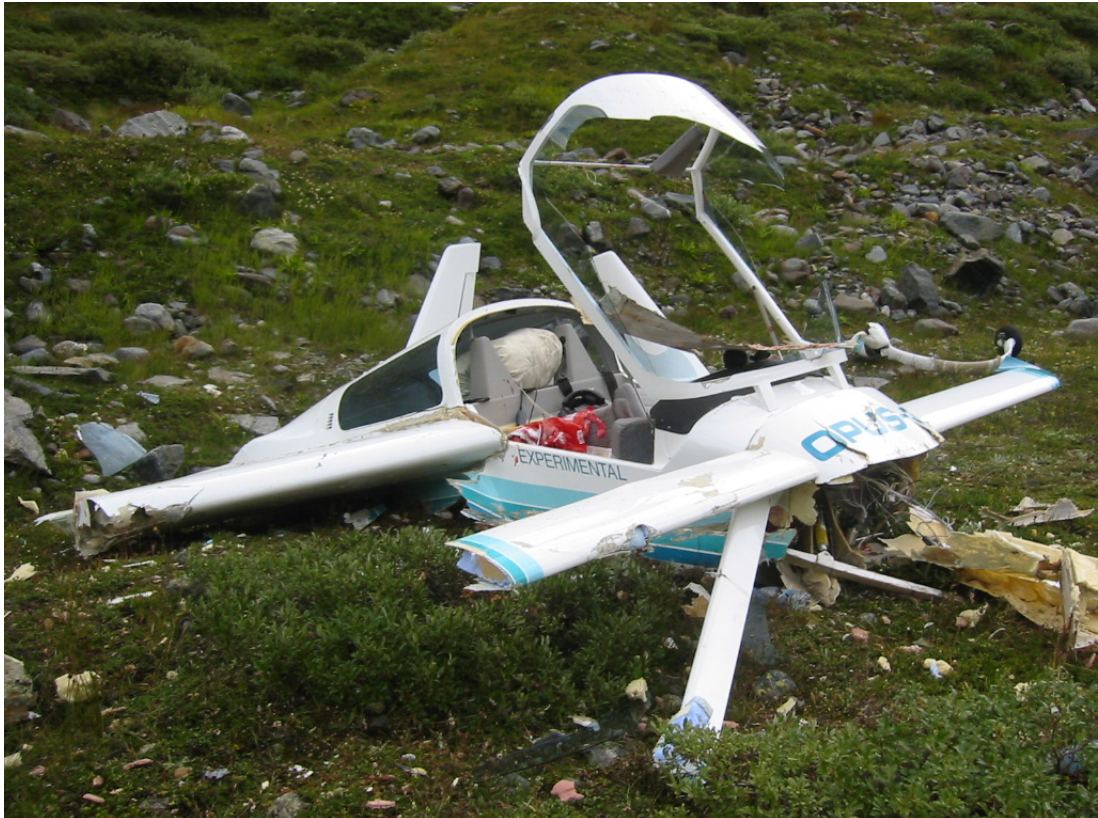
Annex 1

Realising that his aircraft's performance was no longer sufficient to gain the necessary altitude to cross the pass, he envisaged turning back. At this moment, again according to his statements, his indicated airspeed was 60 kt and the pilot judged it insufficient to make a turn requiring a high bank angle. He then opted for an emergency landing, continuing his flight towards the slope in front of him. He chose to climb up the valley at full power and low speed. Contact with the terrain took place at a shallow angle. The Opus 3 touched the ground once before rebounding and coming to a standstill about fifteen metres further on (Annex 1).

The accident occurred in a mountainous environment, on the spurs of a slope, the type of terrain being pasture and rocks (Annex 1).

- The right wing was torn off during the second impact and was found behind the left wing.
- The left wing was still attached to the airframe.
- The cockpit did not suffer major deformation.
- Part of the landing gear was torn off during the initial impact.
- The two wooden propeller blades were severed identically at half their length.
- The altimeter was set at 1015 hPa.
- The contents of the fuel tanks had emptied.
- The windscreen was broken.
- The safety belts had been used and withstood the deceleration forces.
- A visual examination of the wreckage provided no indication of a pre-existing defect.

The aircraft came to a standstill after two impacts about 15 metres apart. The traces left by the initial impact indicate that contact with the ground was violent, which is confirmed by the components torn off the aircraft.

Views of the wreckage at the site of the accident

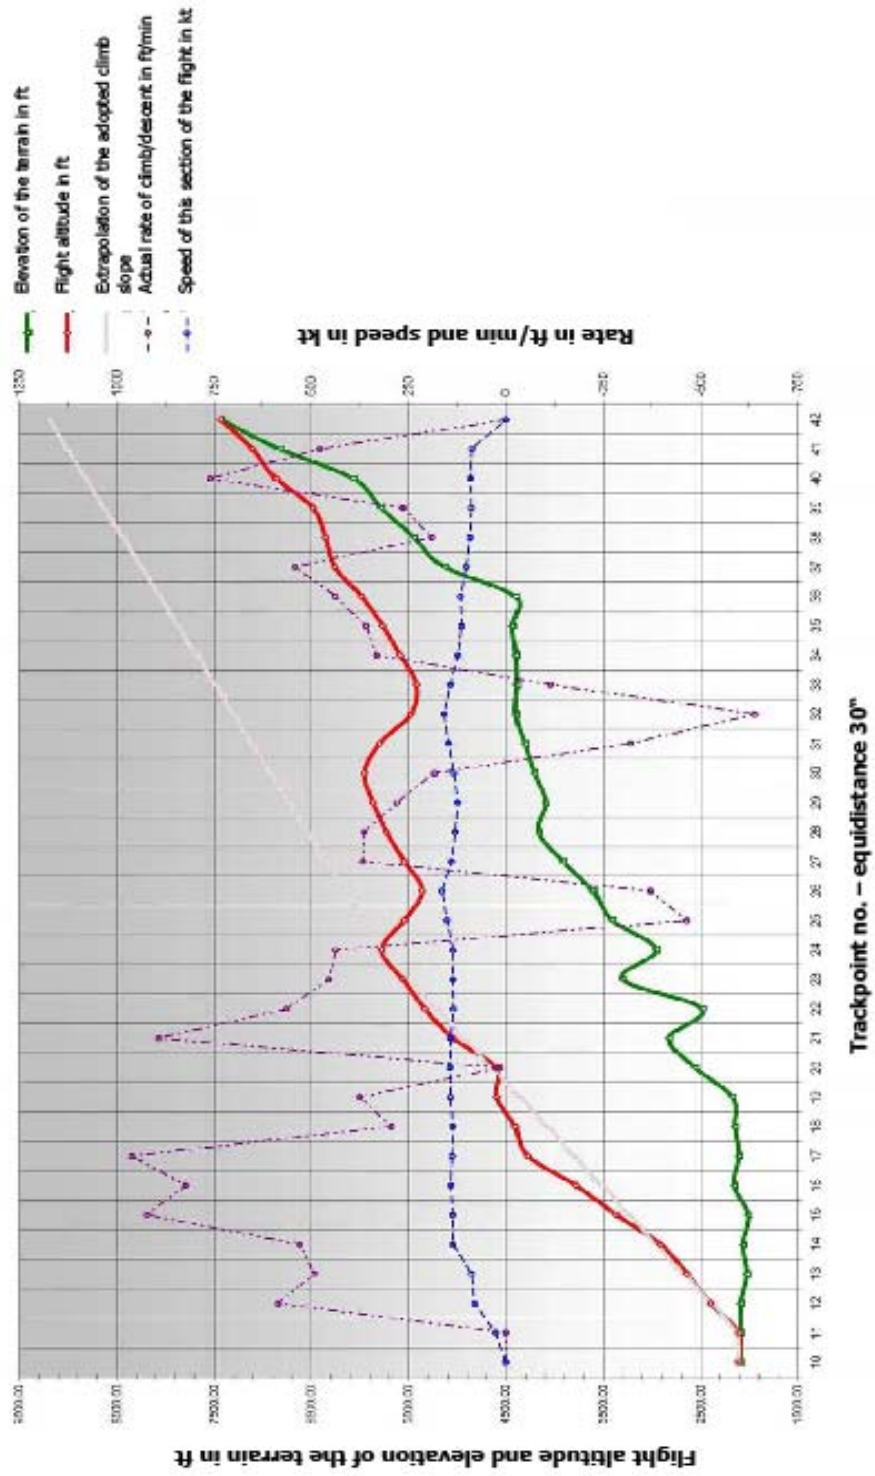
Diagram of different flight parameters

It was possible to extract the parameters of the accident flight from the GPS receiver (Annex 2).

These revealed that the pilot first of all climbed steadily up to an altitude of 5777 ft (1761 m), which he reached just before flying over the town of Fiesch. This corresponds to the desired profile for the route over the Furka Pass. He continued his flight, alternately losing and gaining altitude, for a distance of approximately 12 NM, to remain clear of the cloud base. In fact, when over Ulrichen aerodrome, his altitude was only 5586 ft (1703 m), i.e. 191 ft below the altitude he had reached 12 NM earlier. From this location onwards, a regular climb is observed, but with a climb angle insufficient to cross the pass, together with a progressive reduction in his speed. Consequently, he arrived at the foot of the pass with a major altitude deficit.
