Final Report No. 2010 by the Aircraft Accident Investigation Bureau

to the Robin DR300-180R aircraft, HB-EPG

on 4 July 2006

Saanen aerodrome, municipality of Saanen/BE

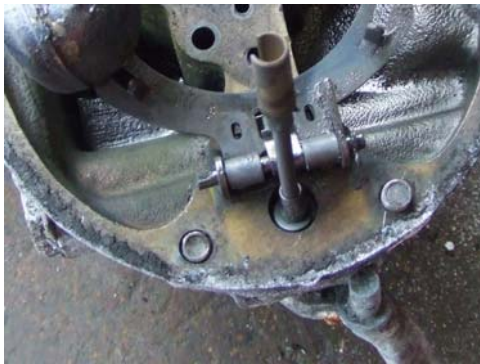
Fig. 1: Float hinge and bowl

The fitted float was made of metal. The hinge of the float, which was supposed to enable unrestricted up and down movement of the float in the carburettor bowl, was measured.

Although the carburettor was subjected to high temperatures during the fire, among other things it was still possible to examine the clearance ratios of the float hinge mechanism and compare them with those of a new part. The clearance in the hinge on the aircraft involved in the accident, compared to the new part, was greater by a factor of 2.5. The result was that the free upward movement on the outside of the float (rotation) was 10 mm, compared to 4 mm on a new float. The float on the aircraft involved in the accident moved 5 mm laterally compared with 2 mm on a new float.

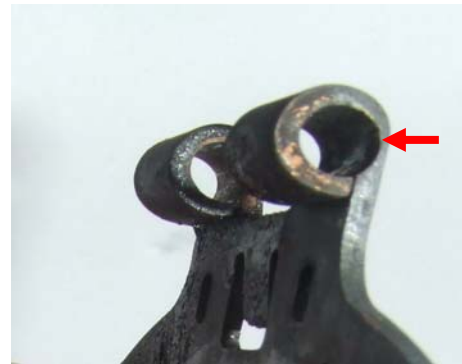
Fig. 2: Wear on the float hinge

It can be assumed with a high degree of probability that the large clearance in the float hinge at times seriously impeded the free up-and-down movement of the float, thereby preventing level regulation in the carburettor. When the fault occurred, the float chamber overflowed.

- Excessive clearance between the bore and the bolt of the hinge mechanism was found on the carburettor's float system.
- The EPG/1 authorisation issued to the operator by the FOCA only permitted minor maintenance work on aircraft HB-EPG, but not repair work such as the dismantling and refitting of the carburettor.

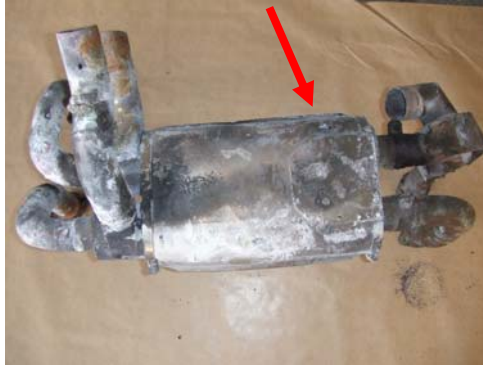
Fig. 3: Muffler housing with hole

A round hole approximately 2 cm in diameter was found in the muffler housing. No connection could be established between this damage and the engine cut-out before the landing, the ensuing outbreak of fire and the subsequent destruction of the aircraft.
