# **Final Report No. 2017**

concerning the accident  
to the MDD 500N helicopter, HB-XYP  
operated by Fuchs Helikopter AG  
on 26 July 2007  
Municipality of Eglisau/ZH  
approx. 25 km north of Zurich

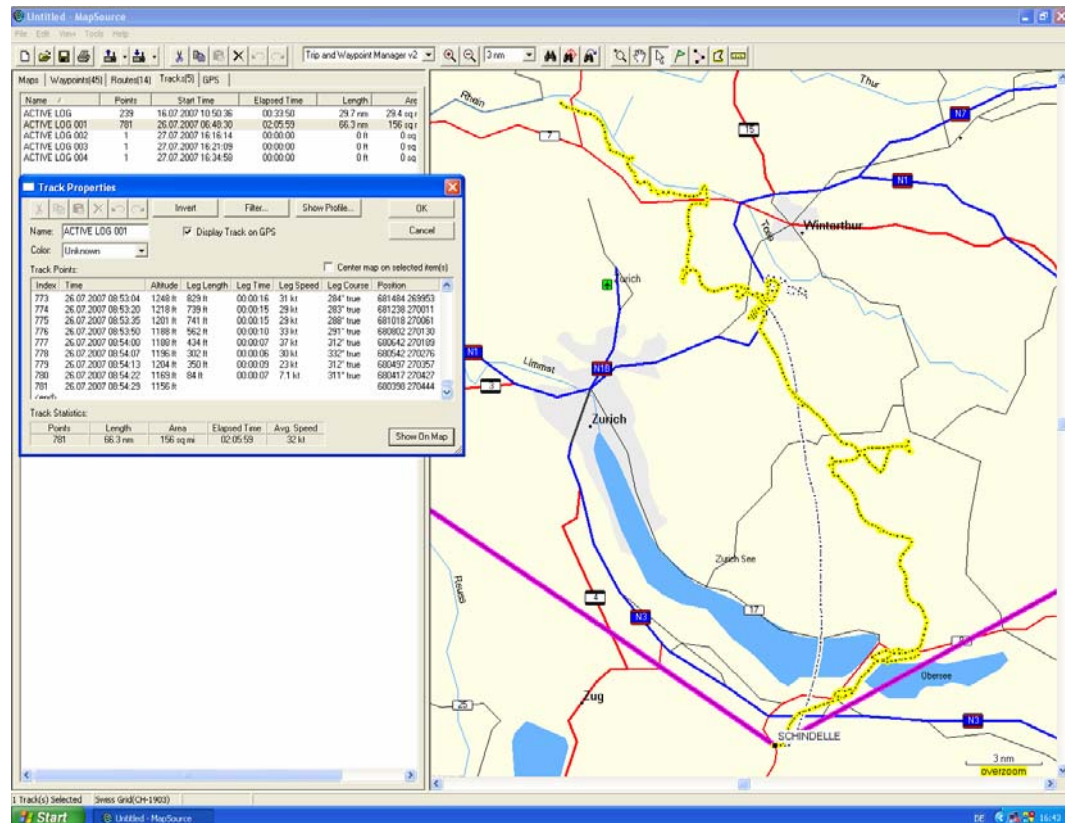
Recorded flight path of the GARMIN 295 GPS:

Index 777 corresponds to the position shortly before the cable collision.

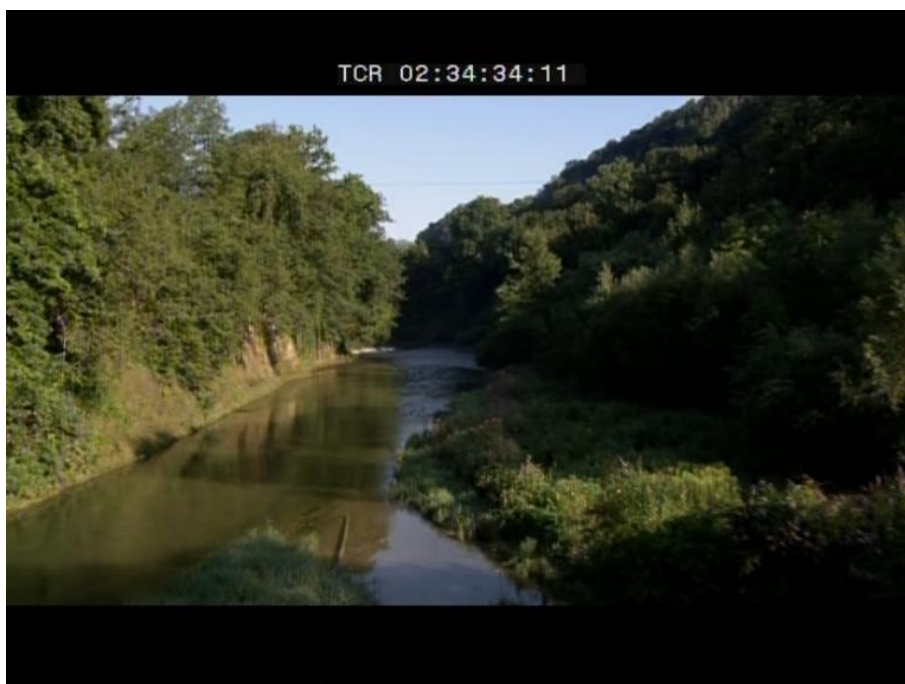
In the planned section along the Töss in the lower Töss valley, filming took place a few metres above the river bed between the trees. Just before the municipality of Freienstein, according to the film which was shot, the helicopter flew under a cable (see figures 1 and 2).

Figure 1: Camera view above the Töss just before Freienstein. Telephone line visible only against light background (sky).

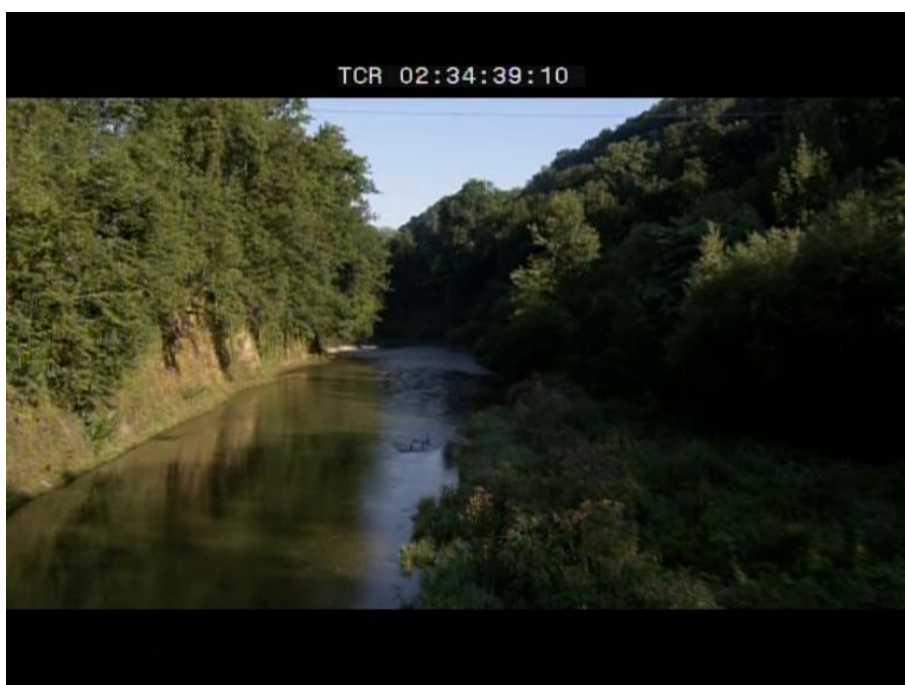
According to his statement, the pilot had been aware of this. The pilot stated: *"On the morning in question, when we reduced altitude to do some low-level filming, I informed the client/director of the fact that a cable crossed the flight path. If I had been flying solo, we would have climbed and flown over the cable. At the request and insistence of the client, I flew under the cable in question."*

Figure 2: Camera view just before flying under the cable near Freienstein. Telephone line at top edge of image.

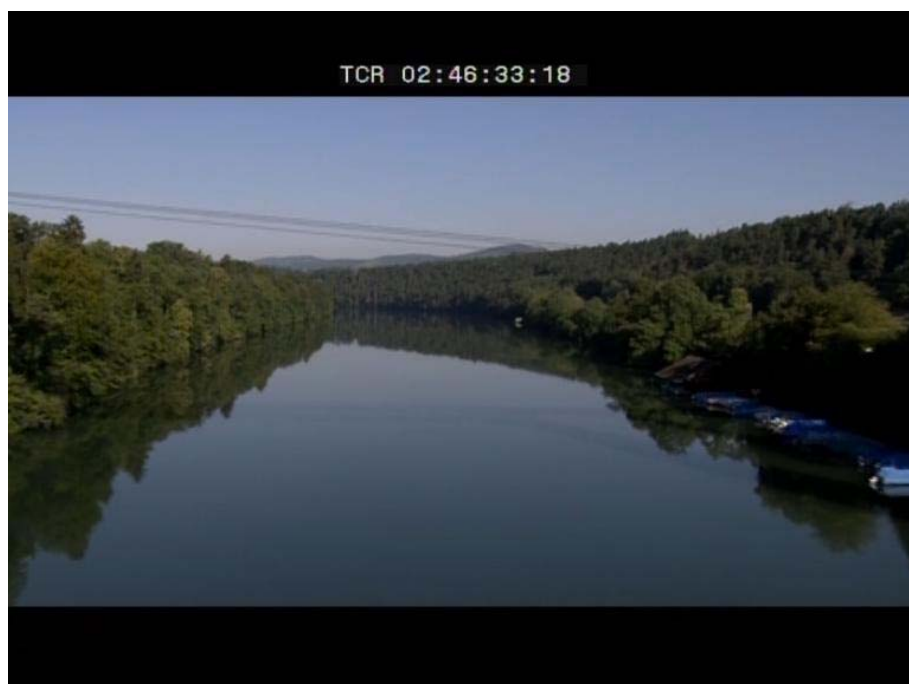
Figure 4: Camera image from a position approximately 1 second or approximately 18 m before the cable obstacle

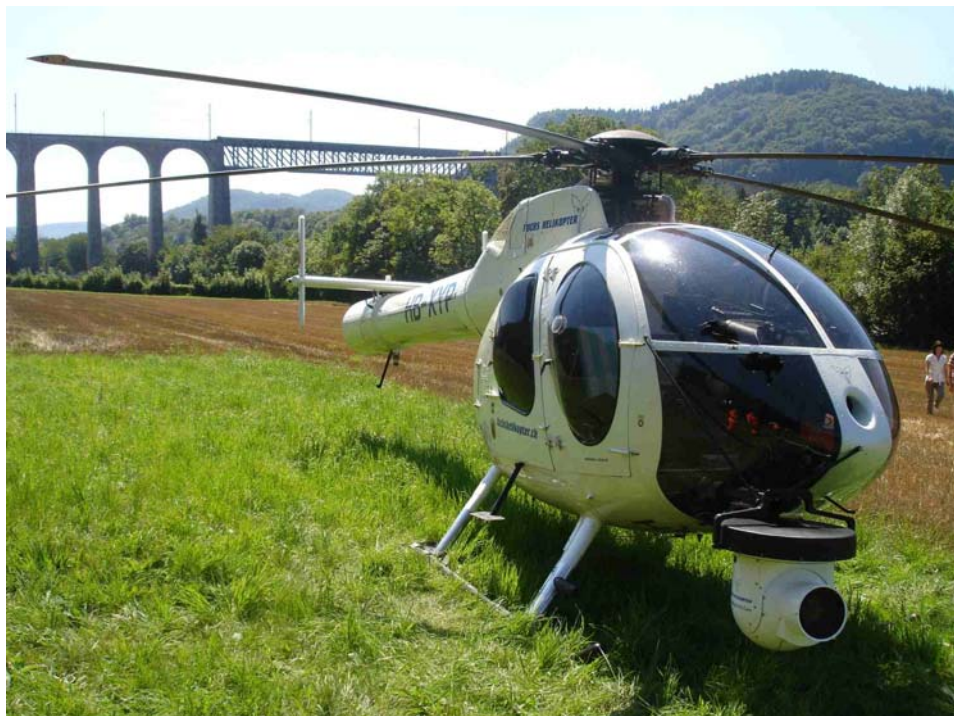
The helicopter was badly damaged. The visible damage was located in the following areas (see figures 6 and 7 Canopy):

- canopy: 2 plate-sized holes
- upper composite fuselage panels: locally dented
- all 5 main rotor blades: traces of friction, scratching and heat, surface dented over small areas

This damage was caused by the collision with the lines and a whiplash effect due to the briefly over-tensioned, and then severed, cable. Magnetisation of various metal components also occurred, because of the contact with the high-voltage line and a momentary high current flow.

Figure 6: Helicopter after emergency landing on the north bank of the river.

After a detailed inventory in the maintenance workshop, the following parts were assessed as damaged and had to be replaced:

- all 5 M/R Blades
- M/R Drive Shaft
- Inlet Fairing
- Canopy L/H und R/H

- Windshield UPR L/H and R/H, Windshield LWR R/H
- Interconnect Shaft

The following components had to be overhauled:

- M/R Transmission
- M/R Hub Assembly
- Overrunning Clutch
- Fan Transmission
- Engine

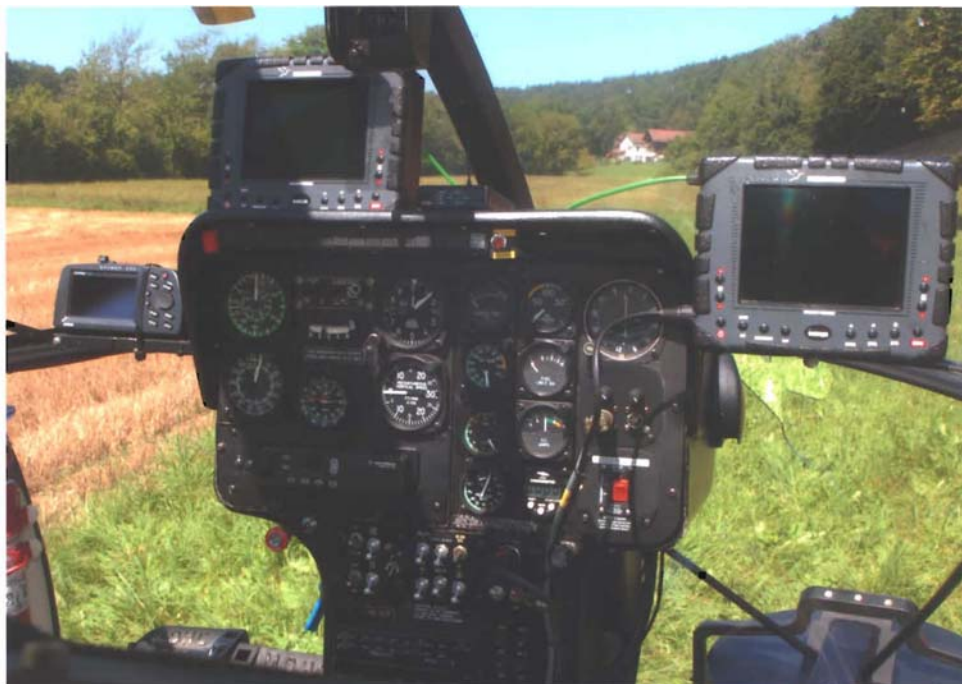
The filming equipment included, on the cockpit side, two monitors which together with the Garmin 295 GPS unit and the FLARM unit were mounted in the direct field of vision of the pilot and the front-seat passenger (see figure 8).

Figure 7: View from cockpit, Garmin GPS seen pilot side left, one camera monitor each for pilot and director.
