Final Report No. 2028 by the Aircraft Accident Investigation Bureau

to the aircraft Bombardier DHC-8-402, registration HB-JGA

on 22 June 2008

Bern-Belp Airport

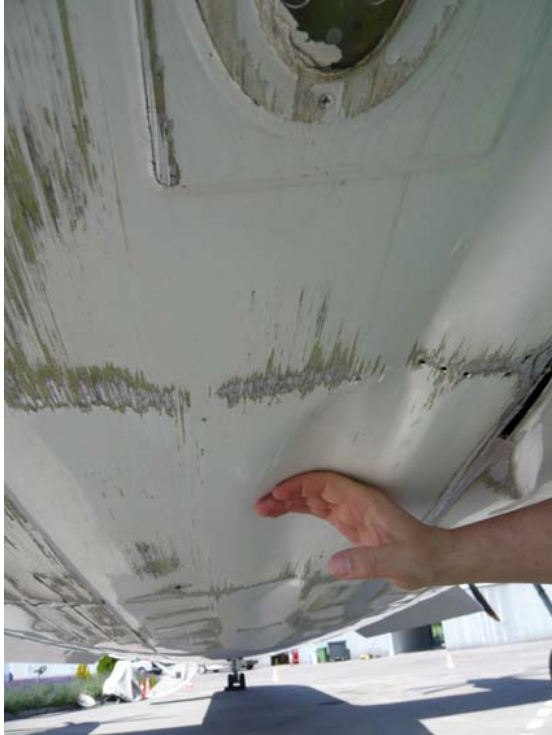
1.3 Damage to aircraft

The aft lower fuselage of the aircraft was considerably damaged. As a result, all structural parts as well as the skin panels had to be replaced between fuselage stations FS X683.450 and FS X819.102 and between stringers #30 left and #30 right.
