Final Report No. 2044 by the Aircraft Accident Investigation Bureau

to the Beechcraft 35-C33 aircraft, registration HB-EHB

on 9 May 2008

at "Grandchamp", municipality of Boudry/NE

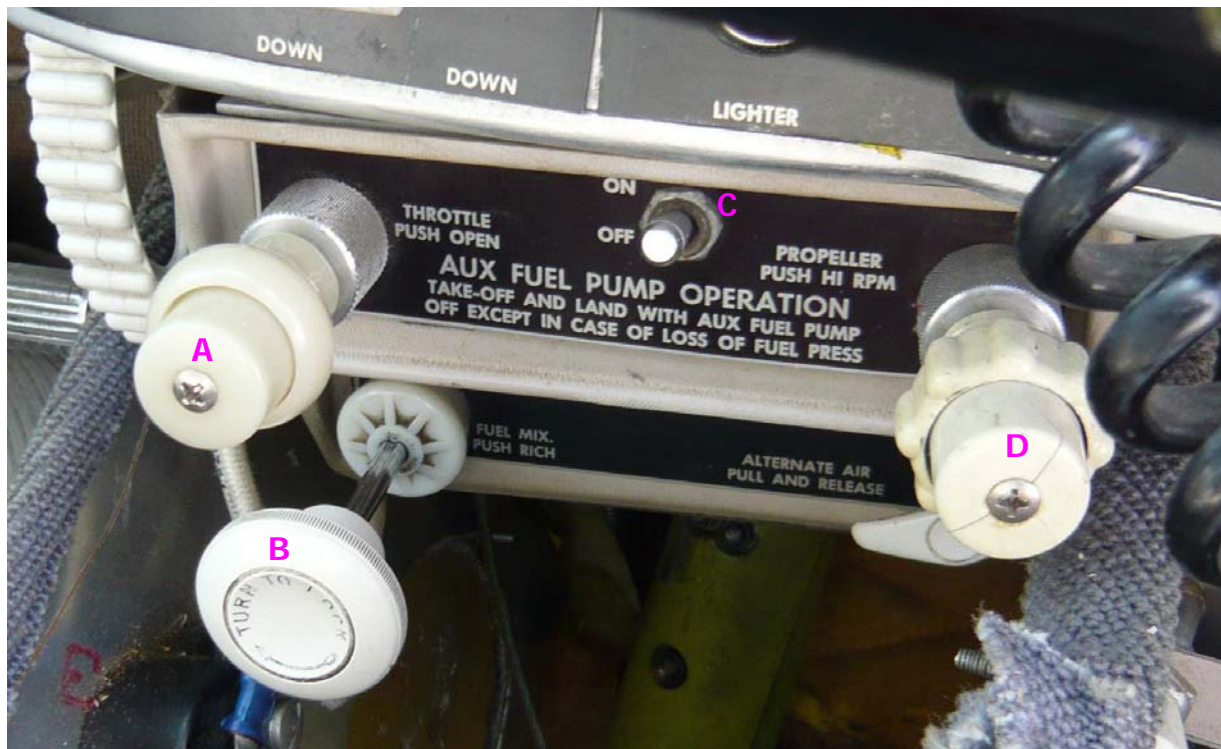
Annex 1 - Position of the controls after the accident

The three engine control knobs, i.e. throttle, propeller and mixture, are of the same colour but of different form and arranged in an "L" shape rotated 90 degrees clockwise. It should be noted that the throttle control is located above the mixture control. Annex No. 1 shows the position of the engine controls as found after the accident.

According to the statements of the mechanic, the drop in fuel flow occurred during manipulations to reduce power after take-off. In all probability, the pilot pulled on the mixture knob instead of the throttle knob. This is corroborated by the fact that the mechanic, at this precise moment, noticed a reduction in the fuel flow. Thinking it was a fault in the mechanical pump and in accordance with the manufacturer's manual, the mechanic engaged the electric auxiliary fuel pump with the intention of re-establishing an adequate fuel flow. This action, although logical, was unable to remedy the situation because the reduction in flow was a result of the incorrect position of the mixture control, as confirmed after the accident (see annex No. 1).

The pilot then wisely decided to go around, but without retracting the flaps, which were at that time fully extended. Because of the configuration of the aircraft and the lack of power due to the wrong setting of the mixture lever, the aircraft was unable to gain sufficient height. The pilot then turned left in order to be able to land on one of the adjacent fields or on the runway.
