# **Final Report No. 2048 by the Aircraft Accident Investigation Bureau**

involving the Diamond DA 42 "Twin Star" aircraft, registration N321SV

on 2 July 2008

Paradiesgletscher, municipality of Hinterrhein/GR

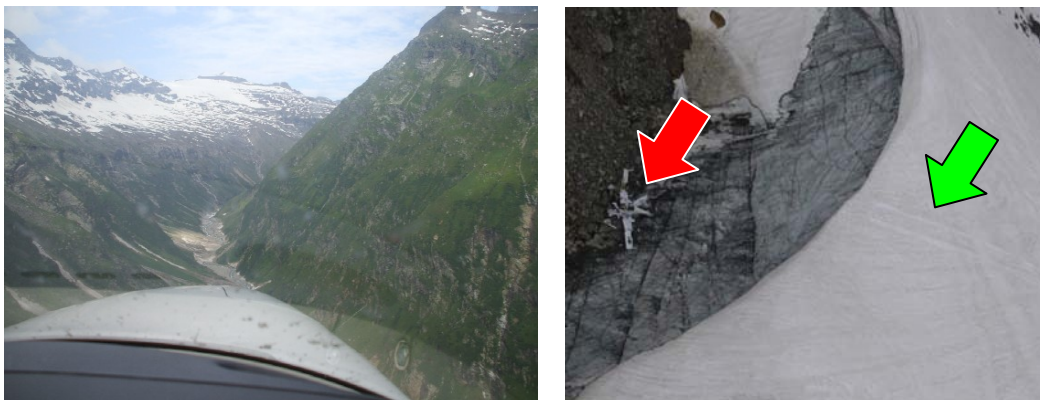
At 08:57 LT, N321SV flew over the village of Hinterrhein at an altitude of 6300 ft QNH. Engine power was then increased to 90% and in the following one and a half minutes the aircraft climbed about 600 ft. During this phase, the picture on the left of figure 1 was taken.

**Figure 1:** Left: Picture taken by the passenger from N321SV at about 08:58 LT. At this time the aircraft was about 4 km west of the village of Hinterrhein at an altitude of approximately 6600 ft QNH. Right: Photo of traces on the glacier (green arrow) and of the wreckage (red arrow) at the foot of the glacier ridge.

However, it can be stated that the pilot maintained the aircraft in a controlled flight attitude up to the unavoidable contact with the glacier. The aircraft finally slid over the topmost part of the glacier and dropped into a dip, leading to the injuries to the occupants and the destruction of the aircraft.
