Final Report No. 2050

concerning the accident

involving the EXPRESS 2000 ER aircraft, registration HB-YMN

on 23 July 2007

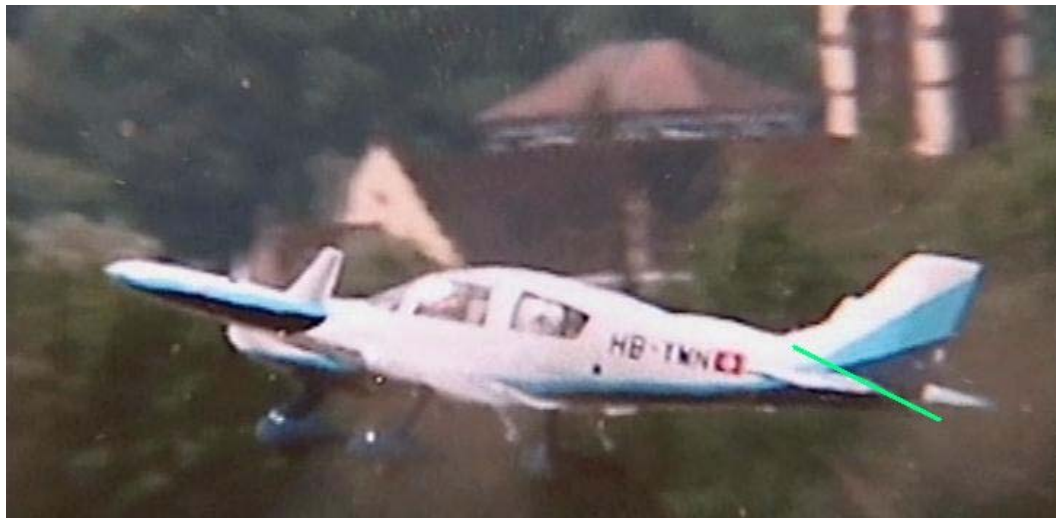
The aircraft did not lift off until the area of the intersection of the two runway systems, i.e. after a 3400 m take-off roll. It was at a high angle of attack and was unstable around the longitudinal axis. At this time the elevator was deflected downwards.

Fig. 2: Aircraft shortly after take-off with elevator deflected down (freeze out of video)

The visibly unstable progress of the flight after the extraordinarily long take-off roll indicates that the aircraft's speed was too low.

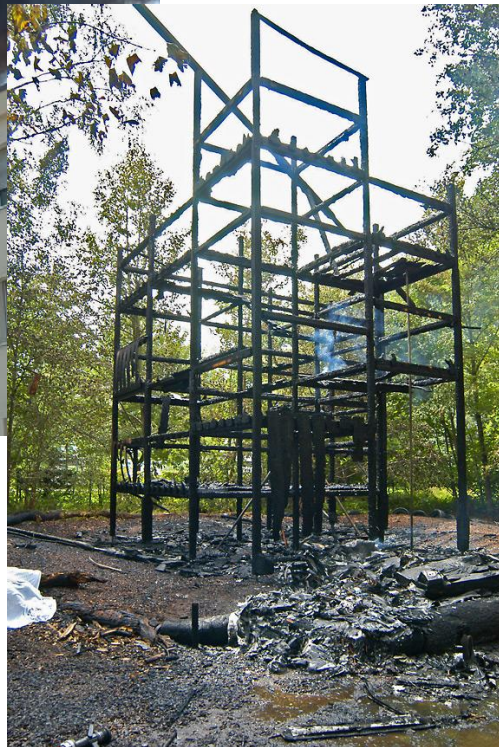
Parts of the aircraft and leaking fuel fell onto a children's playground area. Some of the equipment was destroyed by fire.

Fig. 8: Burnt-out climbing frame in the adjacent playground

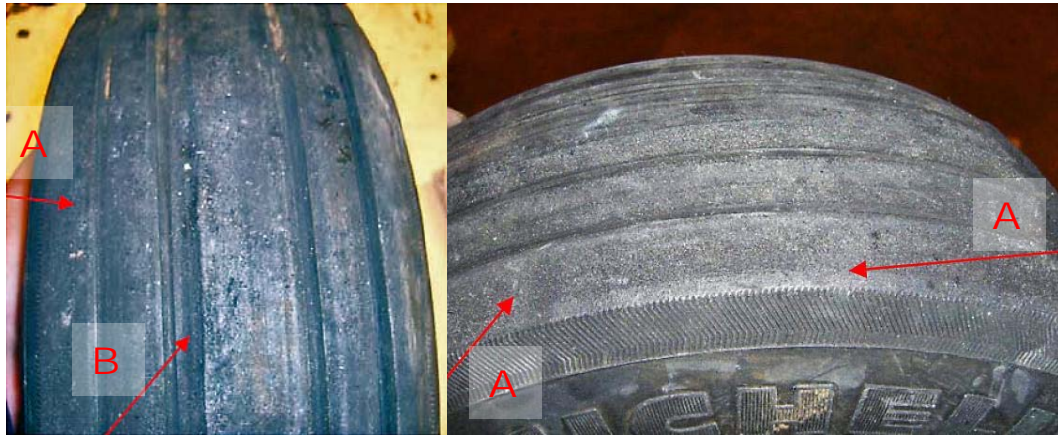
The scorched remains of the right tyre were examined by the tyre manufacturer at his facilities. The tyres, manufactured by Michelin, dimension 6.00-6 AIR, P/N 070-317-0, S/N 6146W00136, exhibited wear of approximately 80% at the shoulder on the outside (i.e. on the right), but only approximately 14% on the inside. On the outside of the centre rib, the rubber had been abraded by friction over the entire circumference. A small superficial cut was also found on the out-board shoulder of the tyre, though it did not extend to the reinforcement.

No further damage or witness marks of any kind were found on the tyre or the tube which would indicate for instance overheating of the tyre due to excessive fulling (marbling).

Fig. 10: Worn down tread of right tyre (A= worn outboard shoulder; B= Groove on the bearing surface)

The examination of the right main landing gear tyre shows that it was badly worn during the take-off roll. This and the observed smoke permit the conclusion, that the tyres have chafed against the wheel fairing. As the pictures show, the tyre was heavily deformed (flattened) under the load, because the pressure was not commensurate with the load on the wheel. It is possible that a wavelike deformation occurred in the tyres due to the extensive flattening. As the rolling speed increased this led to contact of the tyre with the wheel fairing and resulted in a breaking action.

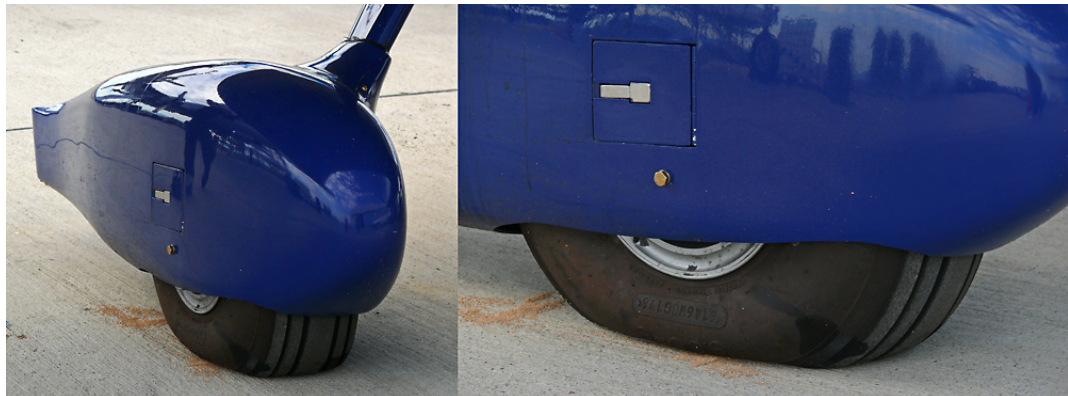
A bystander took several photographs prior to taxi of the right main landing gear in the parking area where the aircraft had been refuelled and loaded before departure, . The S/N of the tyre is visible on these pictures. This matches the S/N of the examined tyre.

Fig. 11: Right wheel with tyre in mint condition

Major deflection due to heavy load

These pictures also show that at this time the tyre appeared as new and exhibited no apparent indications of wear.

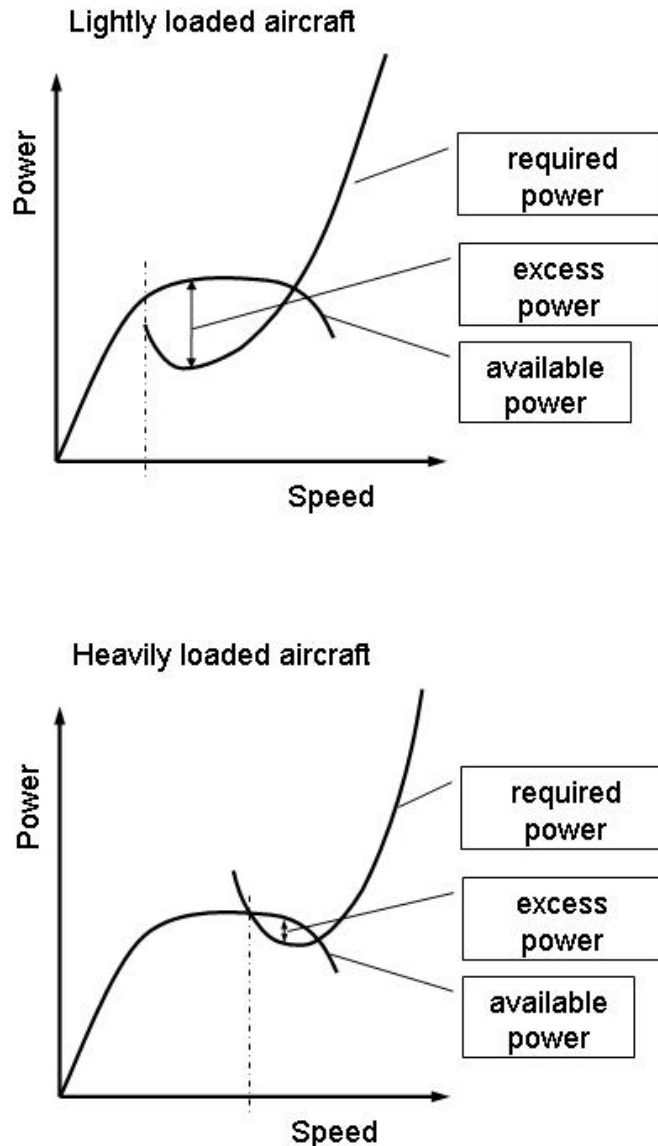
The fact that this condition did not change indicates that the aircraft, regarding excess power, was in an indifferent flight condition, i.e. drag and thrust were just balanced. Evidently sufficient excess power was not available. Therefore the pilot was not able to accelerate the aircraft to the range of excess power. As a result, it was not possible to climb and the continuation of the flight was not possible.

Fig. 13: Effect of take-off mass on excess power (qualitative depiction)
