Final Report No. 2051 by the Aircraft Accident Investigation Bureau

concerning the serious incident

involving the Cessna 550 Citation Bravo aircraft, registration LZ-ABV

on 24 January 2007

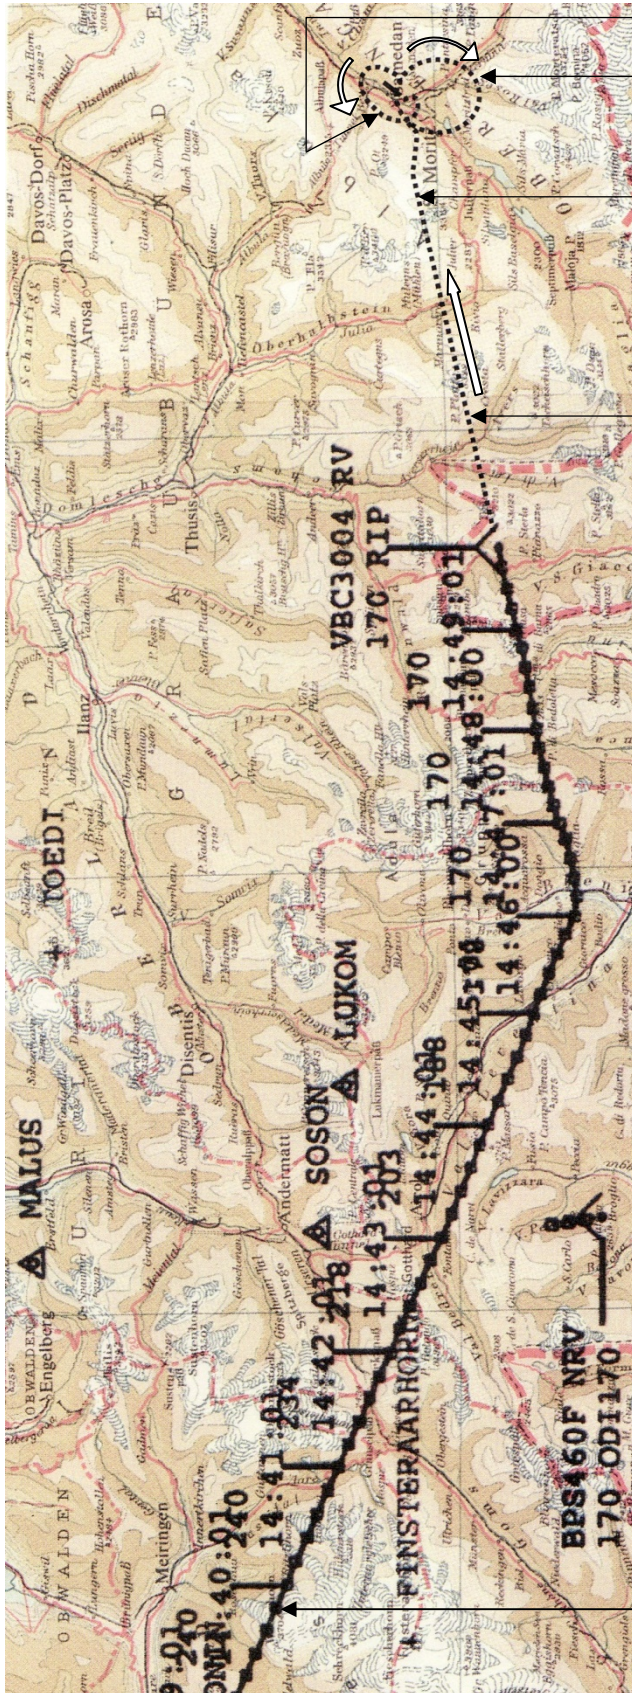
Annex 1: Flight path of flight VBC 3004

14:50:45 UTC
 Crew cancels IFR flightplan
 PA: 17 000 ft CAS: 221 kt heading: 075°

14:53:35 UTC
 Crew informs ATCO that they have ground contact and requests a heading of 100° and a descent to FL 140
 PA: 14 712 ft CAS: 237 kt heading: 077°

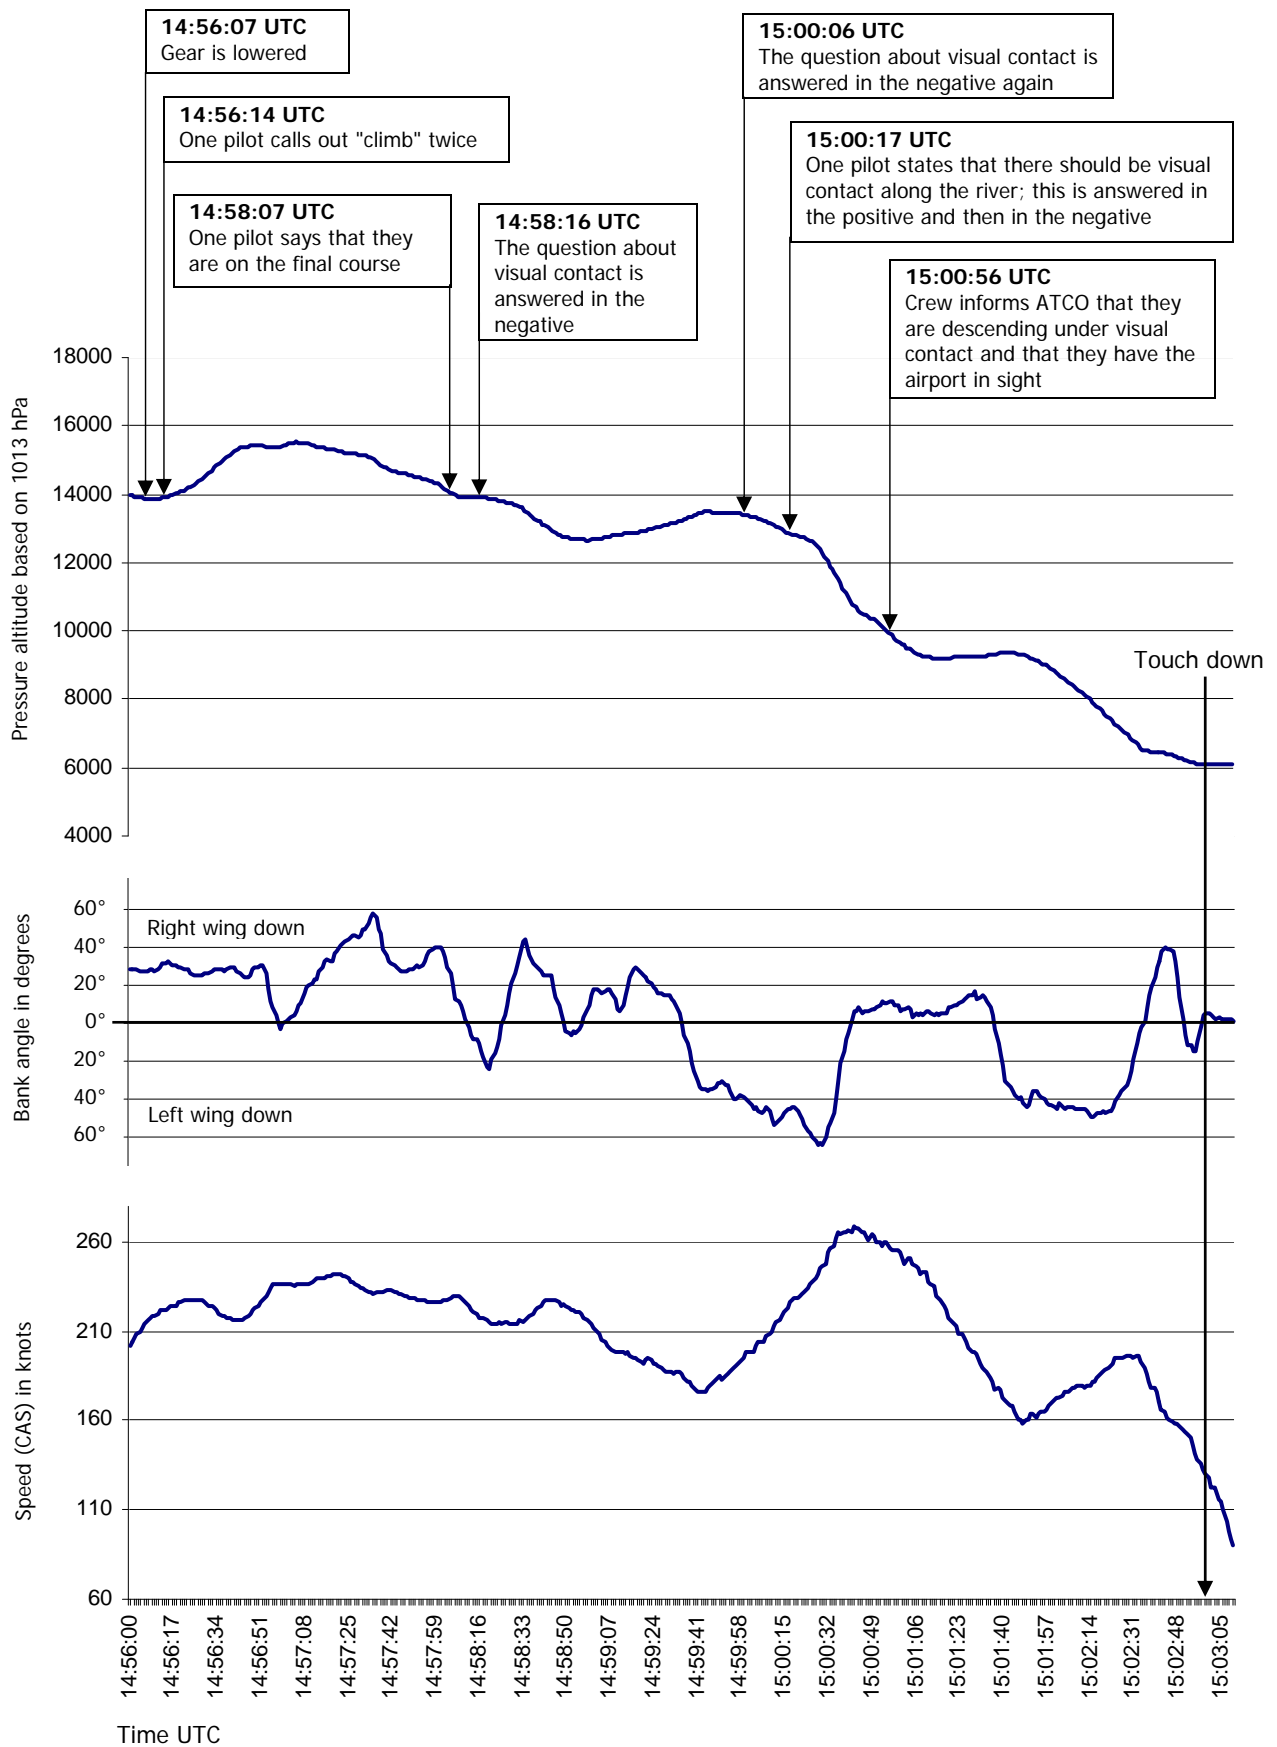
Annex 2: History of the flight during the last seven minutes

The question about visual contact was answered with the comment that the mountain peaks would be visible. It must be assumed that the visual contact reported to Samedan aerodrome at 14:55:10 UTC had been lost again. Subsequently, at 14:55:38 UTC, a clockwise three sixty was initiated. During this manoeuvre, "*climb*" was called out loudly twice at 14:56:14 UTC. It must be assumed that the topography in the area caused this call-out. A shallow climb was then initiated. The landing gear was not retracted. The pitch and bank angle recordings (Annex 2) indicate very nervous handling of the controls.

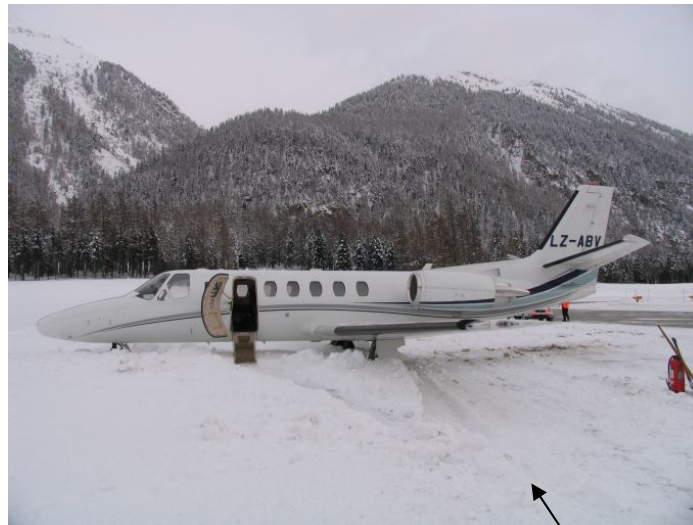
Annex 4: Marks on the runway in Samedan

The aircraft rolled over the end of runway 03 at a speed of approximately 30 knots, and came to a standstill in the snow after 20 metres, about 5 metres east of the runway centre line. The aircraft was not damaged and it was possible to tow it back onto the runway using ropes secured to the main landing gear.

Right main gear drifts 30 cm beyond the right runway edge line

End position of the aircraft (20 m after runway end)

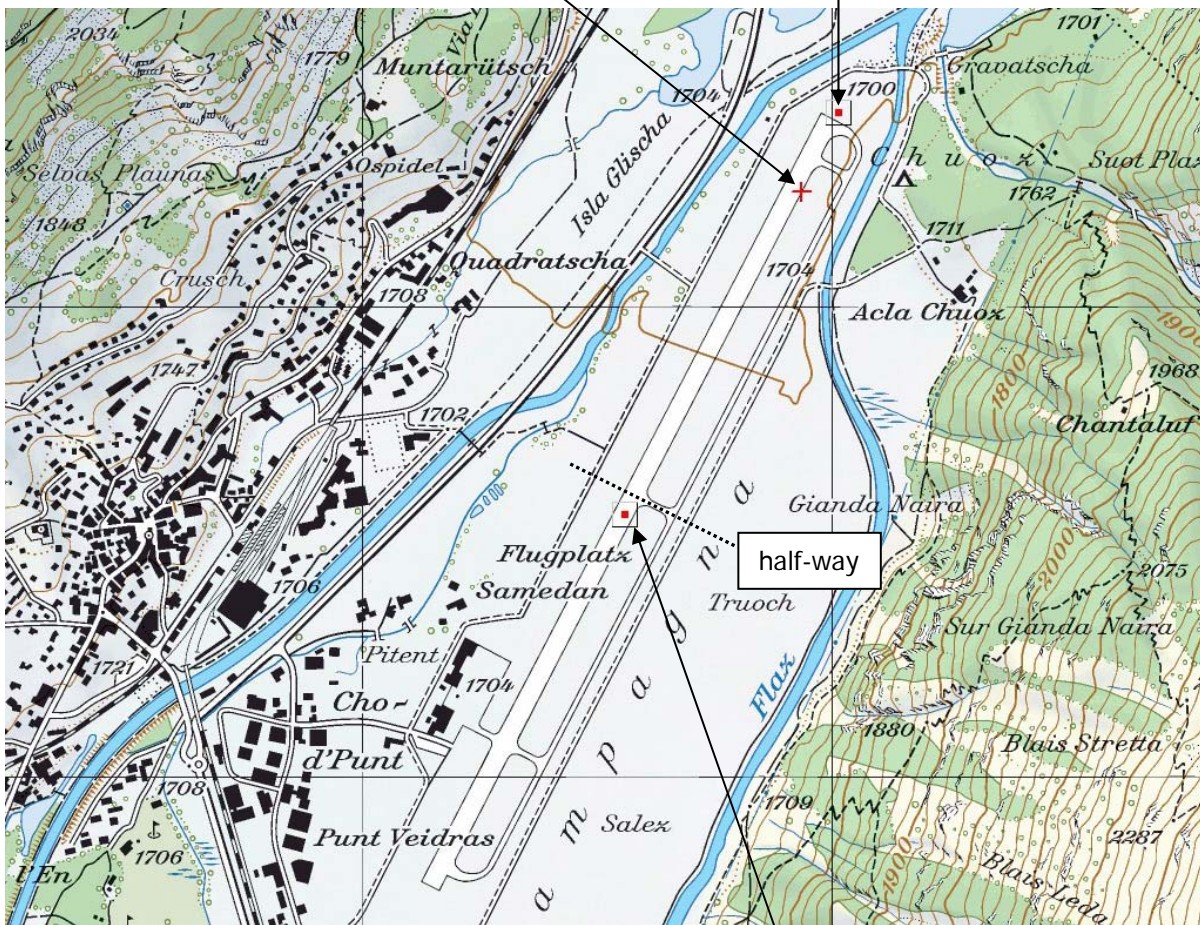
It is much more likely that the aircraft's slight drift to the right caused the commander to retract the reverser buckets, reduce brake pressure and re-align the aircraft on the runway centre line. The one metre high walls of snow along the runway, only 4 metres from the runway edge line, may have reinforced this reaction. The fact that reverse thrust was re-applied only two seconds later may have been an instinctive reaction, as the buckets were still deployed after the aircraft came to a standstill in the snow.

half-way

Touch down point (915 m before runway end and 440 cm right of centerline)
