# **Final Report No. 2055 by the Aircraft Accident Investigation Bureau**

concerning the serious incident (AIRPROX)  
involving PJS 303, Cessna C550, registration HB-VNZ  
operated by Jet Aviation Business Jet AG  
and KLM 59Z, Boeing 737-300, registration PH-BTD  
operated by KLM Royal Dutch Airlines  
on 8 April 2008 at 19:40 UTC  
on the apron of GIA, Geneva International Airport

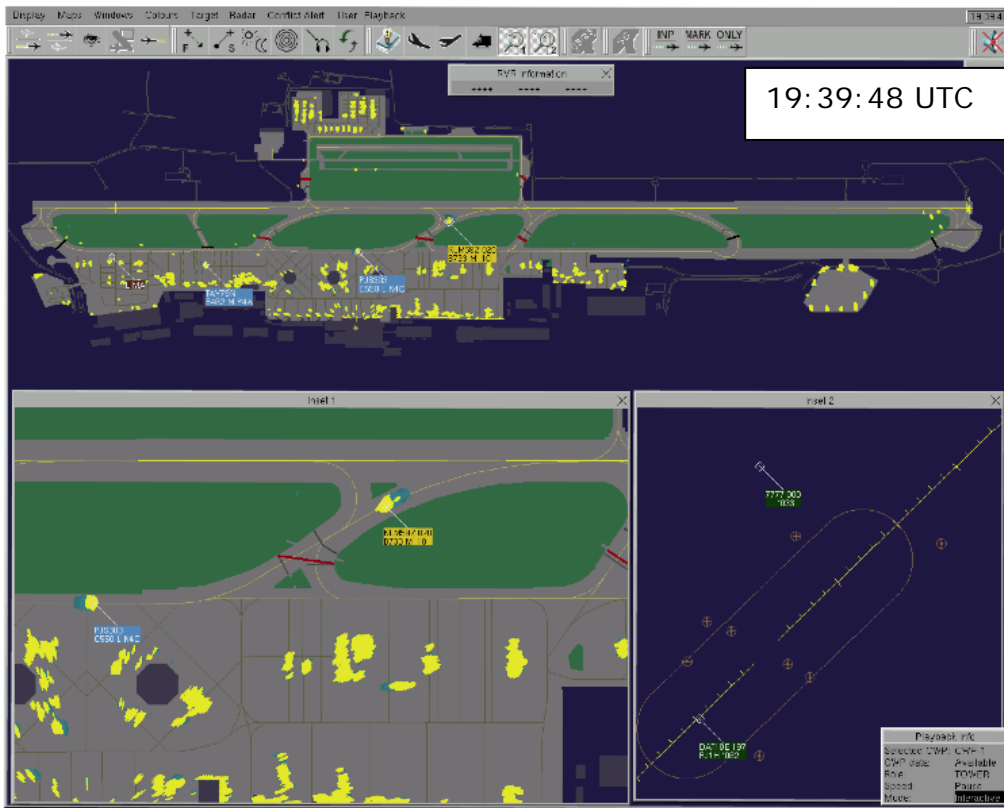
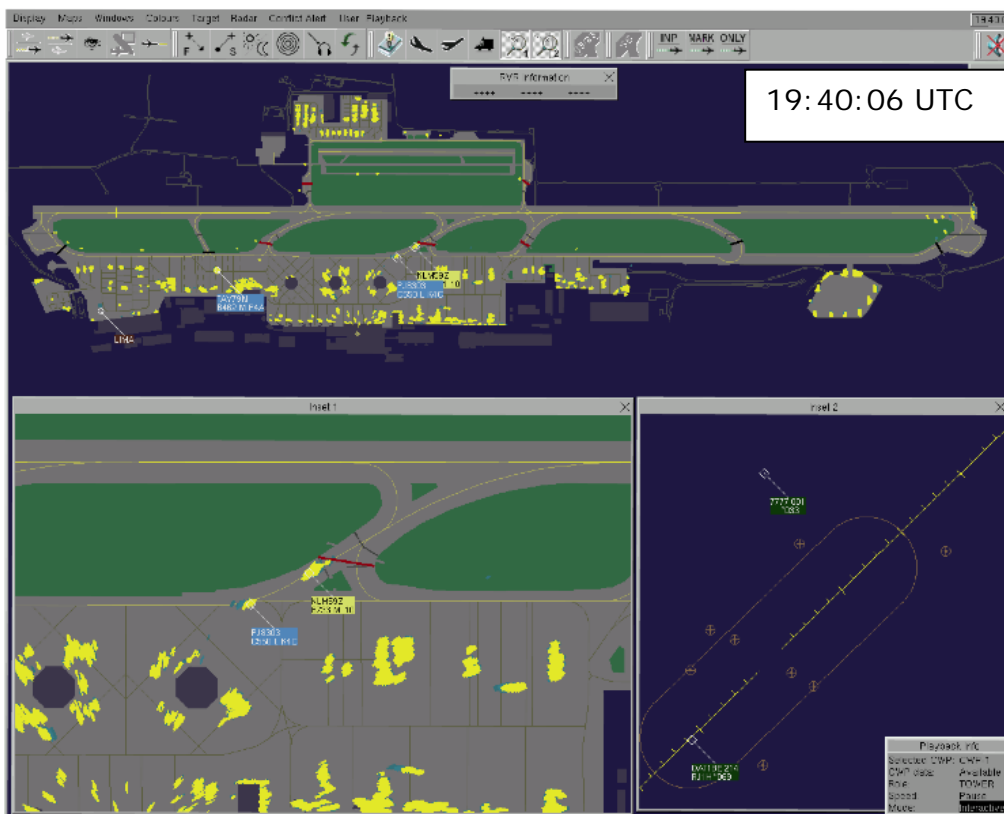
Annex 1: extract of SAMAX incident's replay : KLM with yellow label, PJS with blue label.

At 19:40:00 UTC the Citation on the OUTER taxiway was approaching the intersection with taxiway DELTA and was passing just in front of the B737 at 19:40:10 UTC (see ANNEX 1 SAMAX images).

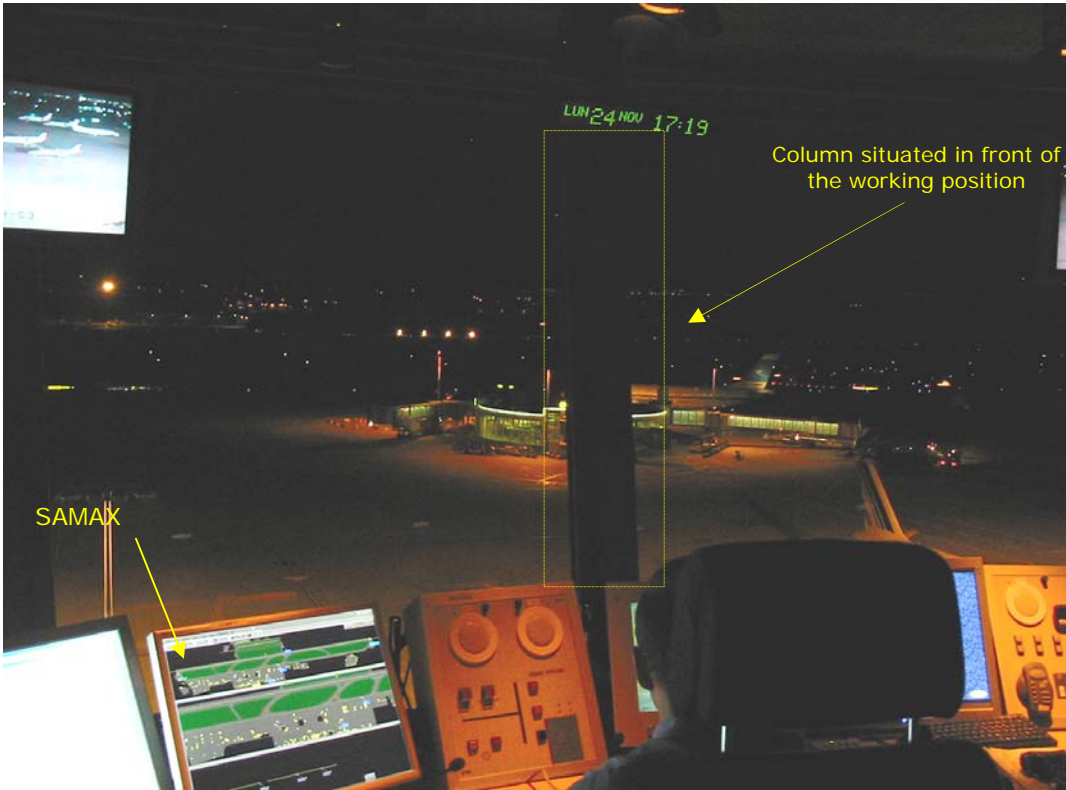
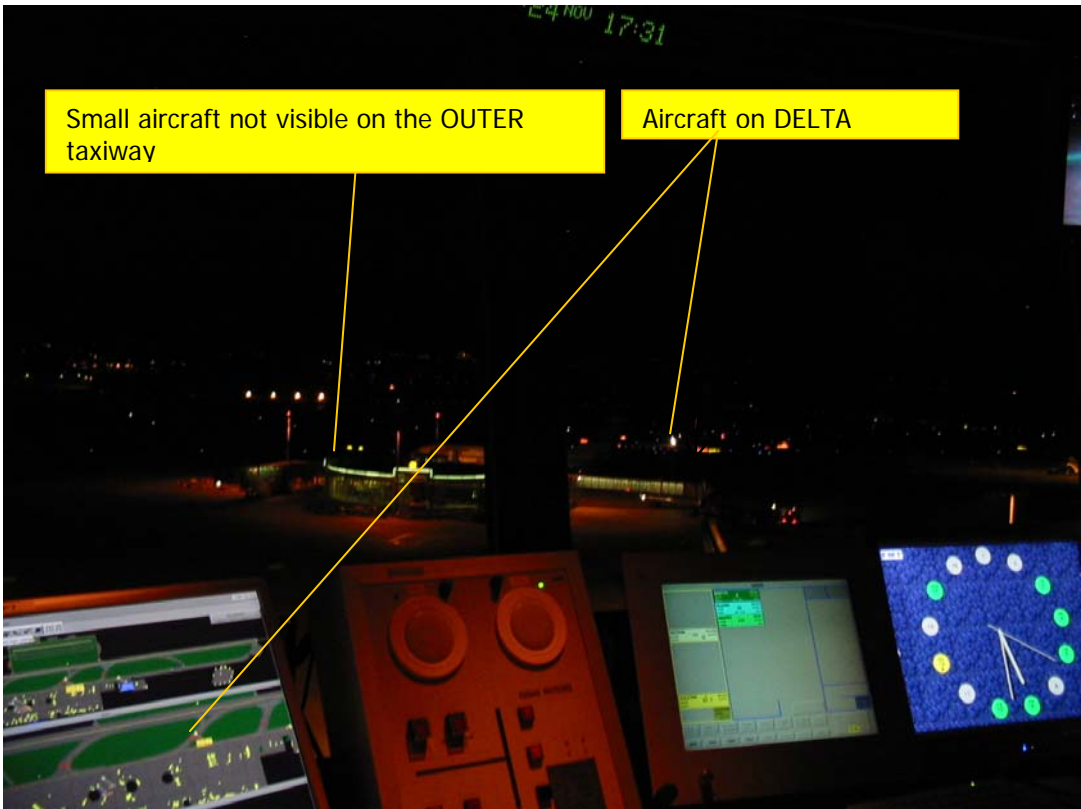
Annex 3 : photos from the AMS Tower, on the 24th November 2008

From the apron controller's workstation, the airport infrastructures obstruct, partially but permanently, the view of the location at which the incident occurred (see ANNEX 3 photos).

- The position of the Geneva APRON service does not allow unobstructed visibility over the intersection formed by the OUTER taxiway and the DELTA rapid exit.

- The sector of the OUTER taxiway located north of satellite 40 cannot be observed at night, given its strong lighting and in particular that of position 43.

- At the time of the incident, several aircraft were parked around satellite 40, masking part of the OUTER taxiway.
- The unfavourable meteorological conditions created a lighting reflection phenomenon due to the rain.
