# **Final Report No. 2072**

concerning the accident  
to the Kaman K-1200 helicopter K-MAX, registration HB-XQA  
on 11 October 2004  
"Petit Truyo", Grandvillard/FR  
approx. 30 km south of Fribourg

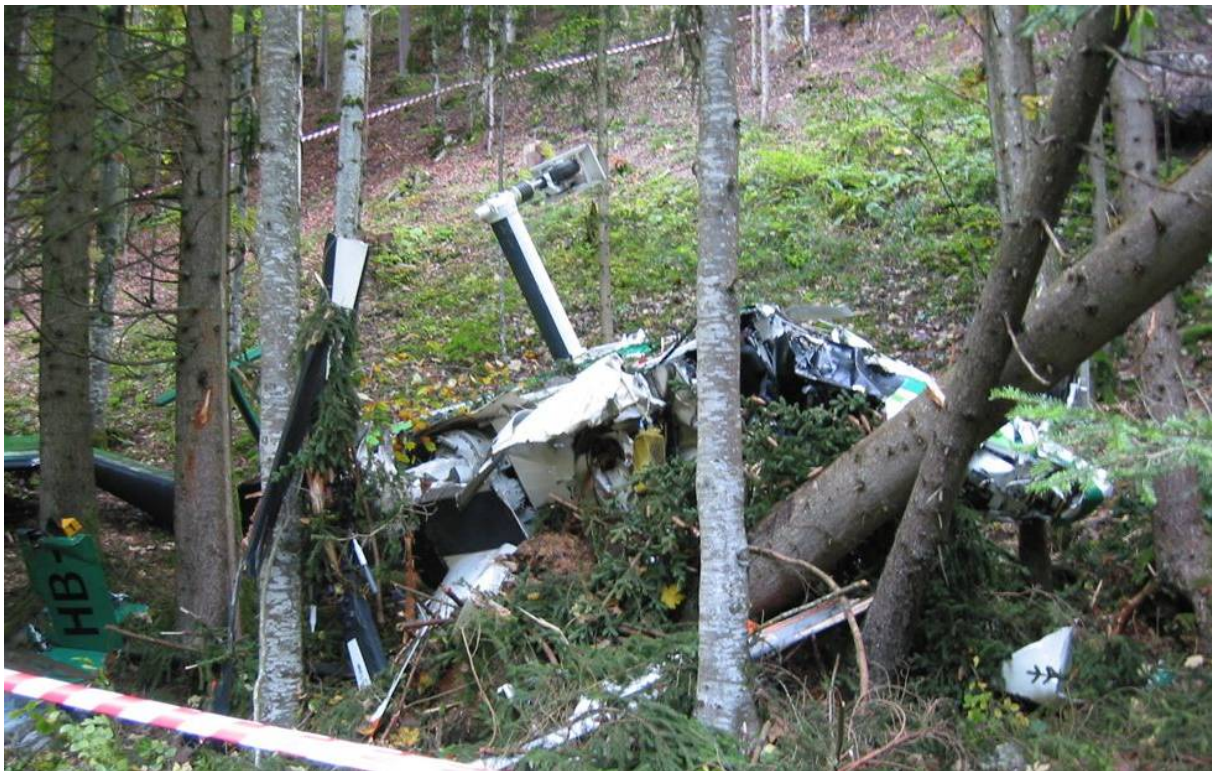
Figure 1: Final position of the helicopter

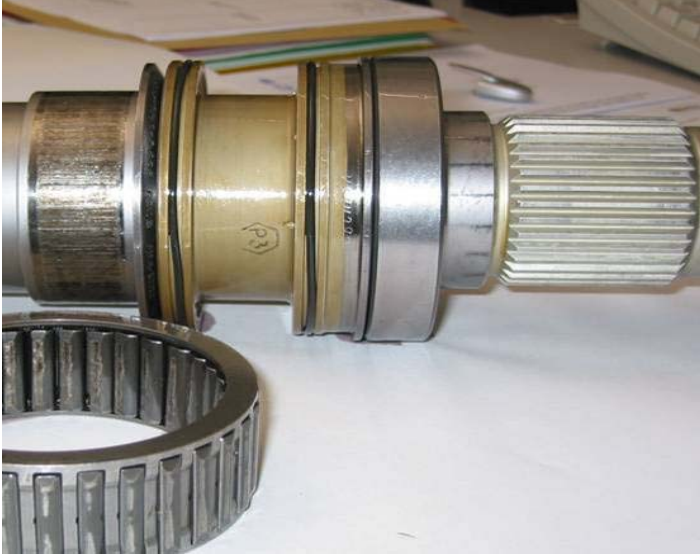
The failure of the clutch assembly was caused by overloading and fatigue of the bearing surfaces on the free-wheel clutch shaft.

<p>Figure A</p> <p>K974047-005, S/N 0166B and K974110-003, S/N 093</p> <p>Event HB-XQA</p> <p>The clutch shaft bearing surface exhibits a very rough, worn surface.</p>

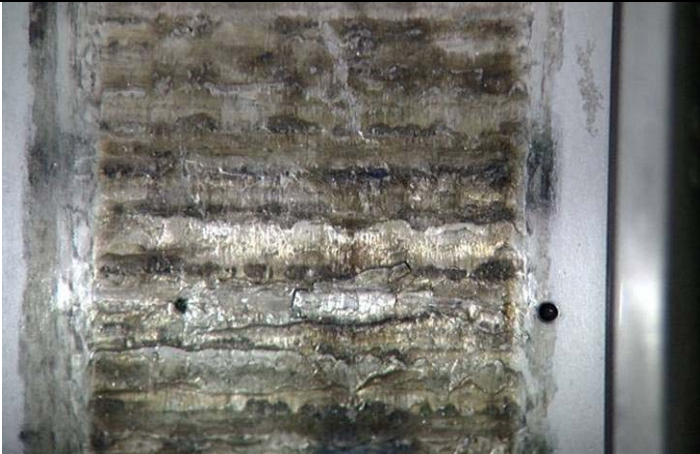
<p>Figure B</p> <p>Component K974047-005,S/N 0166B</p> <p>Event HB-XQA</p> <p>Detail of bearing surface with pronounced brinelling pattern</p>

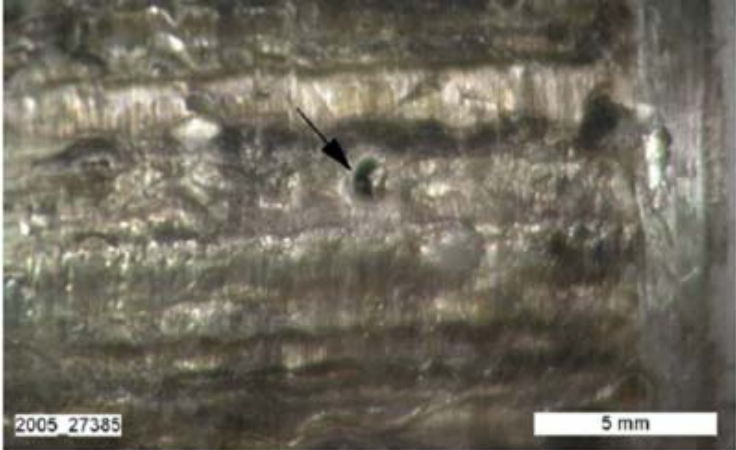
<p>Figure C</p> <p>Component K974047-005, S/N 0166B</p> <p>Event HB-XQA</p> <p>Lubrication bores are partially covered by plastic deformation (arrow).</p>

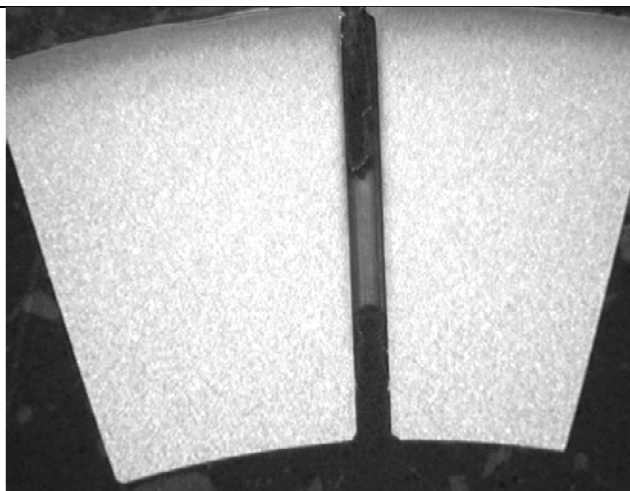
Figure D

Lubrication bores were partially blocked as a result of the deformation of the bearing surface.

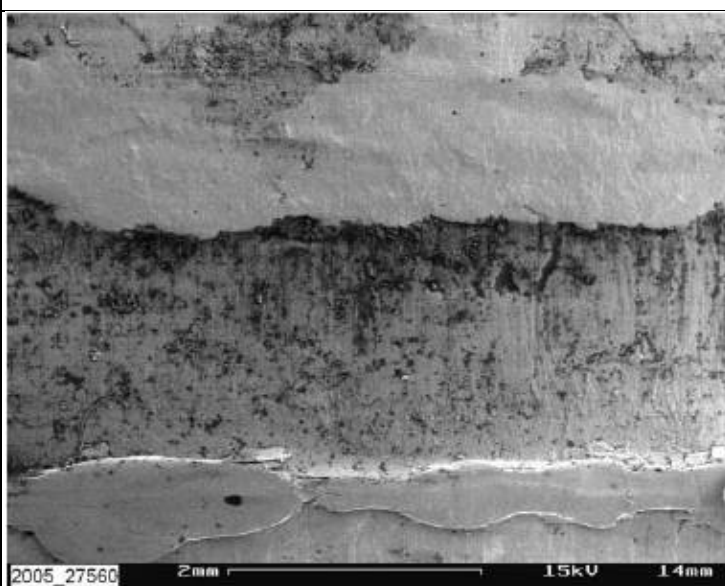
Figure E

View of clutch bearing surface with distinct traces of plastic deformation.

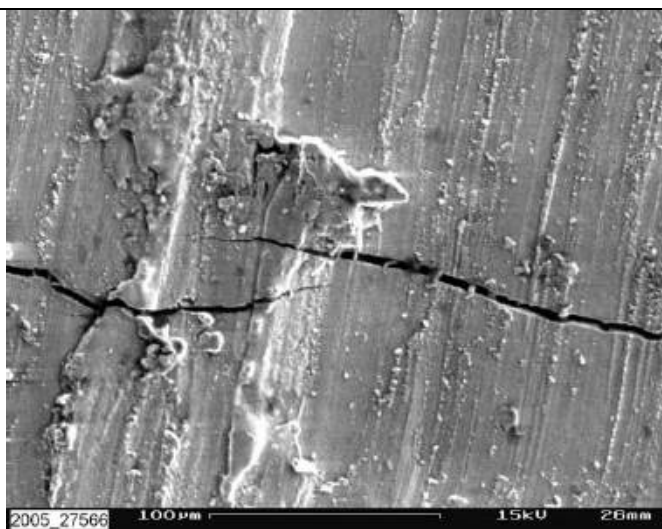
Figure F

Isolated microfissures are visible in the clutch bearing surface.

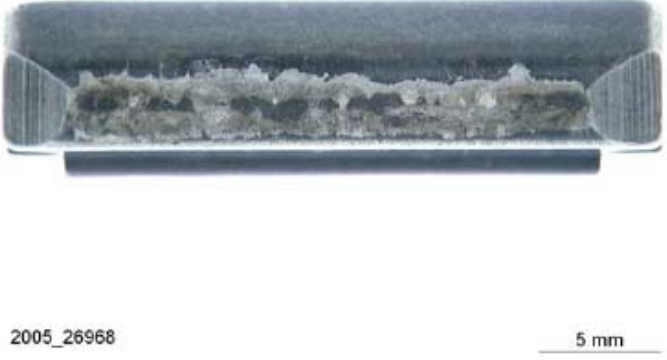
<p>2005_26968</p> <p>5 mm</p>	<p>Figure G</p> <p>Component K974110-003, S/N 093</p> <p>Event HB-XQA</p> <p>Surface detail of sprag element with a flaky surface formation (contact surface with K974047-005).</p>

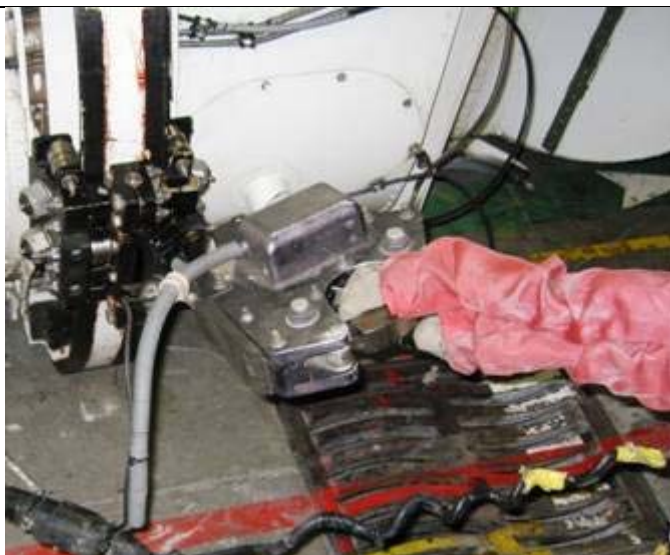
Figure L

Belly cargo hook: The investigation after the accident showed no wood or soil residues on the belly cargo hook. It was only possible to mechanically release the hook by applying great force. The nylon choker (type 3 t) was lined with a textile hose for abrasion protection. This hose was abraded in the contact area and displayed rubbing marks (see attached figures L and M). The cargo hook bumper was damaged and the hook could be released only with difficulty (see attached figures L and M).

Longline loop with protective hose hooked directly into the belly cargo hook.

Increased friction under tension due to the tight longline loop.

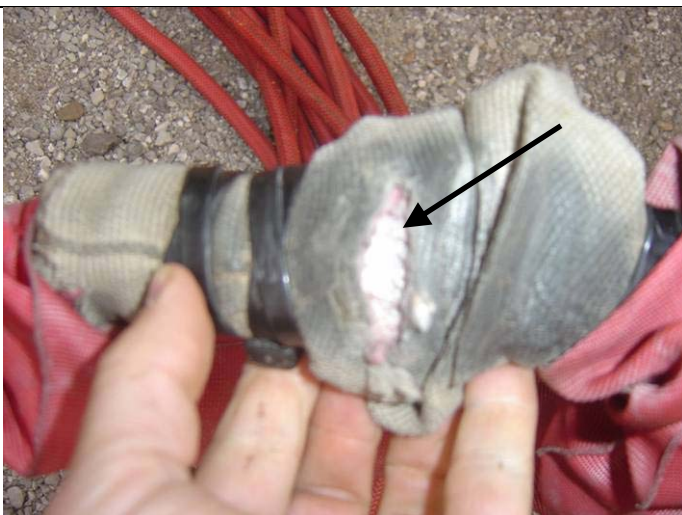
Figure M

Friction witness marks on the contact areas.

Worn through protective hose of the longline loop.

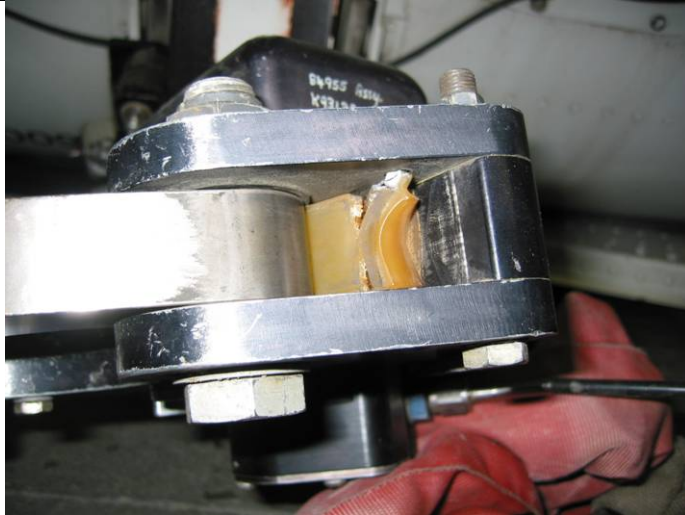
Figure N

Due to the restricted movability of the loadbeam and the evident damage to the bumper which is made from synthetic material, the belly cargo hook was examined in more detail. Increased friction forces were evident when opening the cargo hook. Upon disassembly of the sideplates it was discovered that the yellow bumper was held in place between the sideplates of the belly cargo hook by the bent steel pin. The effect of the bent pin was similar to a barbed hook. After the bumper had been pushed inward by some object, the bent pin acted similar to a barrier which prevented the bumper from returning to its original position. The wear on the yellow bumper and its deformation (Figures N, O, Q) make it evident that the bending of the pin was not a result of the accident. It is not possible that the bending was caused by the loadbeam. The contact between the bumper and the loadbeam resulted in increased friction and explains the restricted movability.

Damaged limit stop bumper on the belly cargo hook

Indications of the original position of the bumper and clear signs of wear on the load beam.

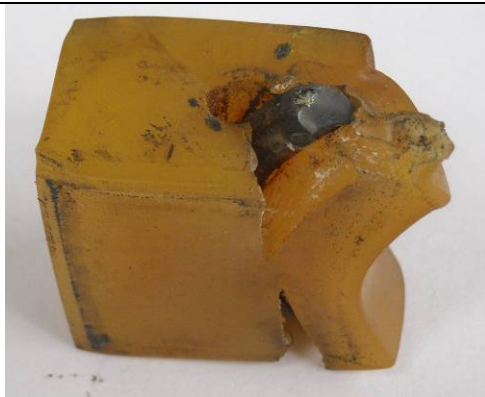
Figure O

Indications of friction and wear
