Büro für Flugunfalluntersuchungen BFU
Bureau d'enquête sur les accidents d'aviation BEAA
Ufficio d'inchiesta sugli infortuni aeronautici UIIA
Uffizi d'inquisiziun per accidents d'aviatica UIAA
Aircraft Accident Investigation Bureau AAIB

Final Report No. 2076

concerning the serious incident (AIRPROX)
involving the Boeing aircraft, B737-800, registration D-AHFO
operated by TUIfly under flight number HLX 2CX
and the Piper aircraft, P46T, registration OO-NMU,
operated by Vianatura
on 29 September 2008
near SOSAL
20 NM west south-west of Fribourg

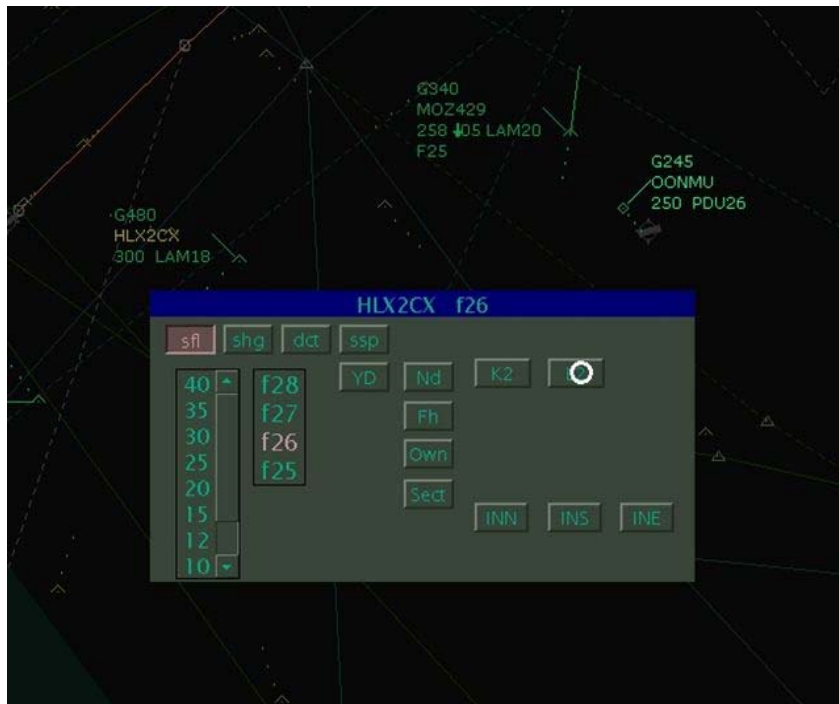
Co-ordination window

- 1 click on the sfl - *suggested flight level* field of the label to open the co-ordination window
- 2 click on f26 (FL 260)
- 3 click on L2

The radar planner of sector KL1 has suggested (by executing mouse clicks) flight level FL 260 for flight HLX 2CX to the controllers of the regrouped sector KL2

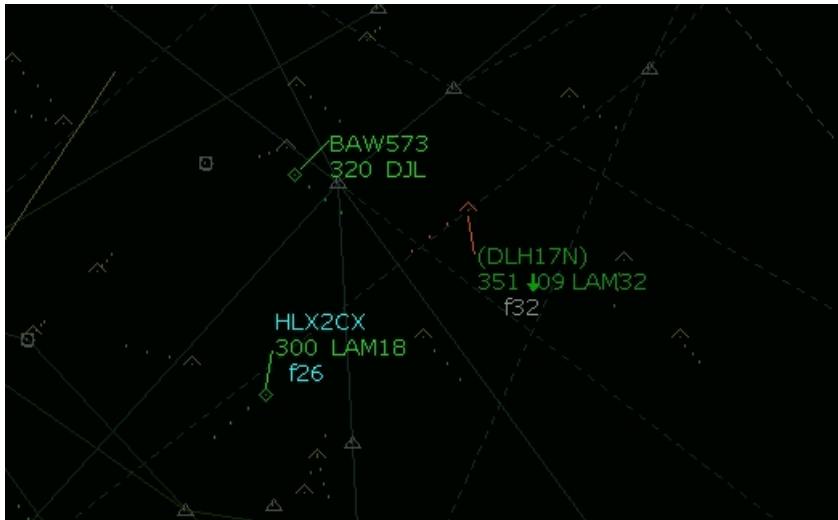
The flight level suggested by the controllers of sector KL1 is displayed on the label of flight HLX 2CX on the radar screens of sector KL2. The call sign and the suggested flight level are displayed in blue colour.

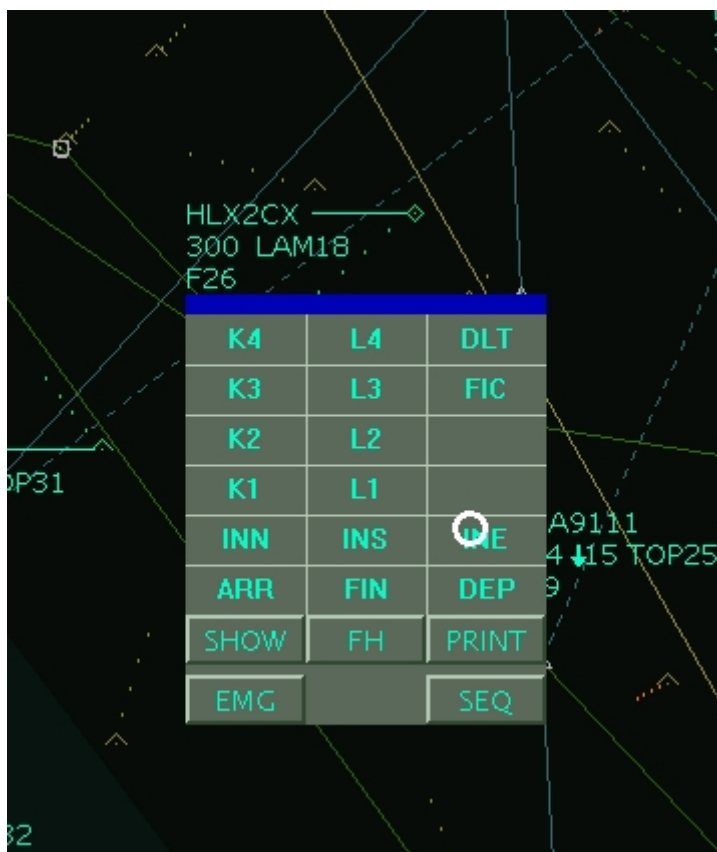
Window SI *special input* permits to select a sector for a transfer on communication – in the present case by a click on the INE field.

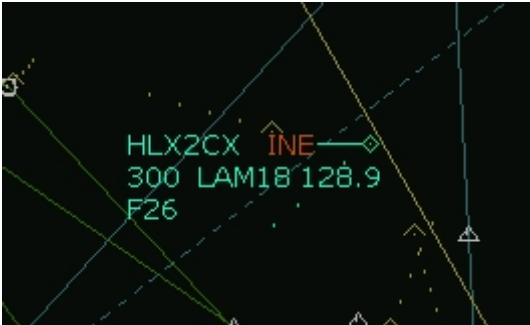
Display on the radar screens of sector KL2. The sector to which the aircraft is to be transferred shows on the radar label of the aircraft concerned.

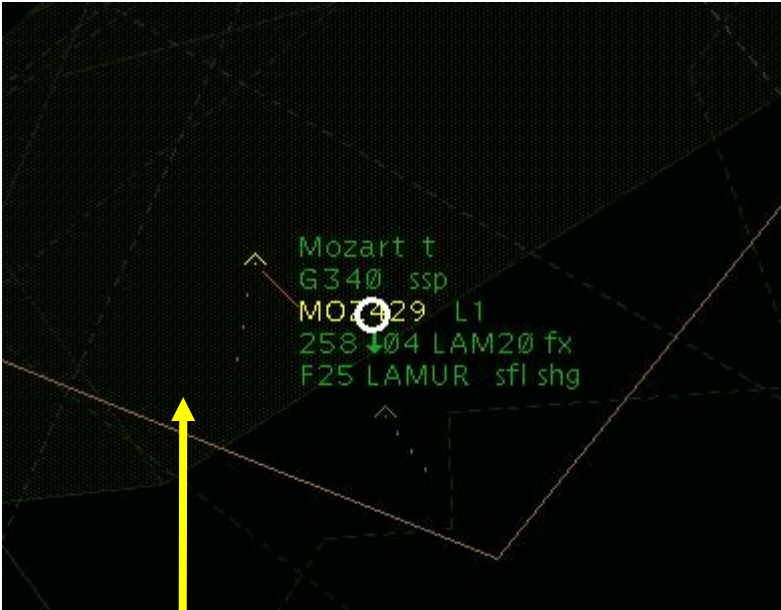
An aircraft is in the «hook» mode prior to AoC at sector INE. The cleared flight level (FL 250) is displayed on the radar label.

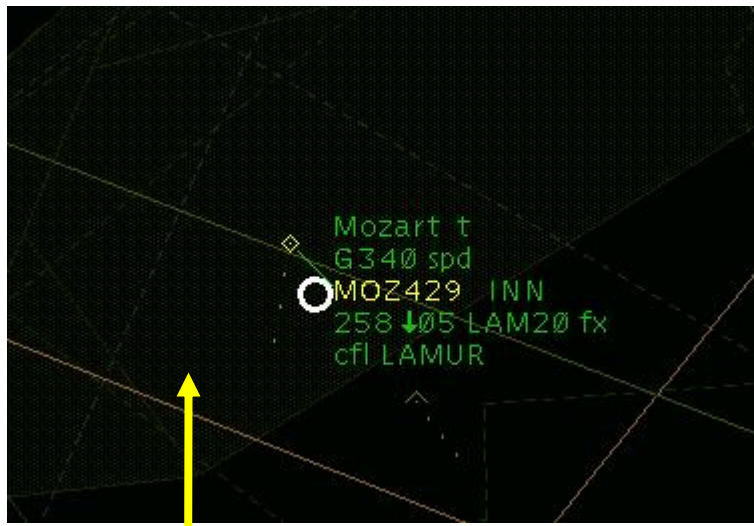
The radar controller performed the AoC function at the time of the first call; because of the speed of this manipulation, the label did not go to "hook" mode; consequently the CFL was never displayed on the screen.

The same aircraft in AoC at sector INE. The cleared flight level (FL 250) is not displayed any more on the radar label. It is replaced by « cfl ».

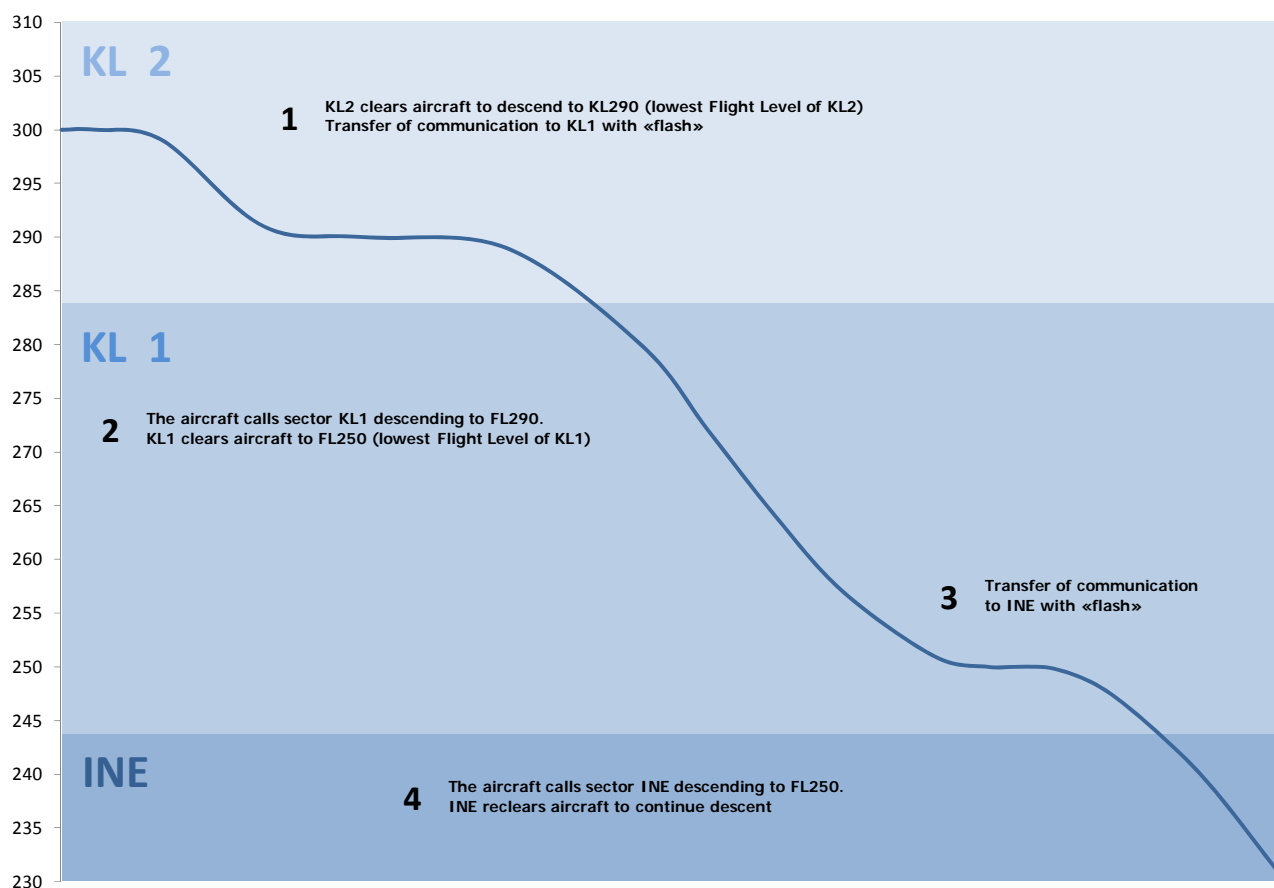
Annex 3

Silent transfer of an aircraft descending from one sector to the following

The sector that doesn't receive a suggested flight level clears the aircraft to the lowest flight level of his sector and sends it – clear of conflict – in contact to the adjacent sector using the "flash" method to show the receiving sector that the aircraft is going to call on his frequency.

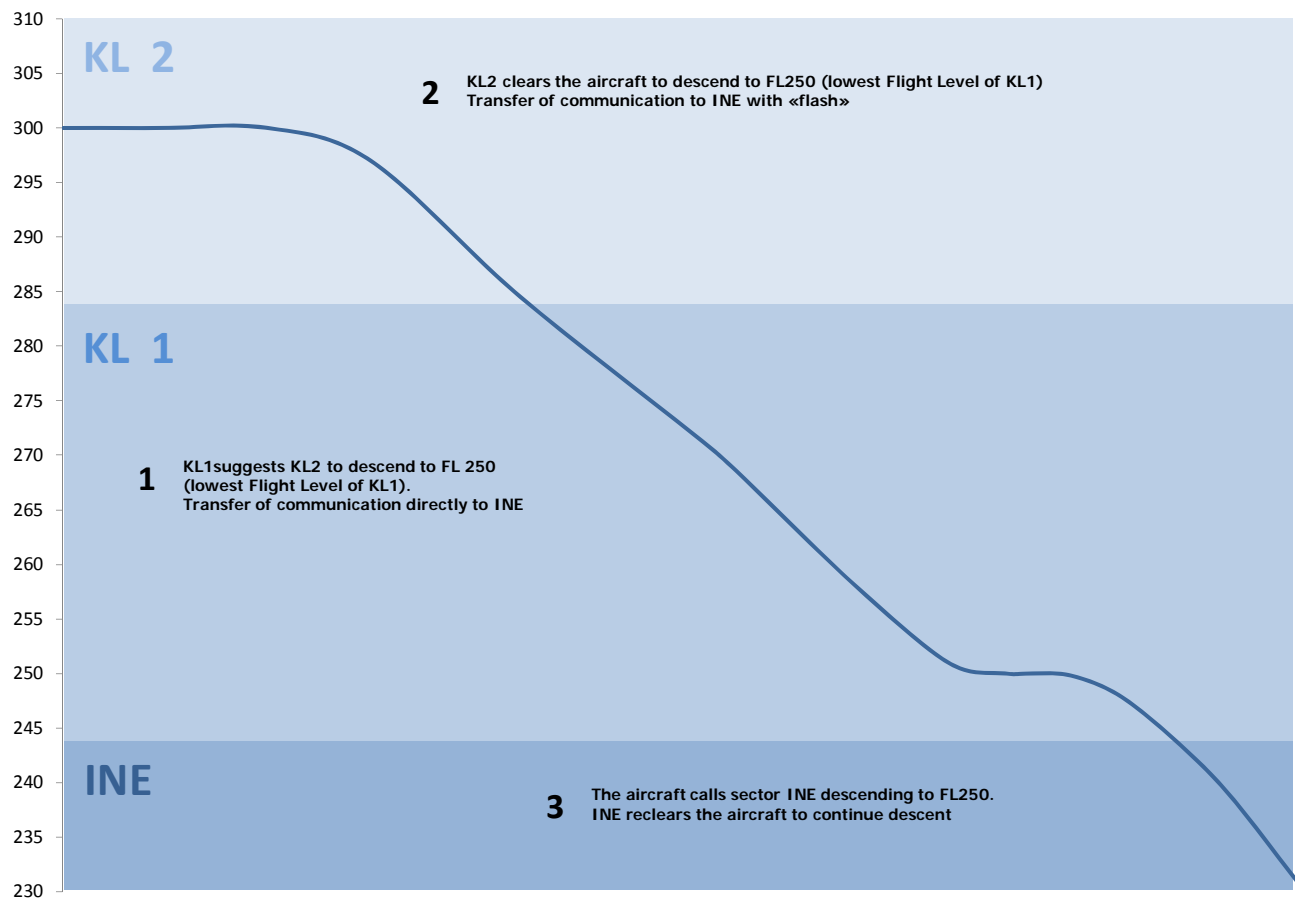
Annex 4

Silent transfer across a sector without transfer of communication

On his own initiative, provided there is no conflicting traffic within the sector, KL1 can suggest to KL2 to descend an aircraft across his sector to the lowest flight level with a transfer of communication directly to INE
