# **Final Report No. 2084 by the Aircraft Accident Investigation Bureau**

concerning the accident involving  
the Bombardier BD-700-1A10 aircraft, registration N906JW  
on 6 February 2009  
Samedan Airport, municipality Samedan/GR

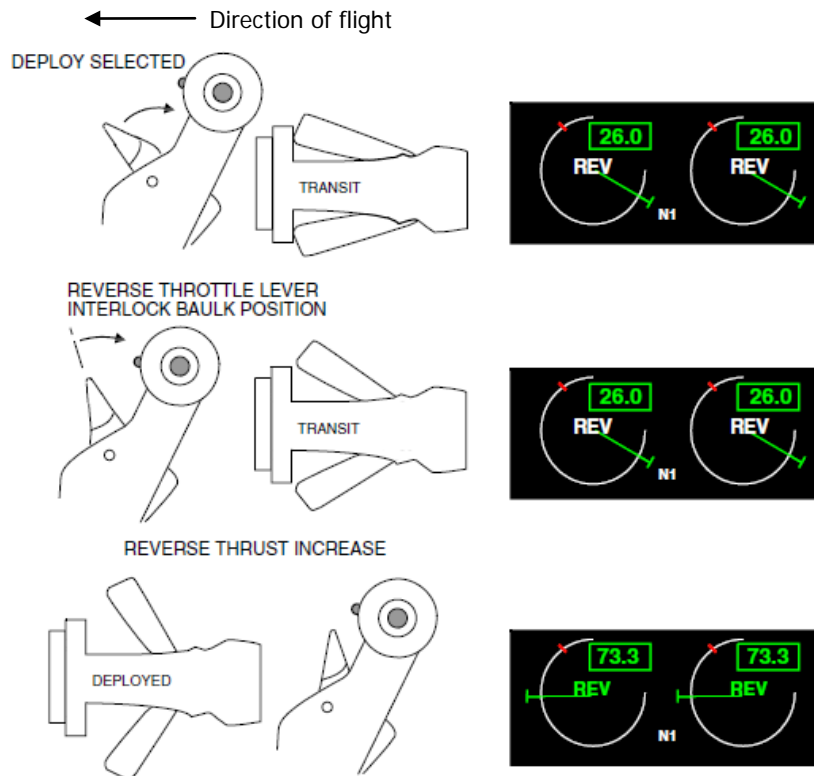
Fig. 3: Procedures and cockpit display during operation of the thrust reverser system

Experience shows that the sequence for activation of the reverse thrust system must be initiated step by step; otherwise there is a risk of causing a malfunction, which may lead to asymmetric operation of the system.

Experience of operation of the thrust reverser system on the BD-700 indicates that the manipulations on the thrust and thrust reverser levers must be initiated step by step. In the present case it can be assumed that, not least because of the stress situation, which among other things was additionally aggravated by the late touchdown, the thrust reverser system was activated too early, although not all the necessary conditions were met. The result was that the right reverse thrust lever got stuck and could not be brought to the interlock baulk position.

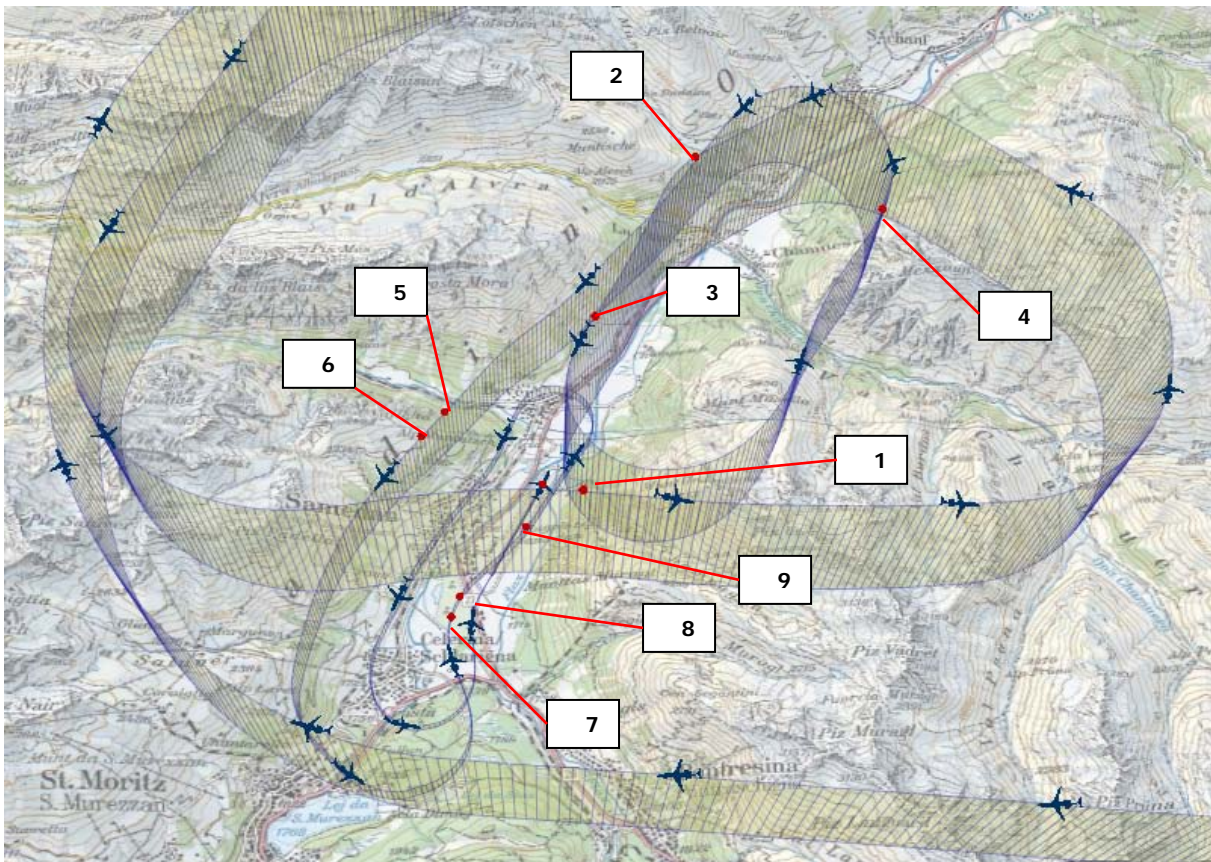
## Annex 2: Final phase of the flight path of N906JW

Time UTC		Altitude	Radio altitude
1	16:35:40	Autopilot is switched off	16 518 ft	
2	16:38:23	Crew: <i>"Runway in sight, right overhead..."</i>	16 070 ft	
3	16:38:55	ATC: <i>"IFR cancel time"</i>	15 552 ft	
4	16:40:12	Landing gear extended	13 922 ft	
5	16:42:04	Crew: <i>"slightly southeast of the field"</i>	9980 ft	
6	16:42:10	FISO: <i>"Runway covered with wet snow and little bit ice"</i>	9844 ft	
7	16:44:08	Crew: <i>"looks like a slight missed approach..."</i>	6290 ft	640 ft
8	16:44:12	EGPWS: <i>"Caution terrain"</i>	6320 ft	674 ft
9	16:44:30	Copilot to commander: <i>"speed, speed..."</i>	6614 ft	968 ft

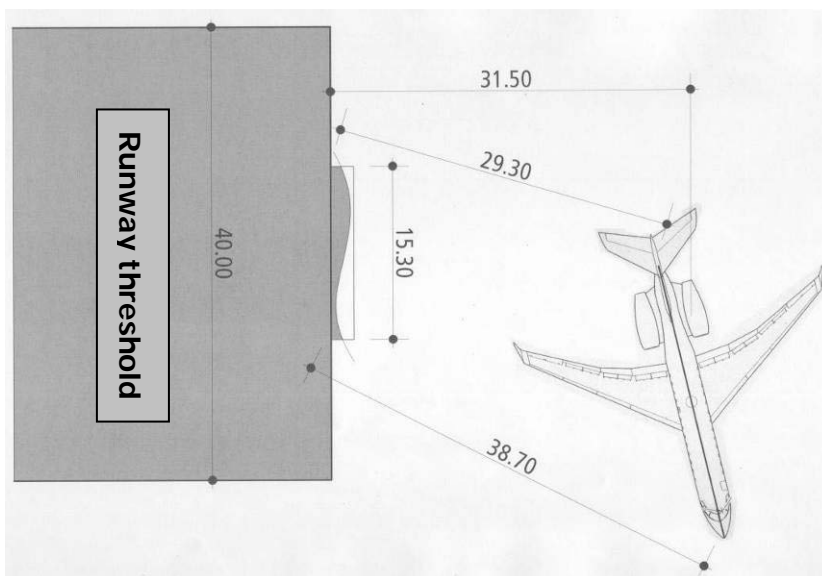
Final position of N906JW after the accident
