Final Report No. 2090

by the German Federal Bureau of Aircraft Accident Investigation

involving the Saab Aircraft AB/Saab 2000, registration HB-IZY

on 10 July 2002

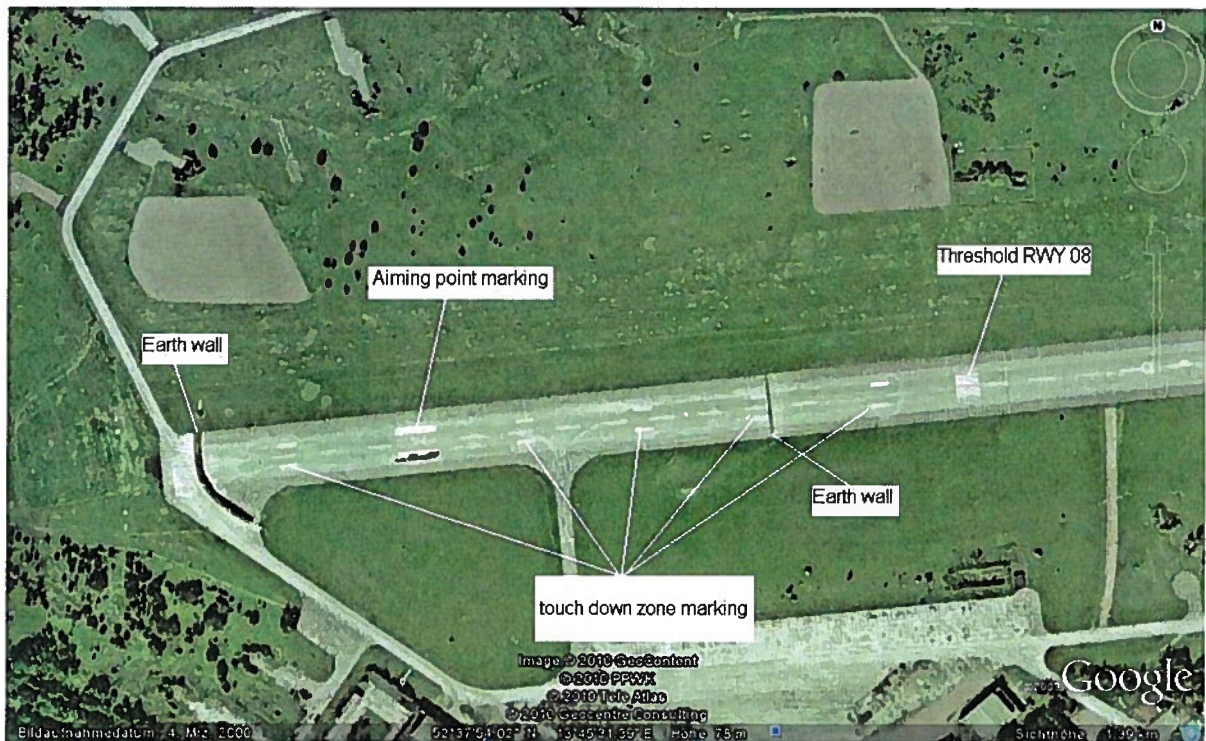
As a precaution against unauthorised access, the aerodrome operator was given permission by the regional Civil Aviation Office to erect an earthen wall no more than four metres high at the western end of the ex-military airfield. In addition, a 70 cm high wall of heavy clay was placed across the entire width of the runway about 235 m west of the threshold to Runway 08 and about 770 m from the western end of the ex-military airfield.

Aerial view of the aerodrome west end, earth wall and wall as seen in 2000

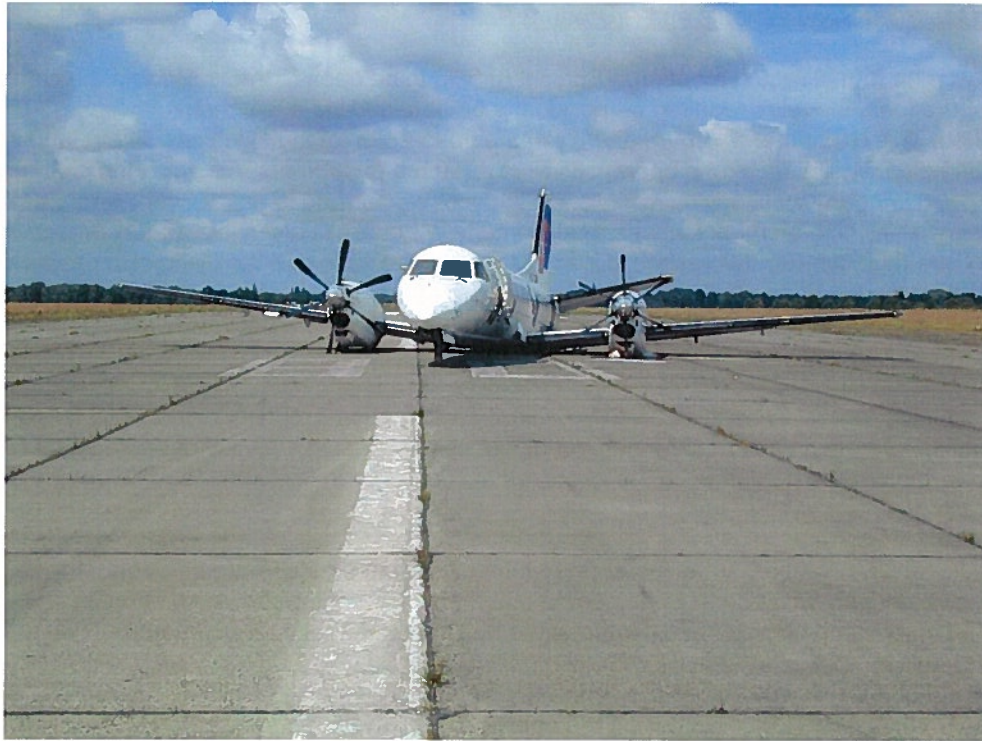
All three landing gear legs were torn off. All the propeller tips on both engines were ground down.

View of the crash site looking west.

In addition to the damage to the fuselage lower surface, the propellers and engine cowls, the fuselage showed evidence of structural deformation.

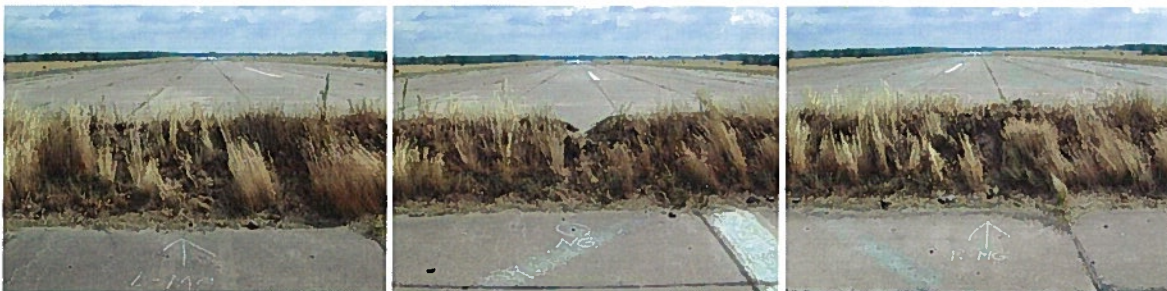
As seen from the aircraft in a westerly direction, the tyre marks ran straight along the runway until they intersected the low earth wall, which had been deposited over the concrete surface. The torn-off left main landing gear leg was found north of the concrete runway centreline about 200 m from the aircraft and about 150 m east of the earth wall.

The west side of the approximately 70 cm high earth wall with impact marks: left, that of the left main landing gear; centre, that of the nose gear; right, that of the right main landing gear.

On the western part of the concrete, about 290 m before the earth wall, tracks of all three landing gears were found leading all the way into the earth wall. The aircraft had touched down about 520 m prior to the threshold of the approved section of Runway 08.

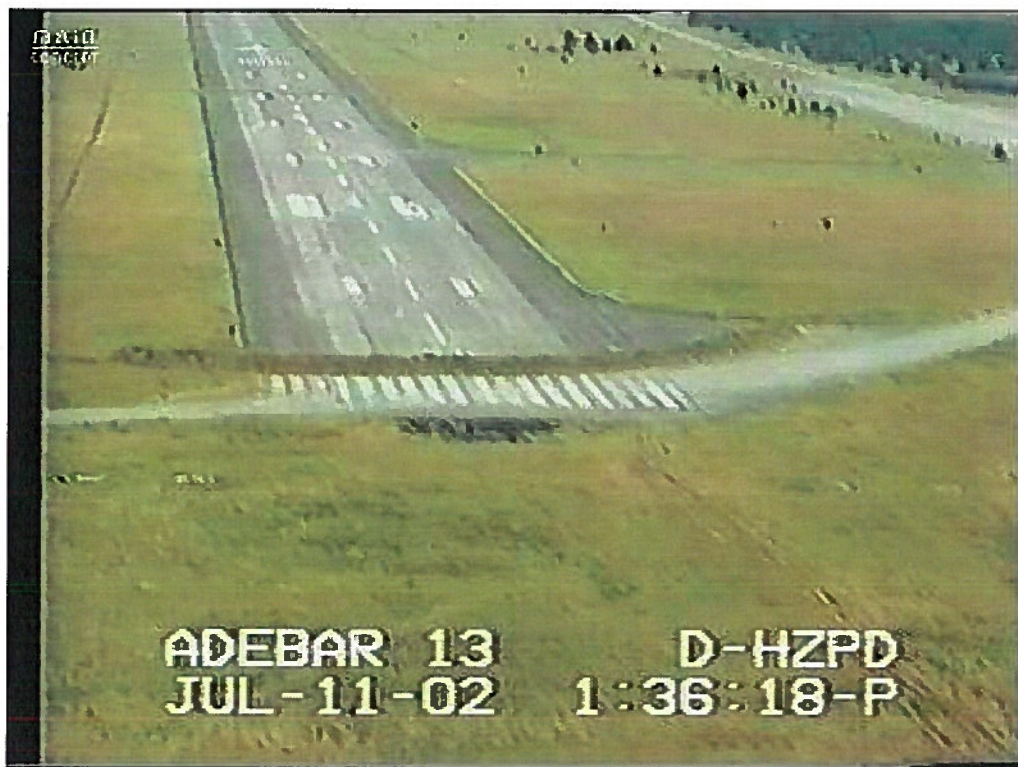
View of the new threshold to runway 08 a distance of about 1.2 km

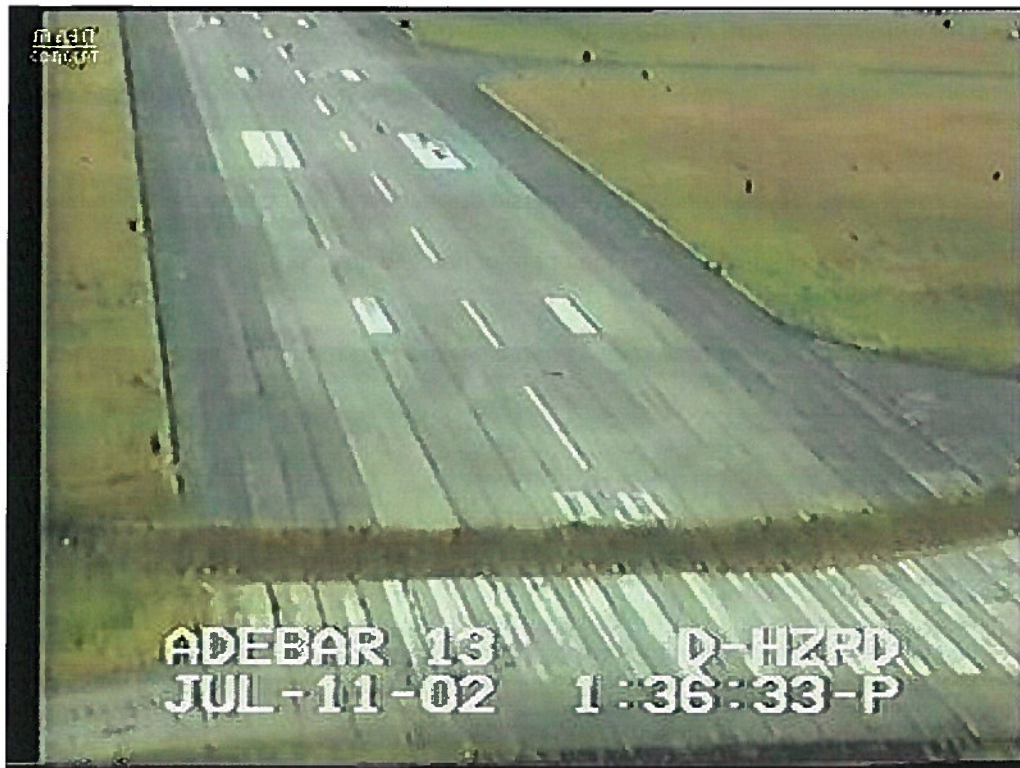
View of the runway at a distance of about 1,000 from the new runway threshold, shortly prior to over-flying the original runway threshold
 Film still: Police

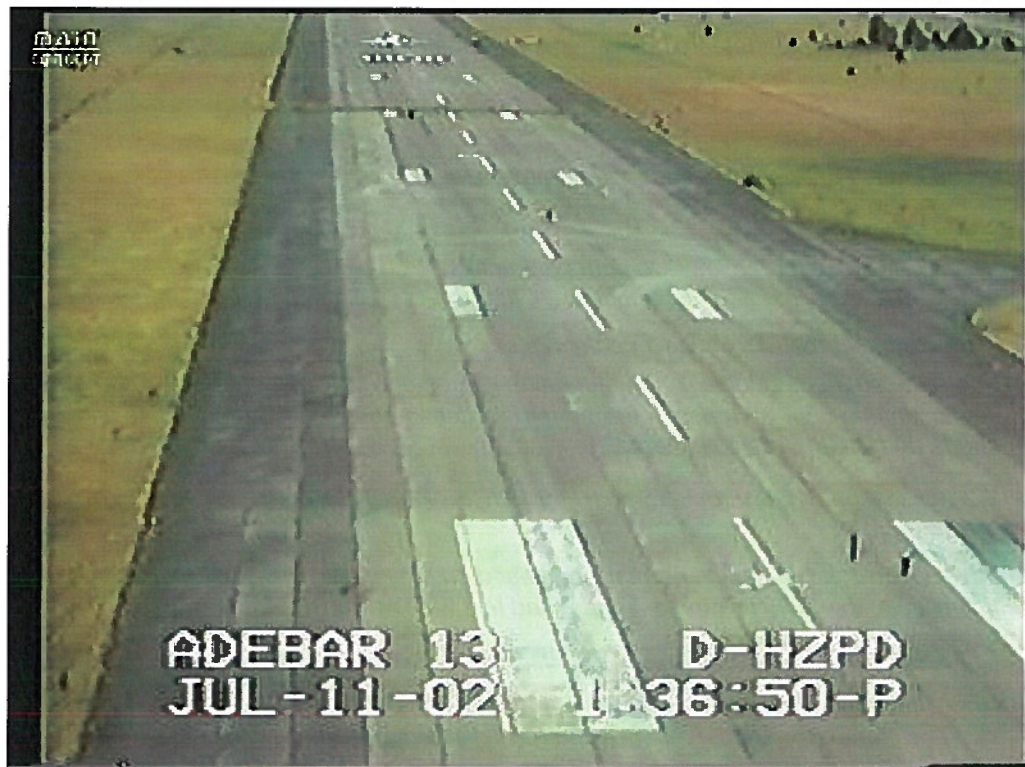
View of the runway shortly prior to over-flying the aiming point markings of the original Runway 08. In the background the earth wall, after that the runway threshold markings on the approved Runway 08, and the position of the aircraft.
 Film still: Police

The low earth wall running across the concrete runway was poorly visible and not seen by the crew. In the opinion of the BFU, under the circumstances (lighting conditions, expectations, urgency of the situation) the earth wall was not recognisable as an obstacle.

- The markings on the disused portion of the old full-length runway had not been removed, nor had the disused portion been marked as such.
- The touchdown zone markings on the old full-length runway were still in good condition, and misled the Saab pilots to use this as a touchdown target marker.
