Final Report No. 2093 by the Aircraft Accident Investigation Bureau

concerning the serious incident - Airprox
involving the Boeing 737-300 aircraft, registration D-ABXY,
operated by Deutsche Lufthansa under ATC callsign DLH 1LA
and the Airbus A320-200 aircraft, registration JY-AYF,
operated by Royal Jordanian Airlines
under ATC callsign RJA 149
on 24 October 2007
2.4 NM north-north-east of the Kloten beacon

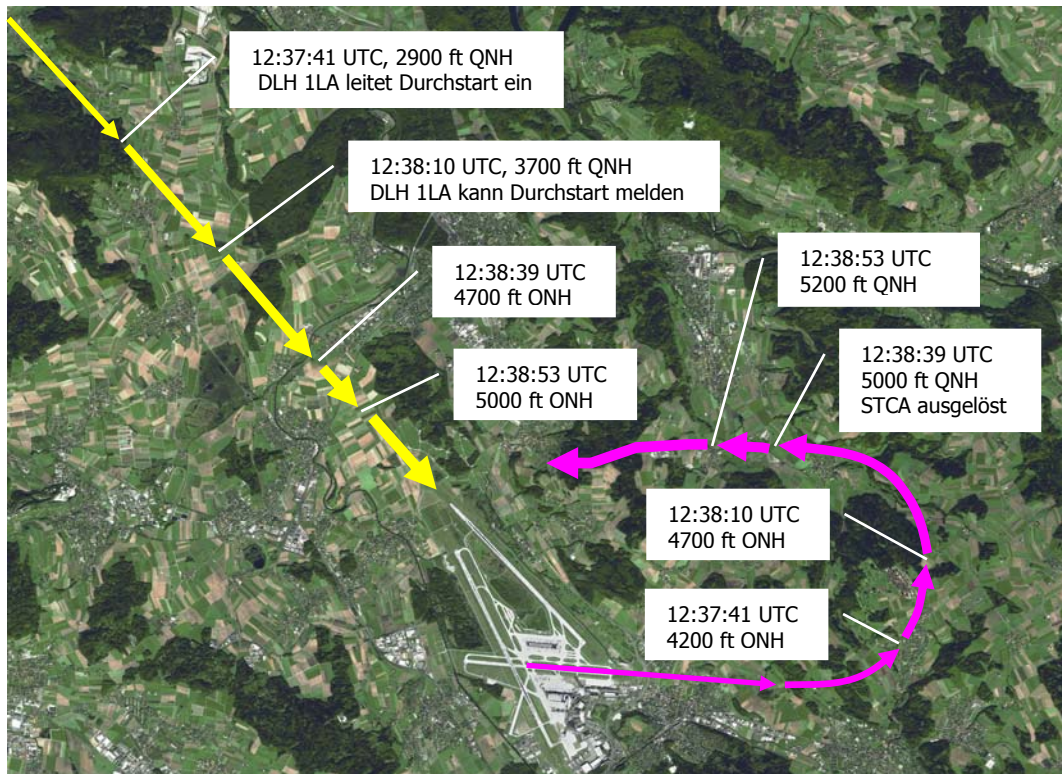
The closest point of approach between DLH 1LA and RJA 149 occurred at 12:39:06 UTC, with a lateral distance of 1.1 NM and an altitude difference of 600 ft.

The minimum separation prescribed in this case is 3 NM horizontally or 1000 ft vertically.

Figure 1: Schematic representation of some selected situations during the serious incident. Flight DLH 1LA is shown using yellow arrows and flight RJA 149 is shown using magenta arrows. The final position of the lines of arrows corresponds to the minimum distance between the two aircraft at 12:39:06 UTC.

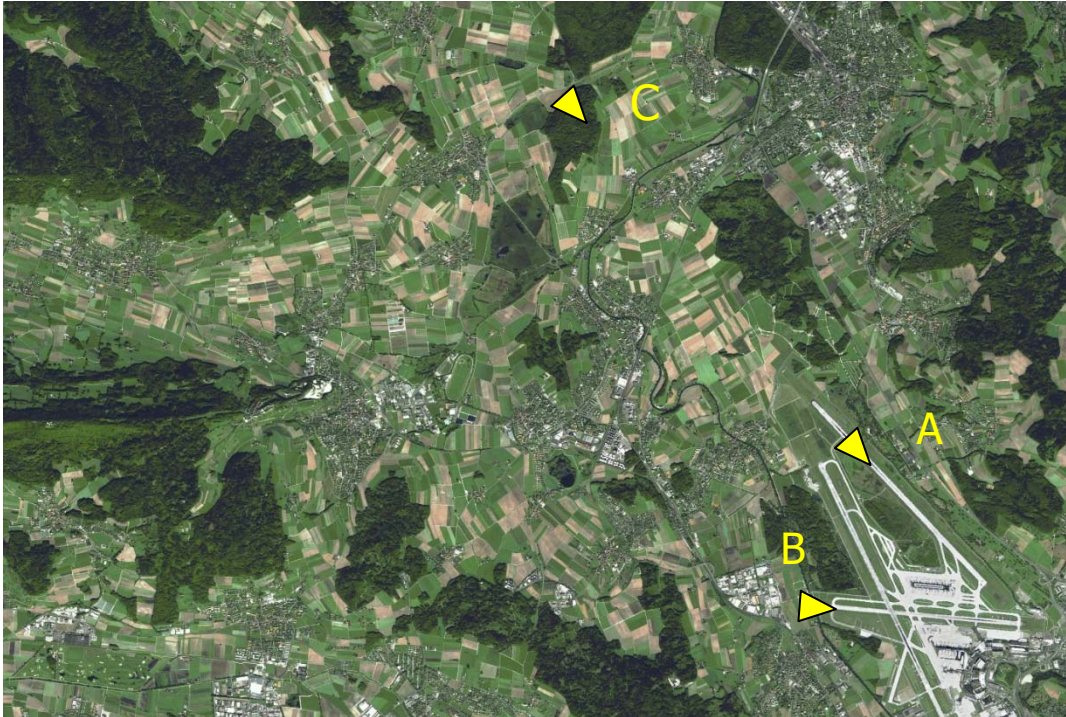
For the ADC controller, this means: aircraft A lands on runway 14; this has to be verified visually. At the same time, aircraft C is already on its approach some 4 NM from the threshold of runway 14. At this moment, a time window of approximately 20 to 30 seconds duration occurs, within which the ADC controller has to clear aircraft B for take-off from runway 10, receive confirmation of this and observe the take-off roll of the aircraft. If, at the point in time at which aircraft C passes a distance of 3 NM from the threshold of runway 14, aircraft B has not yet started its take-off, the take-off clearance for aircraft B must be cancelled. A take-off window for aircraft B on runway 10 only becomes available after aircraft C has landed. If aircraft B takes off as expected, the chronological conditions are generally sufficient to allow the next aircraft to line up on runway 10, so that the next landing slot on runway 14 can be used for a take-off on runway 10.

Figure 2: Schematic representation of the coordination concept for a simultaneous approach on runway 14 and a take-off on runway 10. If aircraft A has landed on runway 14 and the next aircraft, aircraft C, approaching runway 14 is still at least 3 NM from the runway threshold, aircraft B must have started its take-off roll on runway 10.
