# **Final Report No. 2103**

## **by the Aircraft Accident Investigation Bureau**

concerning the accident involving  
the Diamond DA 42 aircraft, registration HB-LUO  
on 19 April 2010  
Zurich Airport

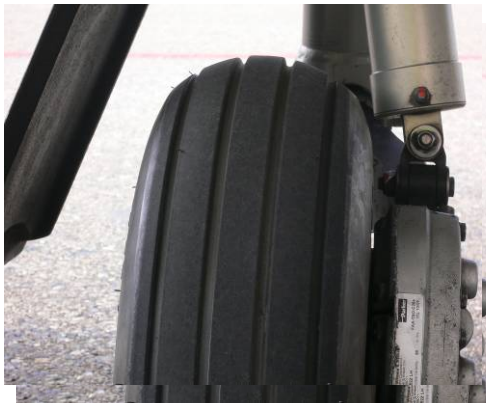
**Figure 1:** Left wheel

Two different types of tyre were fitted to the right and left main landing gear wheels. The right wheel was fitted with a "Goodyear" brand tyre, part No. 156E66-4 and the left wheel was fitted with an "Air Hawk" brand tyre, part No. 33031. The latter has a different cross-section and unlike the Goodyear tyre, which has two grooves, it has four grooves.

*"AIR HAWK  
15X600-6  
Type B III TSO-062d  
6 PLY RATING MAX LOAD 1950 LBS  
PART NO 33031"*

- The procedure specified by the aircraft manufacturer for checking the clearance between the wheel and the wheel well was inadequate.
- The fact that a tyre was fitted to the left landing gear wheel which deviated slightly in terms of outer diameter and cross-section from that specified by the aircraft manufacturer.

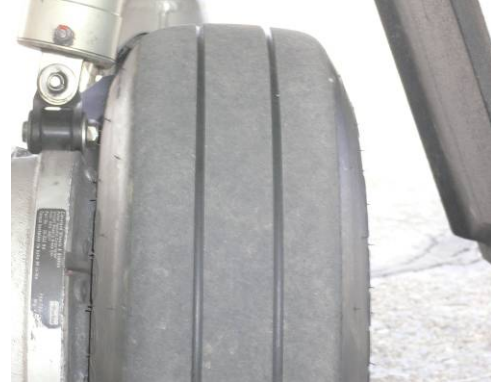
**Figure 2:** Right wheel

On aircraft HB-LUO, a Goodyear tyre with the part number 156E66-4 was fitted to the right main landing gear. According to the Goodyear homepage, this Kevlar-reinforced tyre (Flight Custom III) is explicitly approved for the Diamond DA 42 aircraft. The aircraft manufacturer does not know why this type of tyre is recommended and supplied for the DA 42.

According to the aircraft manufacturer's statement the recommendations of the Flight Custom III tire (part No. 156E66-4) for the DA 42 aircraft on the Goodyear homepage was not in agreement the aircraft manufacturer. In a telephone conference call, dated 1 December 2010, between the aircraft manufacturer and Goodyear the latter was informed that for the time being the Flight Custom III tire is not released for the DA 42 aircraft.

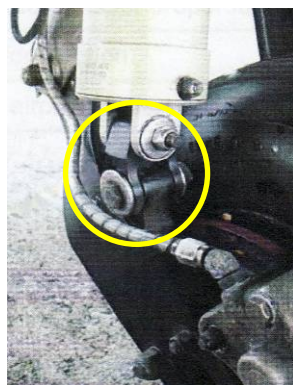
MLG joint (dimensions in mm)

Centring of the wheel in relation to the wheel well is set permanently by the factory and is not changed by the maintenance company. This setting is determined by the assembly of the main landing gear joint (MLG joint), which according to the manufacturer has a nominal dimension (z) of 32 mm between the two axes. The MLG joint is available in three different oversizes so that the wheel can be centred in relation to the wheel well. According to the manufacturer, MLG joints of different sizes can be used on the left and right landing gear.

-51 joint:	x=59; z=32
-52 joint oversize 1:	x=61; z=34
-53 joint oversize 2:	x=63; z=36
-54 joint oversize 3:	x=65; z=38

In this work instruction it is explicitly mentioned that when changing the MLG joint firstly one of the same size (nominal dimension (z), or corresponding oversize) must be fitted and secondly the minimum distance of 4 mm between the tyre and the wheel well must be checked when the landing gear is retracted. Such a check is not required for a normal tyre or wheel replacement (AMM 32-40-00, page 204 dated 30 June 2008).

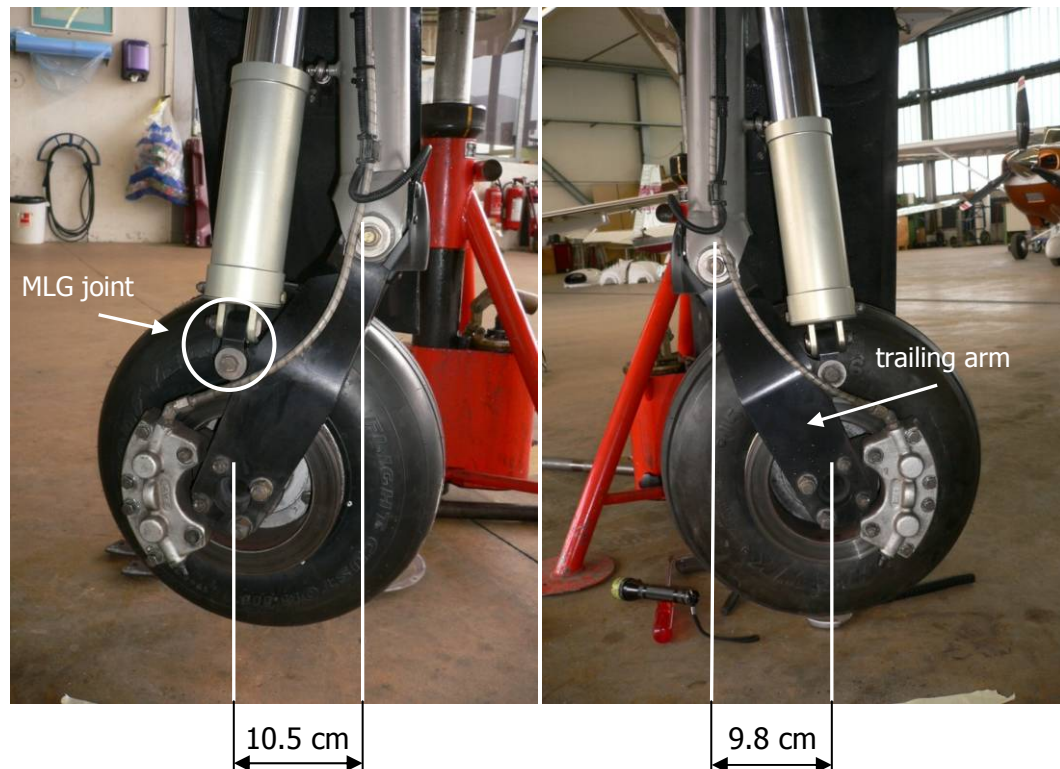
**Figure 4:** Left and right landing gear legs of aircraft HB-LUO

The mandatory service bulletin mentioned in chapter 1.6.1 was carried out on aircraft HB-LUO after the accident: the two MLG joints did not require replacing. On the left an MLG joint, oversize 3 (maximum oversize), was fitted ( $z=38$  mm) and on the right an oversize 2 joint was fitted ( $z=36$  mm).

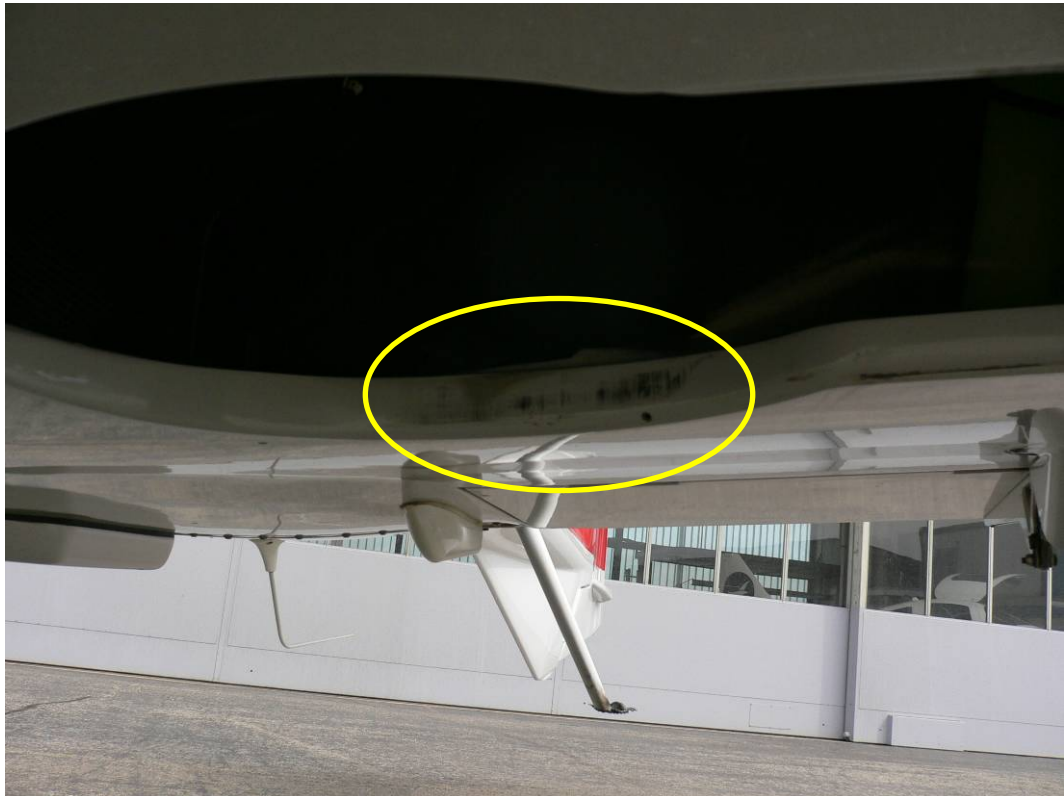
**Figure 5:** Before the tyre marks were cleaned off

Kausal für diese Fahrwerkstörung war der Umstand, dass das linke Hauptfahrwerk gegenüber dem Fahrwerkschacht nicht zentriert war, so dass sich der Reifen im Fahrwerkschacht verklemmte.

**Annexes****Annex 1: Marks on the wheel well in the left wing**

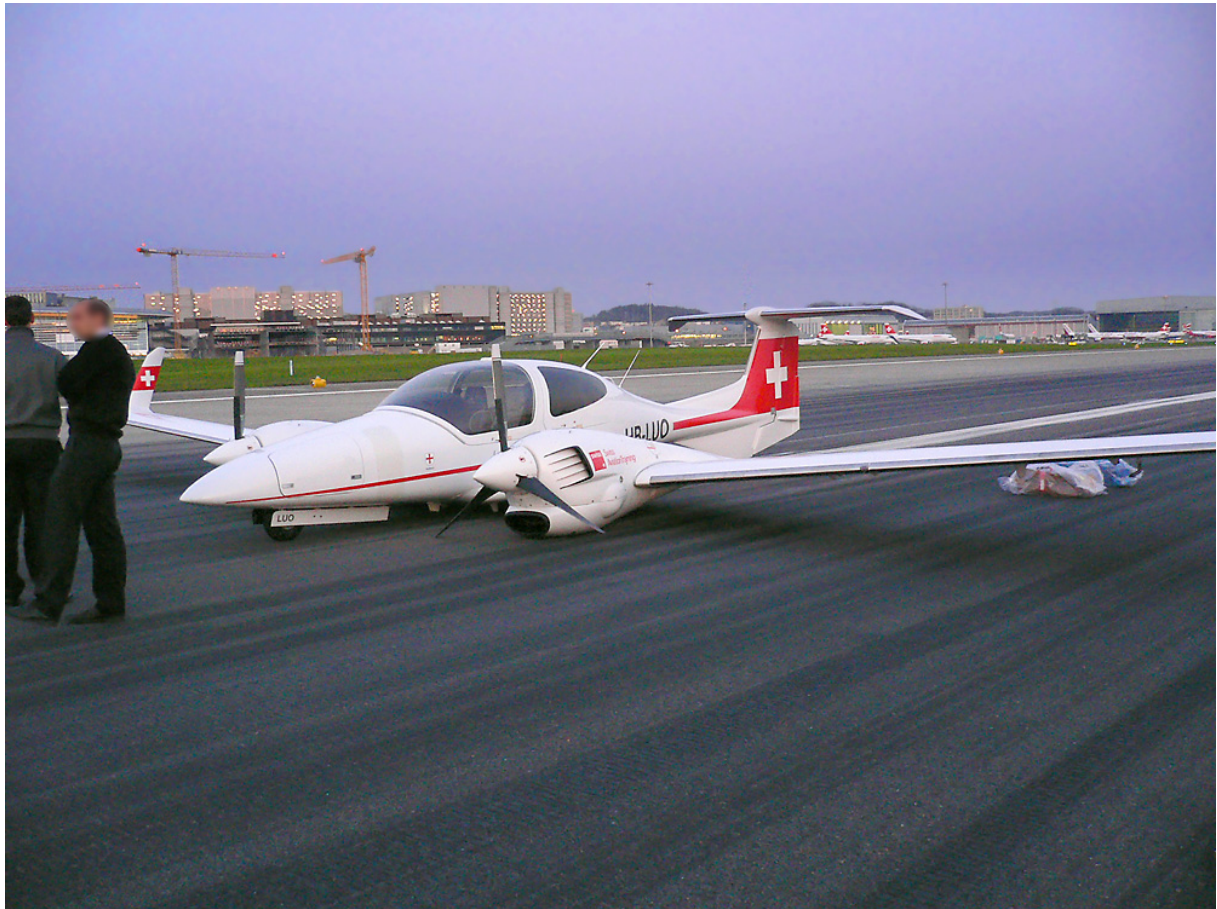
**Annex 5: Aircraft after gear up landing**

Injuries	Crew	Passengers	Total number of occupants	Others
Fatal	0	0	0	0
Serious	0	0	0	0
Minor	0	0	0	0
None	2	1	3	Not applicable
Total	2	1	3	0
<b>Damage to aircraft</b>	Slightly damaged: entrance steps, engine cowling, exhaust pipes and propeller tips			
<b>Other damage</b>	None

Shortly before touchdown the crew shut down both engines, switched off the fuel supply and put the aircraft down on the centreline at a speed of approximately 60 kt just before the runway marking "34". The aircraft came to a standstill after 220 metres (Annex 5).
