# **Final Report No. 2113**

## **by the Aircraft Accident Investigation Bureau**

concerning the serious incident - Airprox  
involving the Airbus A340-600 aircraft, registration HS-TNA,  
operated by Thai Airways International Ltd.

on 18 June 2010

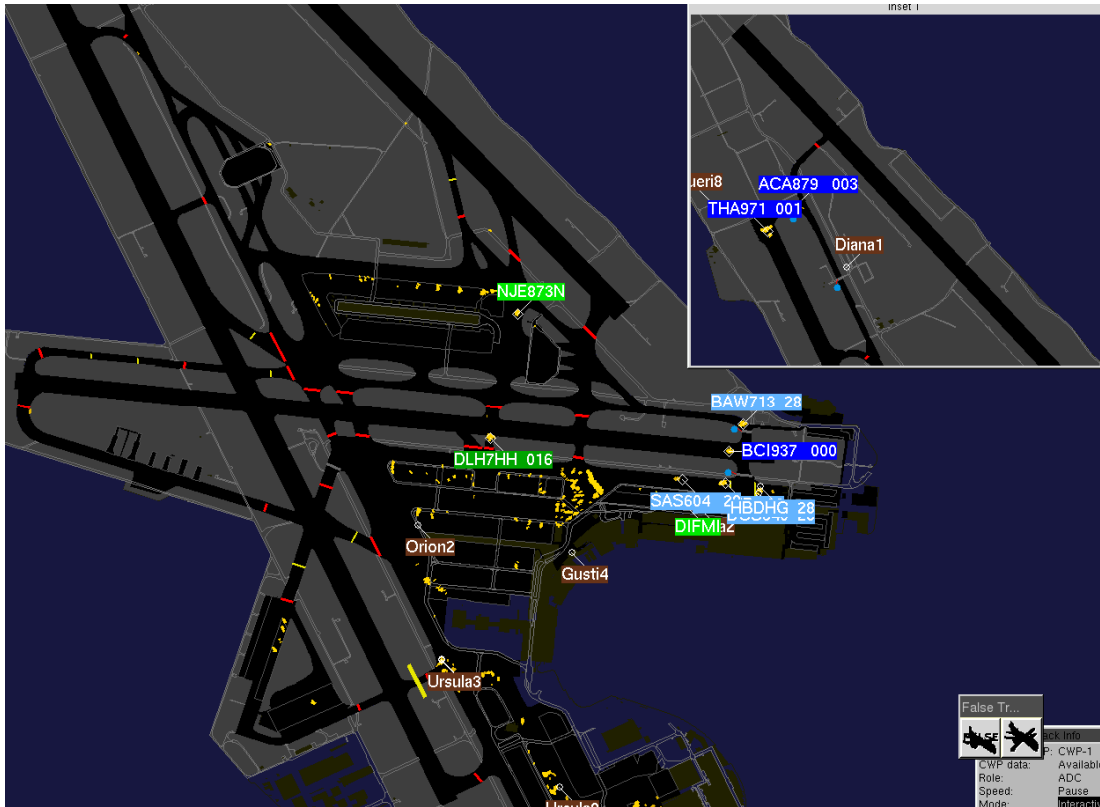
12:02:31 UTC: THA 971 acknowledges the take-off clearance and initiates the take-off

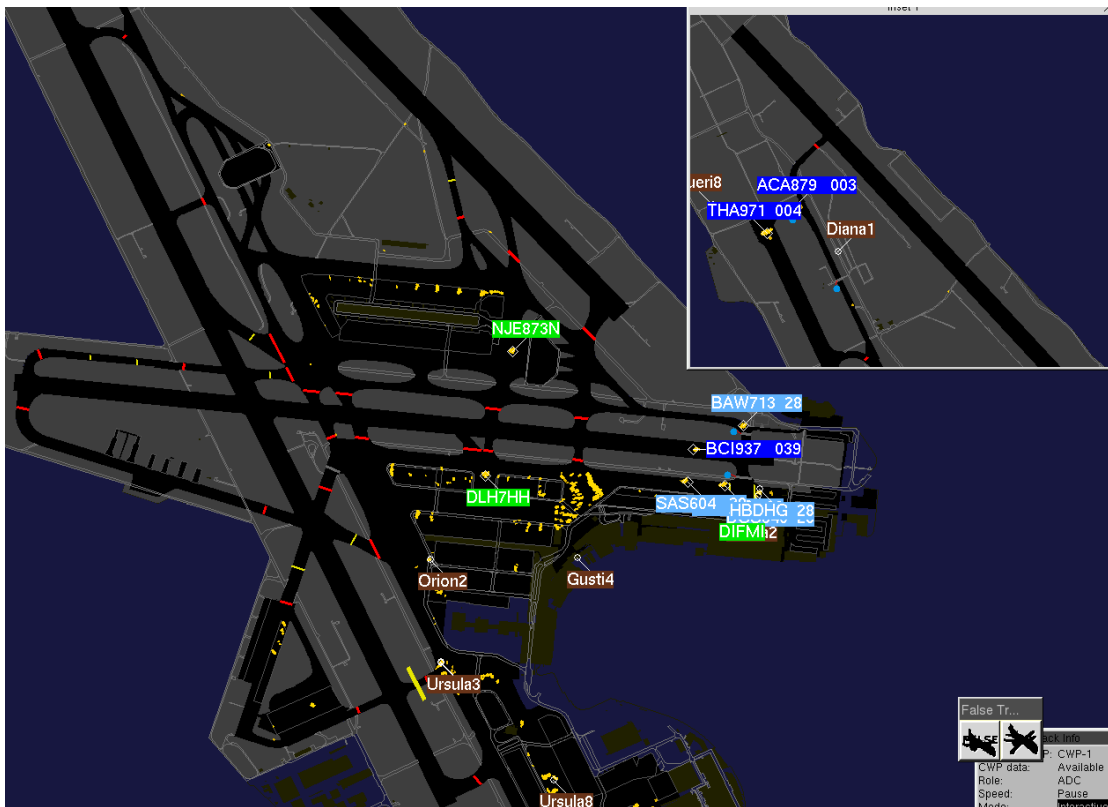
12:02:47 UTC: BWA 713 reports: "Ah, you may have two aircraft taking off at the moment".

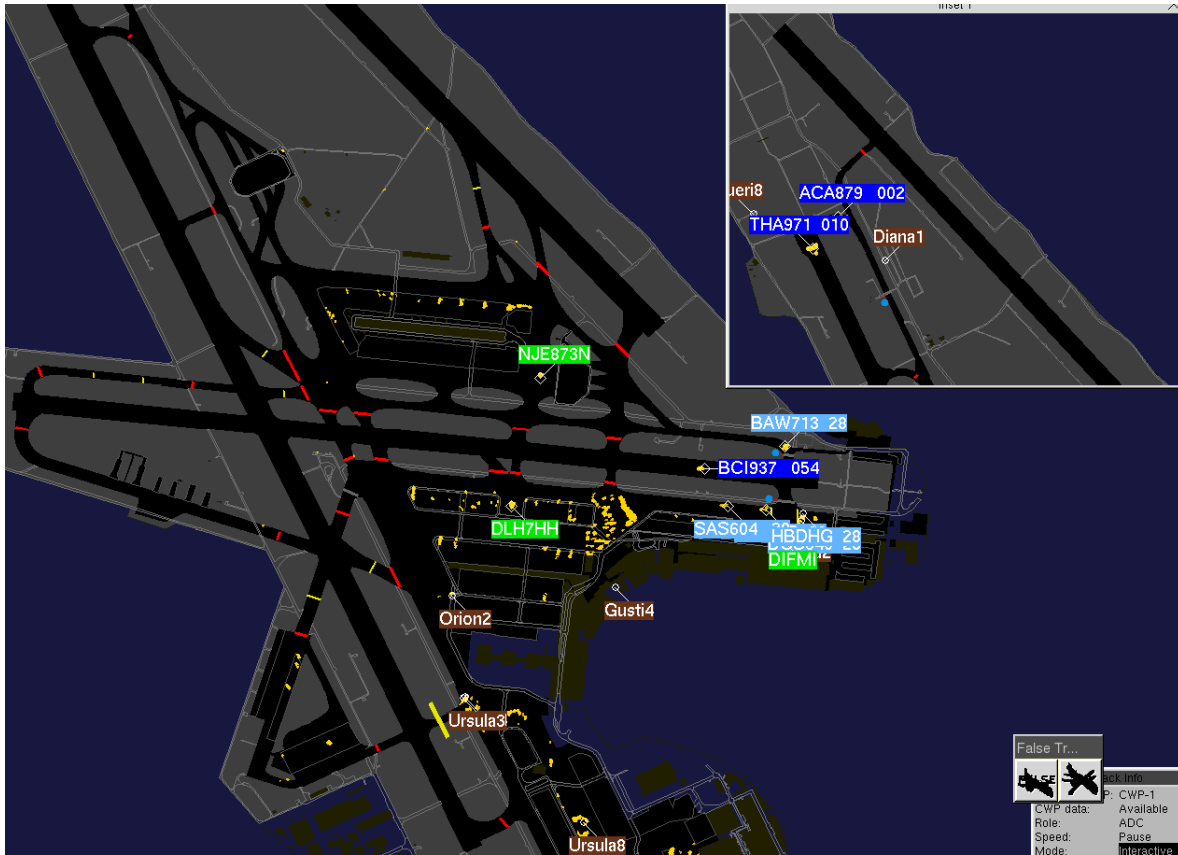
12:02:50 UTC: ADC ATCO instructs BCI 937 to abort take-off (speed of BCI 937: 54 kt)

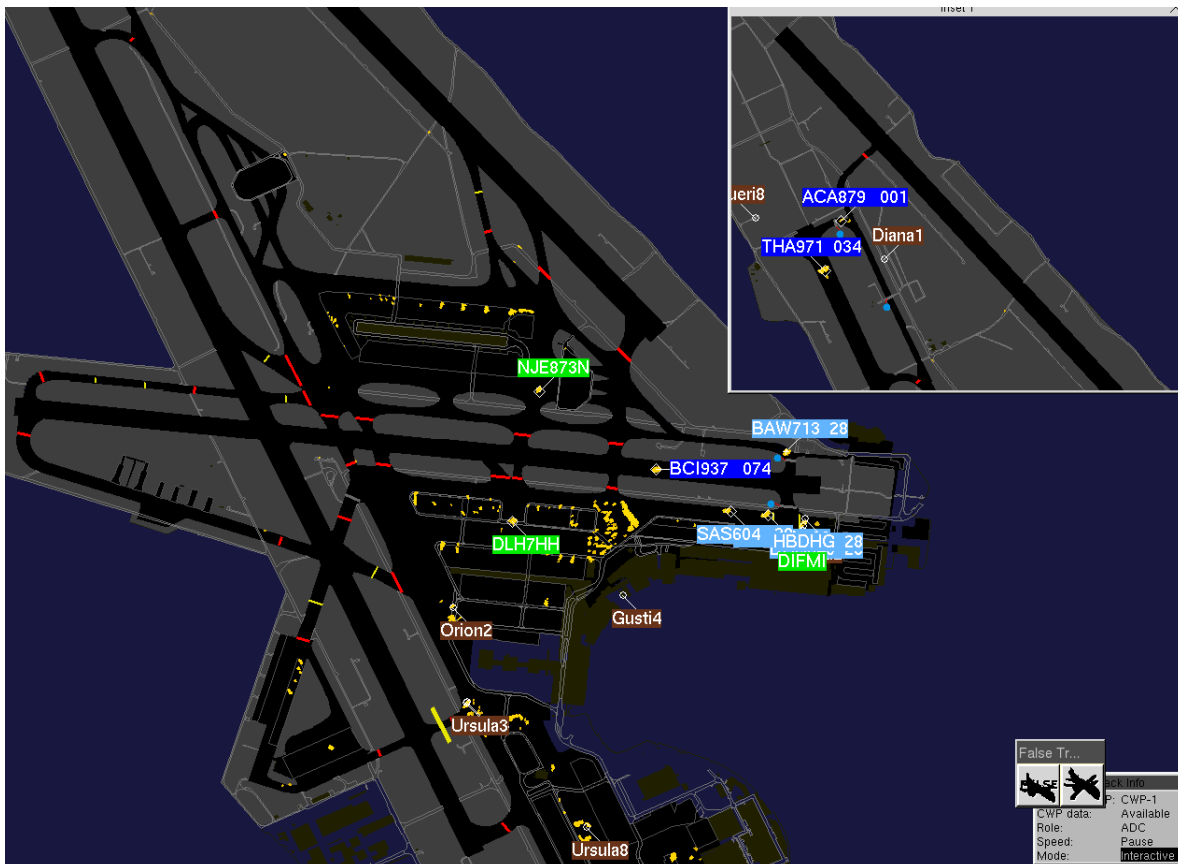
12:02:55 UTC: maximum speed of BCI 937 during the aborted take-off (74 kt)

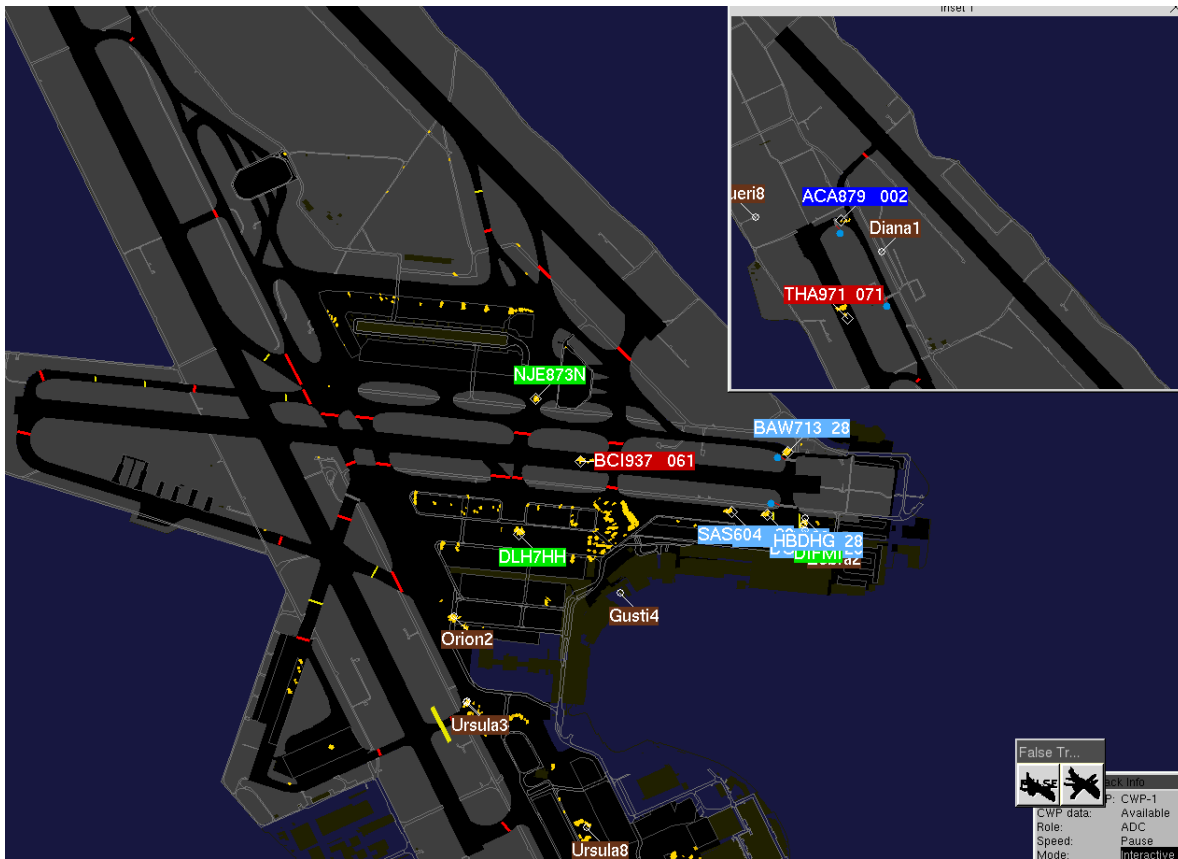
In conclusion, it should be noted that in the configuration existing at the time of the serious incident, the RIMCAS system was not able to trigger an alert in good time when take-offs were taking place simultaneously on runways 16 and 28.

12:03:01 UTC: the RIMCAS system generates a Stage 2 alert

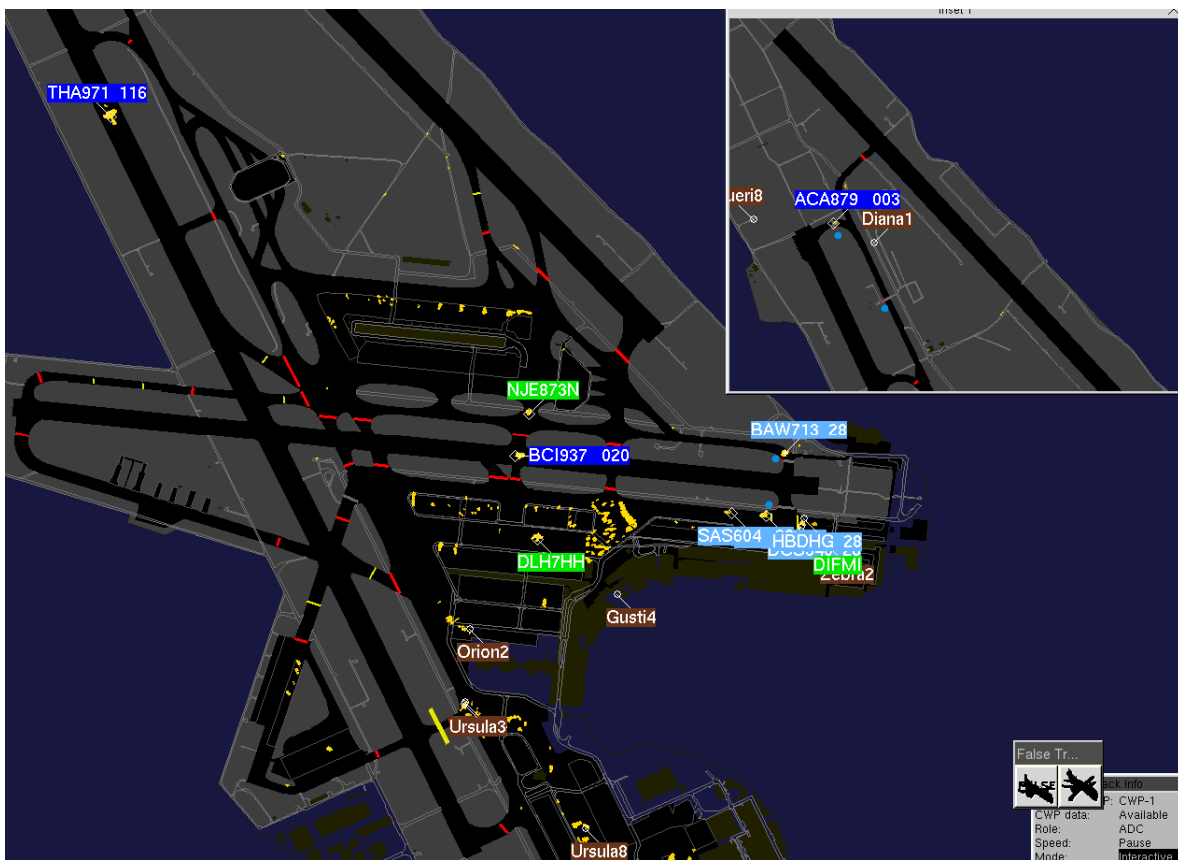
12:03:13 UTC: the RIMCAS system de-activates the Stage 2 alert since no conflict situation exists anymore

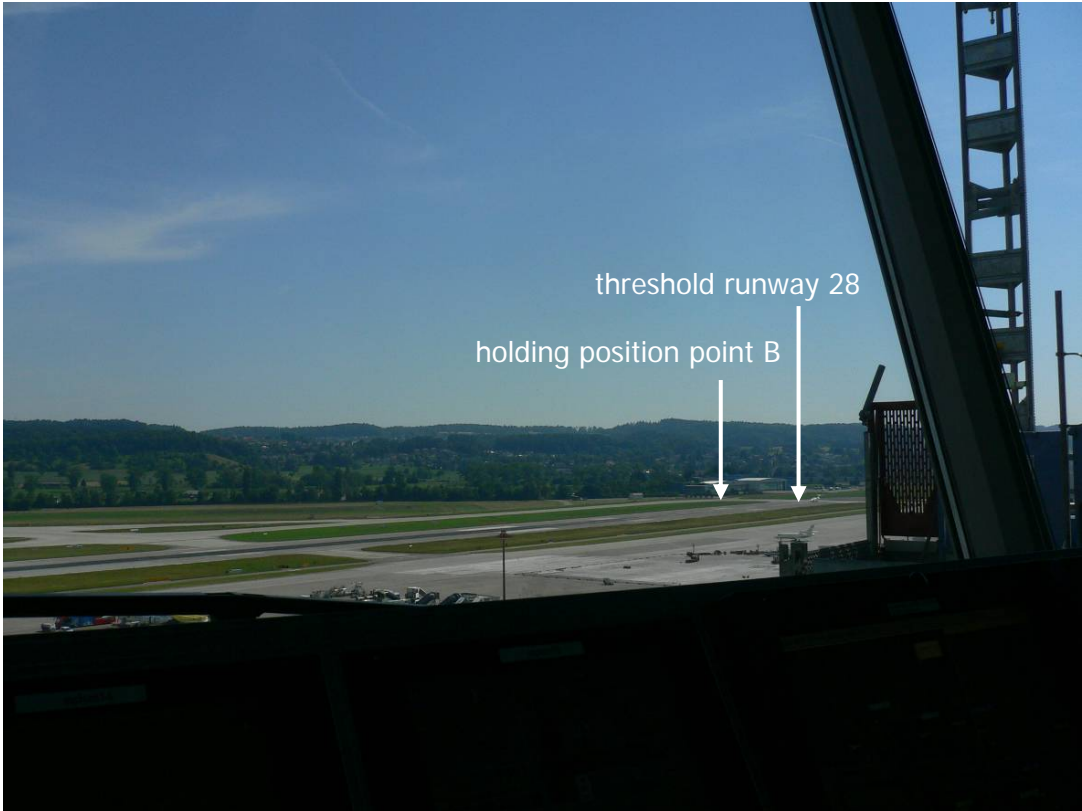
At the time of the serious incident, building work was in progress inside and outside the control tower. In the control tower cab, to the rear of the ADC and GRO workstations, conversion work was being performed on the manager's console. As a result of the notified and prevalent noise during work, the air traffic controller (ATCO) at the ADC workstation was working with a headset.

Figure 1: ADC workstation; looking right, view when sitting (25 June 2010; 08:27 UTC)

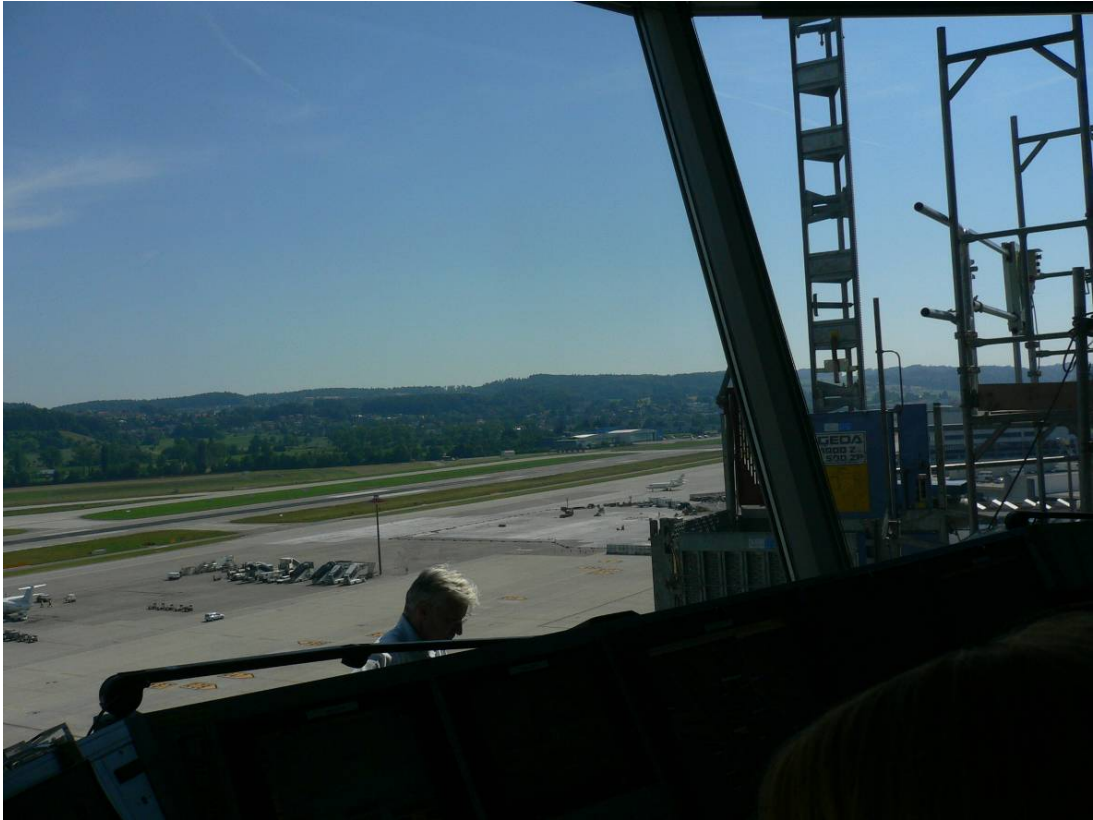
Figure 2: ADC workstation; looking right, view when standing (25 June 2010; 08:28 UTC)

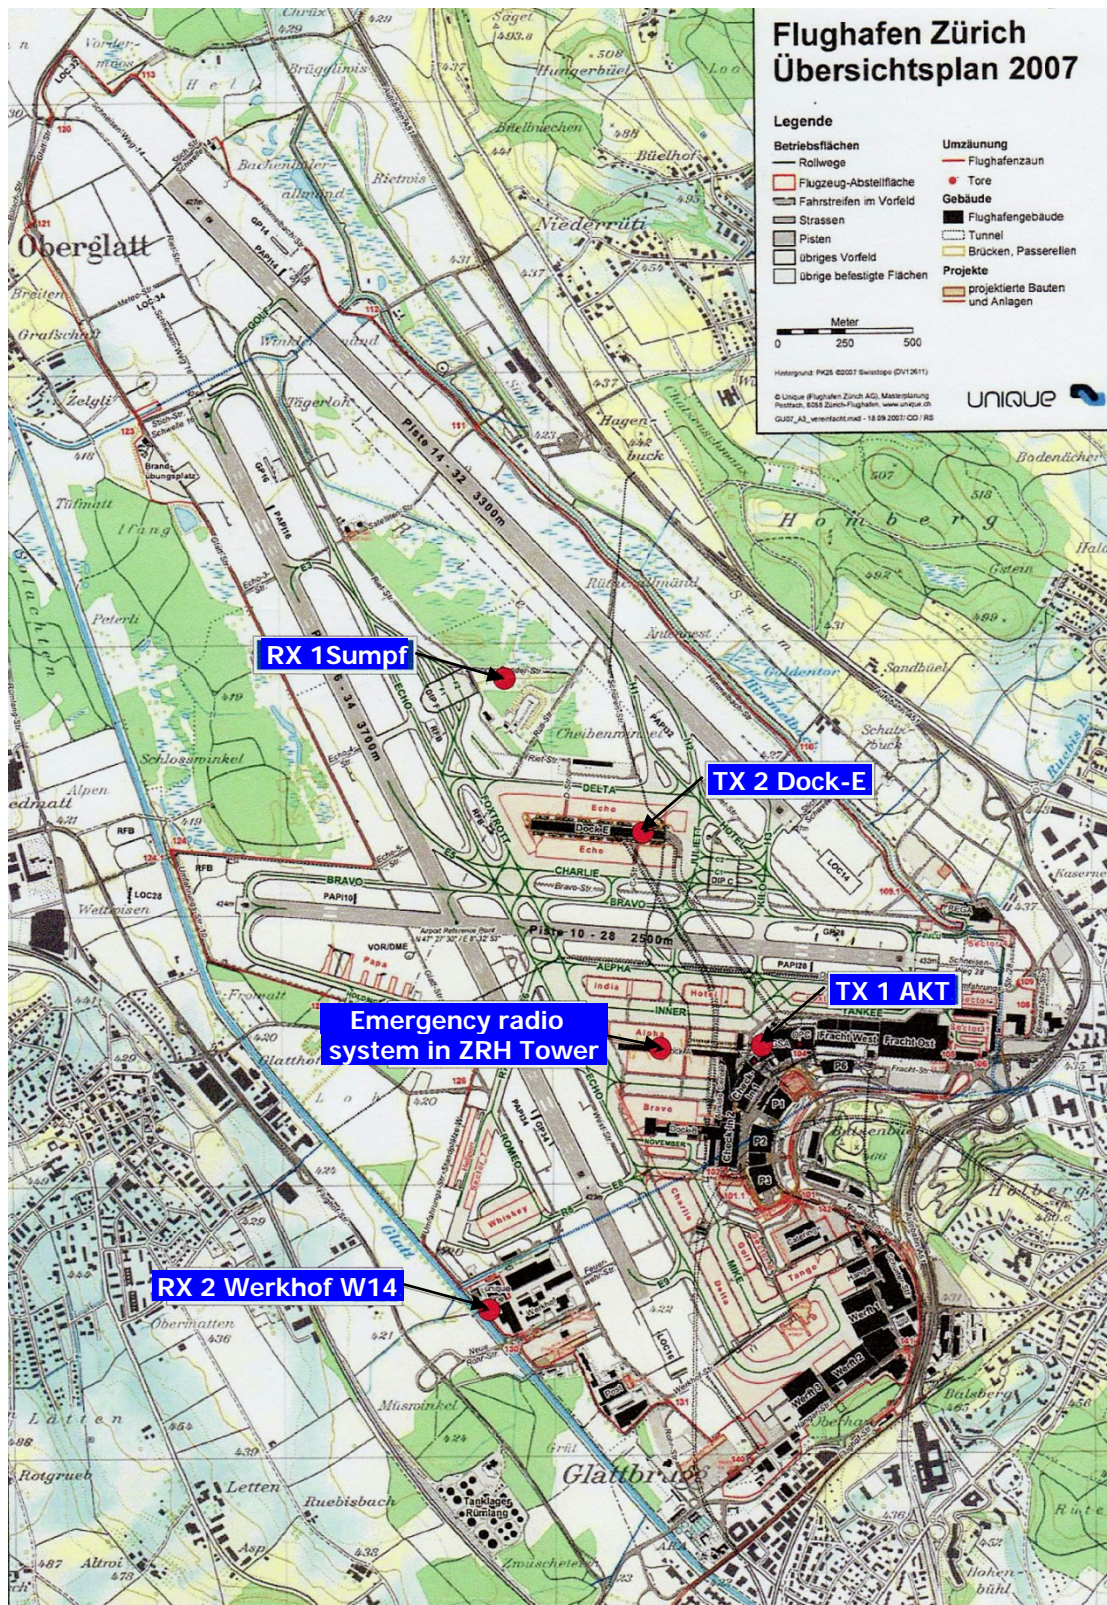
Annex 3: Radio network at Zurich airport

In the recordings of the emergency radio system, the readback of the take-off clearance by the crew of BCI 937 can only be heard indistinctly. This radio conversation was not audible at the air traffic controller's workstation as the corresponding volume control was set to the minimum level in accordance with established practice. It should be noted in this context that the location of the emergency radio receiver was on the roof of the control tower (cf. Annex 3) and that different conditions therefore prevailed with regard to superimposition of signals.

The choice of the two receiver sites "Sumpf" and "Werkhof W14" appears appropriate in order to take into account the reduction in transmission quality caused by reflections or shadowing. The automatic selection of the receiver with the better signal to noise ratio (best signal selection), considerably improves transmission quality. However, this selection may lead to one transmitter being practically suppressed in the event of simultaneous transmissions from two transmitters.
