# **Final Report No. 2114 by the Aircraft Accident Investigation Bureau**

concerning the accident involving  
the Robinson R22 Beta II helicopter, registration HB-ZHB  
on 27 May 2010  
"Auzelgli", municipality of Uzwil/SG  
approx. 12 km south-west of Sitterdorf aerodrome

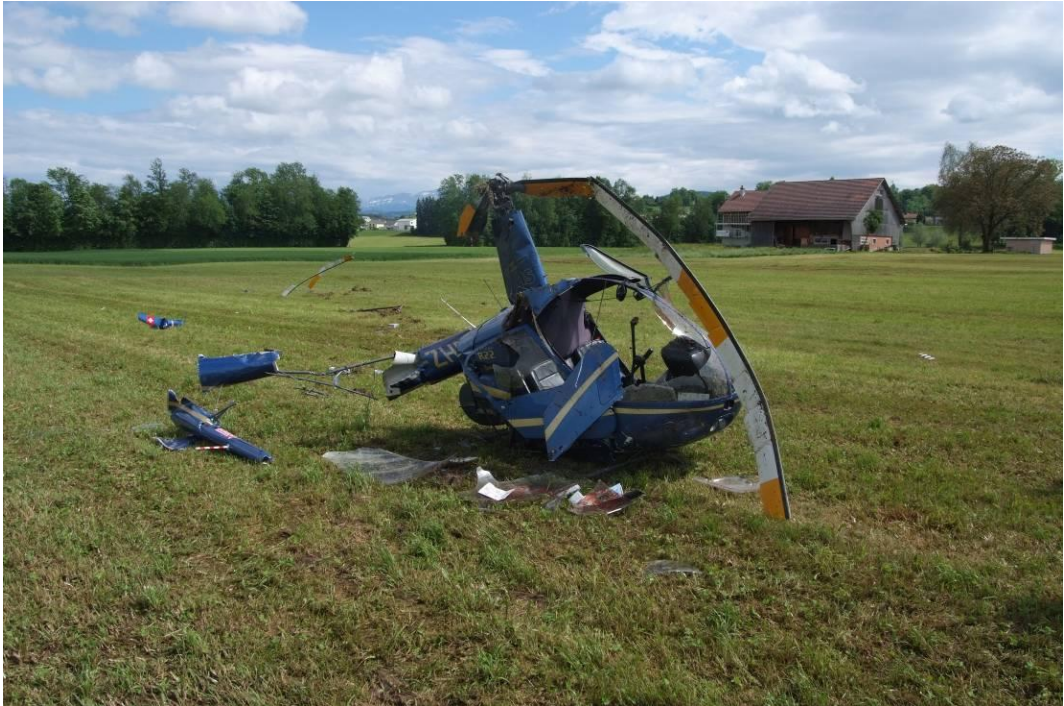
The helicopter impacted the field in an approximately horizontal attitude with forward speed. The landing gear was deformed laterally by the high impact forces and the underside of the fuselage also left distinct traces of impact. The helicopter then tipped forward, the rotor blades struck the ground and the tail boom became detached. After flipping over once or twice the helicopter came to lie on its right side and slid in this position a few metres further before it came to a standstill, destroyed.

**Figure 1:** Main wreckage of the helicopter after the accident. The helicopter was righted after the accident to prevent further leakage of fuel, oil and lubricants. In the background, other individual components and various traces of impact can be seen, allowing the direction of approach to be determined (approximately the reverse of the camera angle).

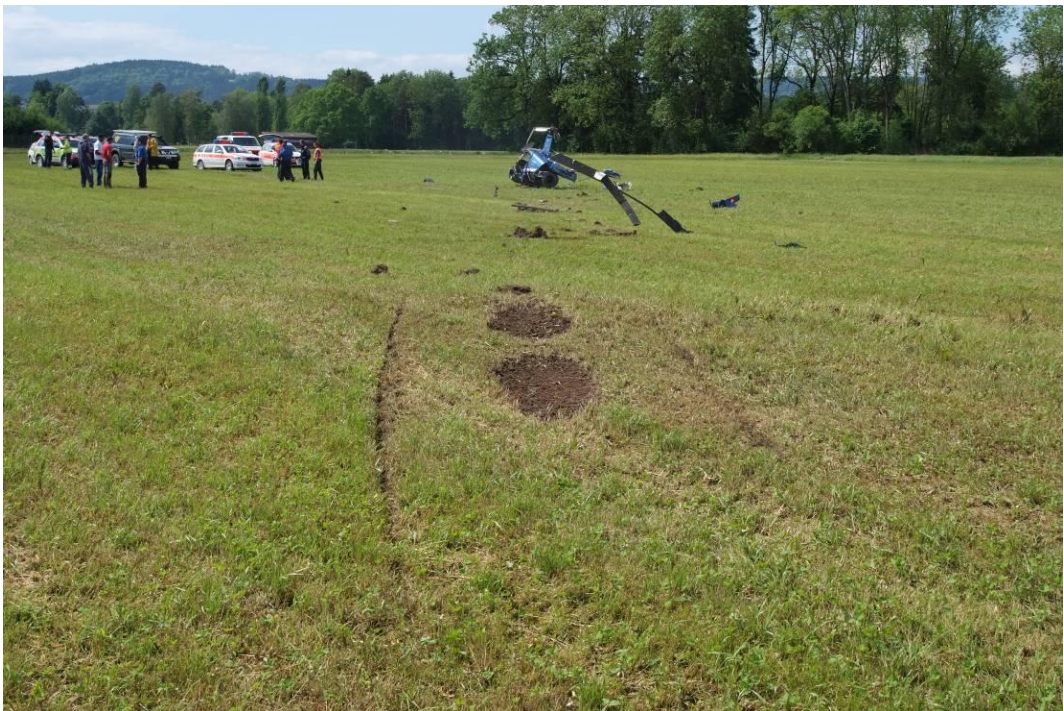
**Figure 2:** In the foreground, the initial traces of impact of the skids and the underside of the fuselage can be seen, further back is one of the two main rotor blades, which was torn off and which stuck in the ground, the main wreckage can be seen to the rear.

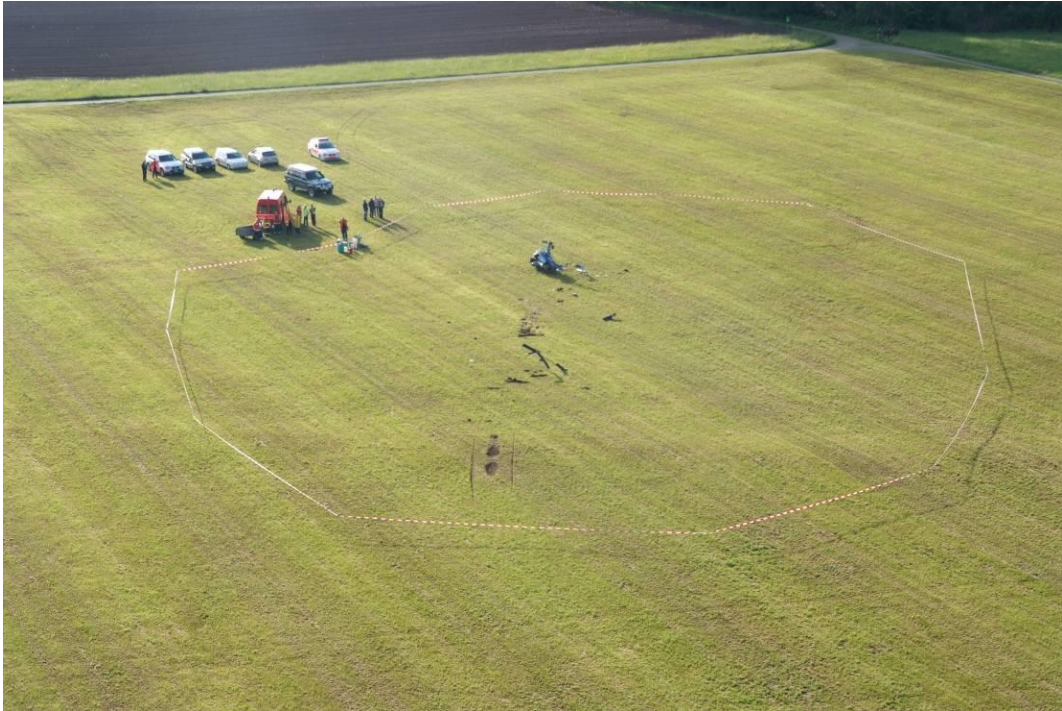
**Figure 3:** Initial impact traces, other impact traces and individual components, plus the main wreckage, photographed from the air from the approximate direction of approach.
