Final Report No. 2122 by the Swiss Accident Investigation Board SAIB

concerning the accident involving the
Agusta A109K2 helicopter,
registration HB-XWJ

on 23 June 2008

Helicopter landing pad on the roof of
Samedan Hospital/GR

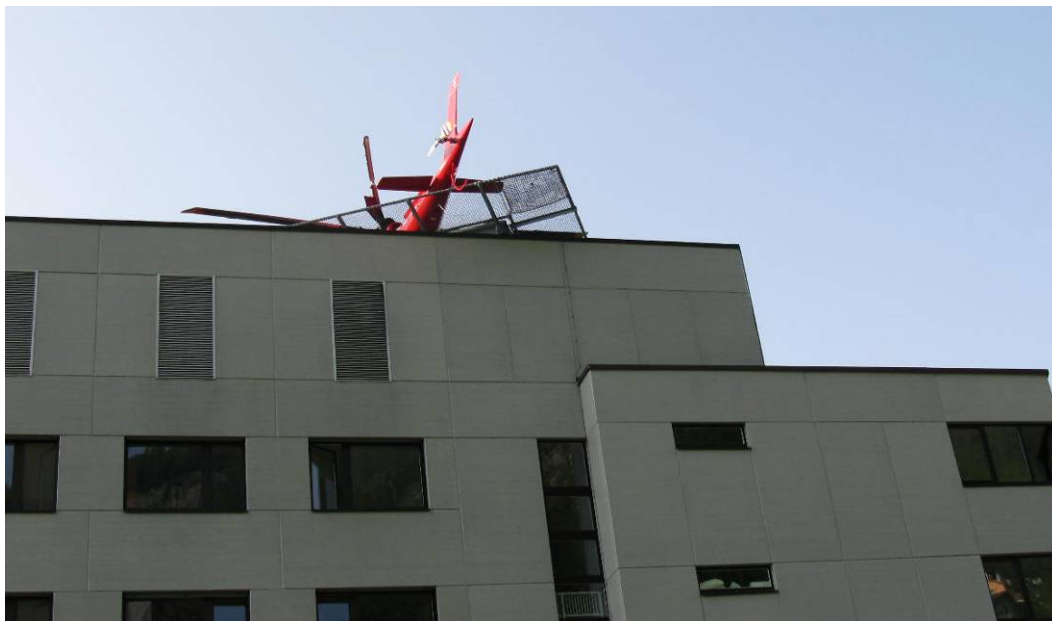
After exiting, the pilot and the other two crew members observed major damage to the helicopter and damage to the helipad of the helicopter landing site. A shattered rotor blade and badly damaged landing gear were evident. The two main landing gears were collapsed. The helicopter was at the outer edge of the helipad and the tail extended approximately 1 m beyond the facade of the building. The gratings of the helipad had been partially detached from their fixation and had shifted.

Figure 1: The damaged helicopter extends beyond the helipad and the facade of the building.

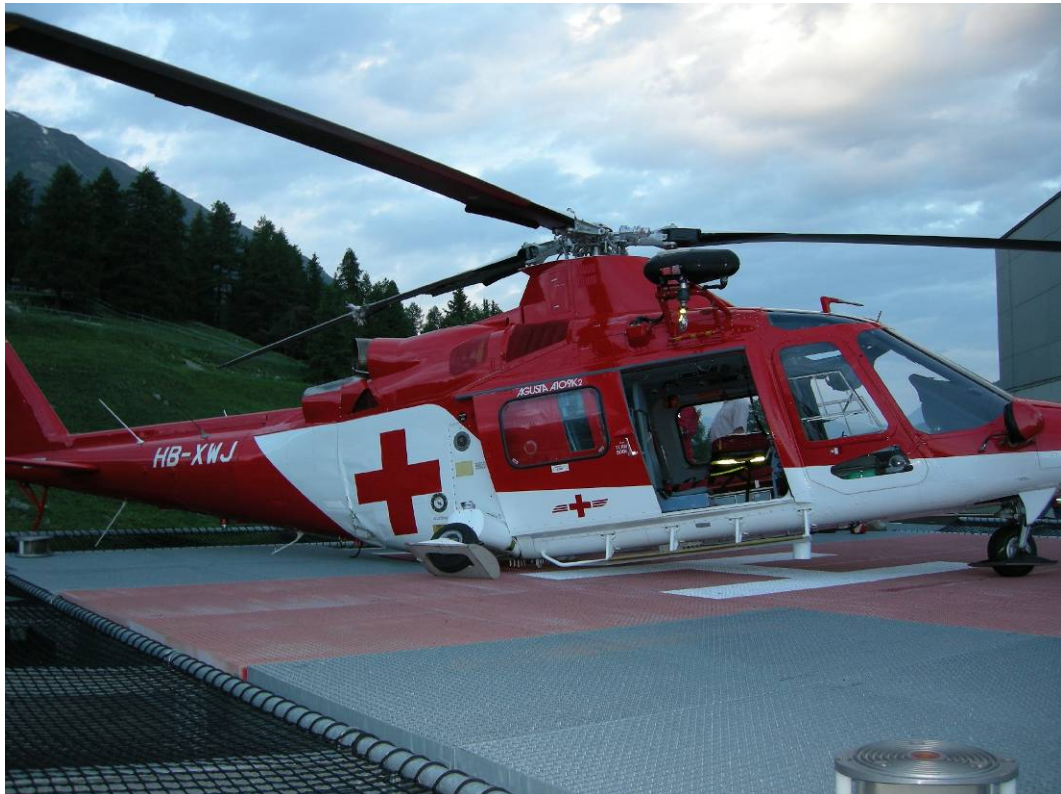
Figure 2: Final position of the severely damaged helicopter on the helicopter platform

The severely damaged helicopter was located at the outer edge of the helipad.

The tail extended approximately 1 m beyond the facade of the building. During an initial investigation, the following damage was observed:

- One rotor blade was destroyed.
- The red drag damper was missing.
- The two main landing gear were collapsed. The structure of the nosewheel landing gear was severely damaged.

- The skin of the rear section of the fuselage exhibited major deformation approximately 1 metre aft of the main landing gear.
- The upper part of the fin was severely damaged.

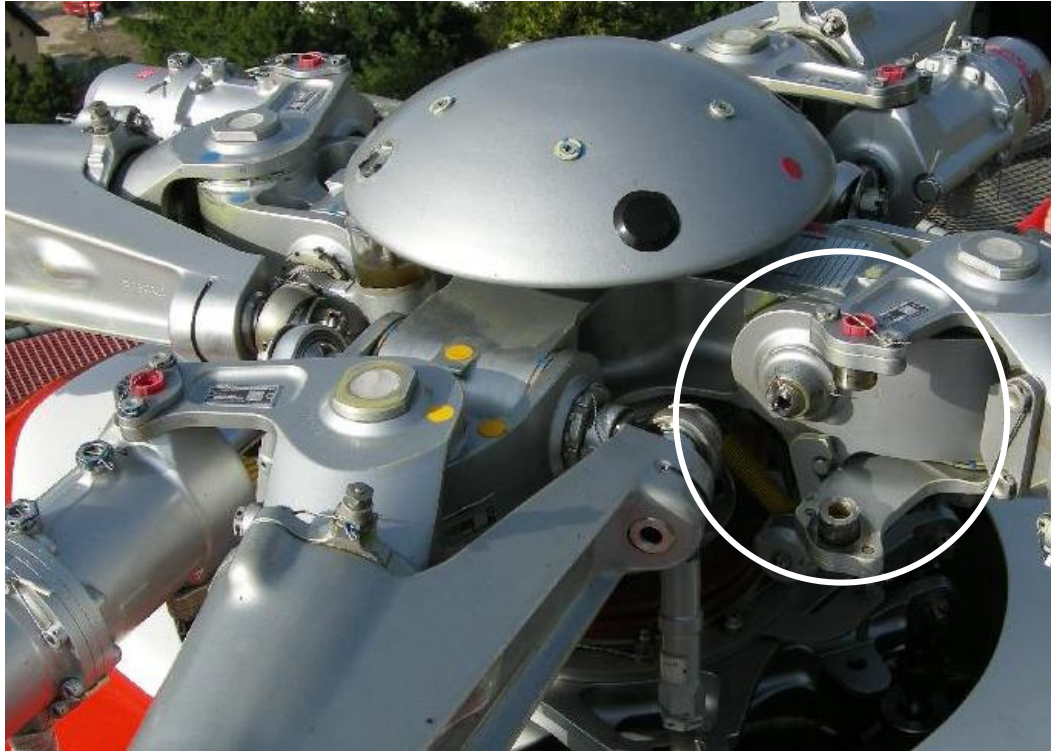
The missing drag damper was found on the day of the accident approximately 150 m from the site of the accident, in the attic of a house. The piston rod of the damper was missing and could not be found despite an intensive search.

Figure 3: "Red" drag damper missing, fracture area on the rotor head

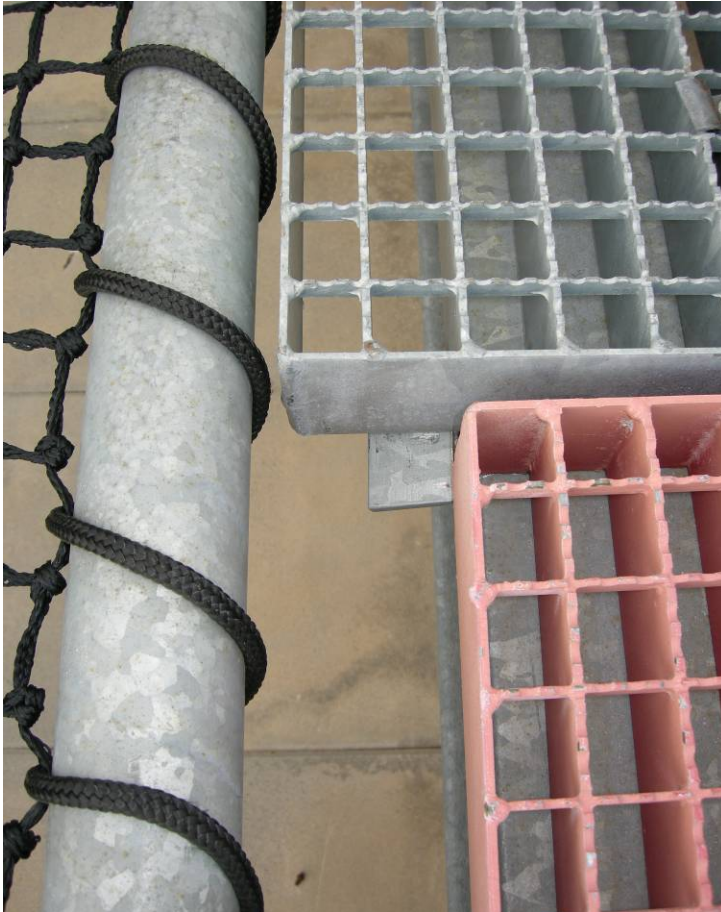
The visual inspection after the accident found damage to the helipad as listed below:

- On individual gratings, grating bars with local plastic deformation.
- Looseness and bending of clips that were used to secure the gratings against lifting.
- Gratings which were displaced laterally on the supporting structure.
- Edge retaining profiles which had been torn out at the welding points by the lateral displacement of the gratings.
- Local plastic deformation of cross beams.

Figure 4: Displaced grating

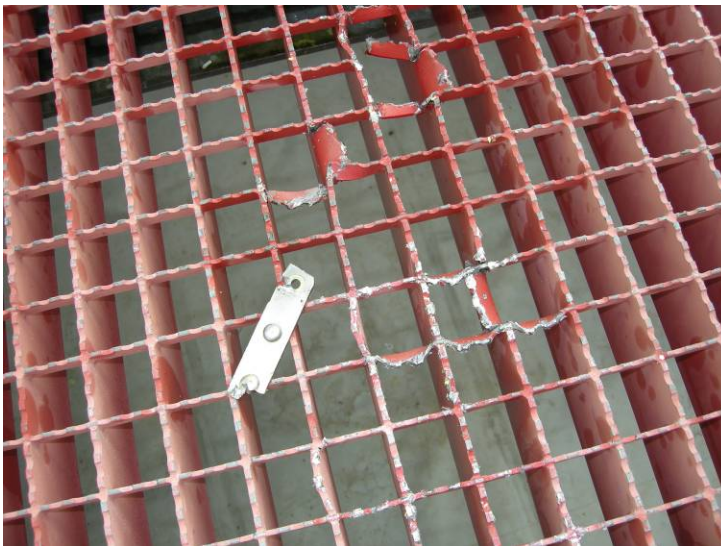
Figure 5: Torn out retaining clip and damage to grating

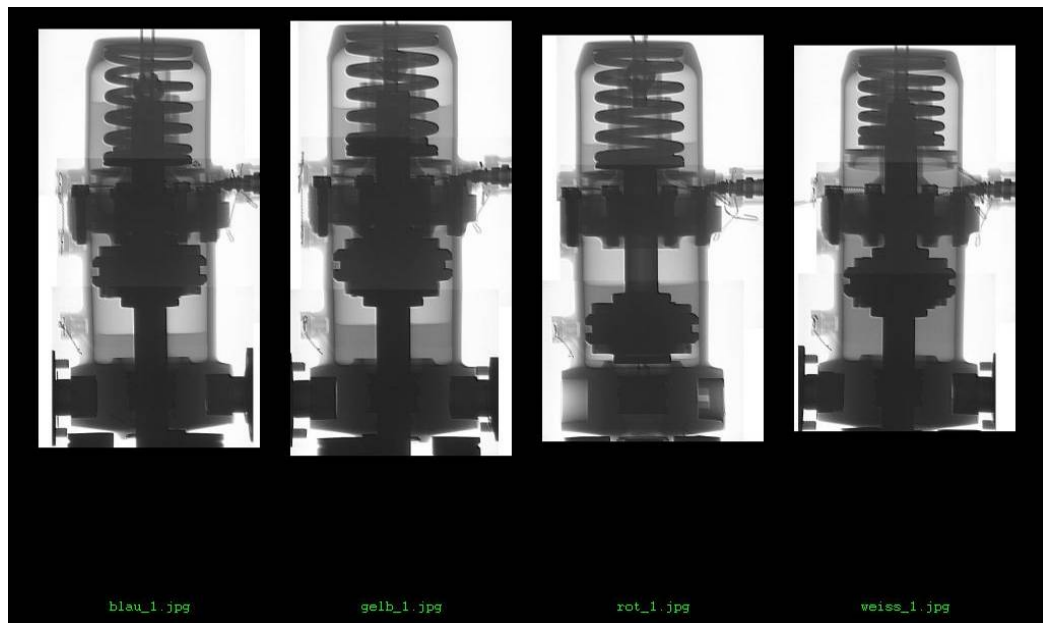
Figure 6: X-ray images, shock absorbers: Blue – Yellow – Red – White

The x-ray examination of the four drag dampers showed that the piston rod mounting nut was missing on each of the three shock absorbers – “Red”, “Yellow” and “Blue”. The absorber springs were accordingly expanded.

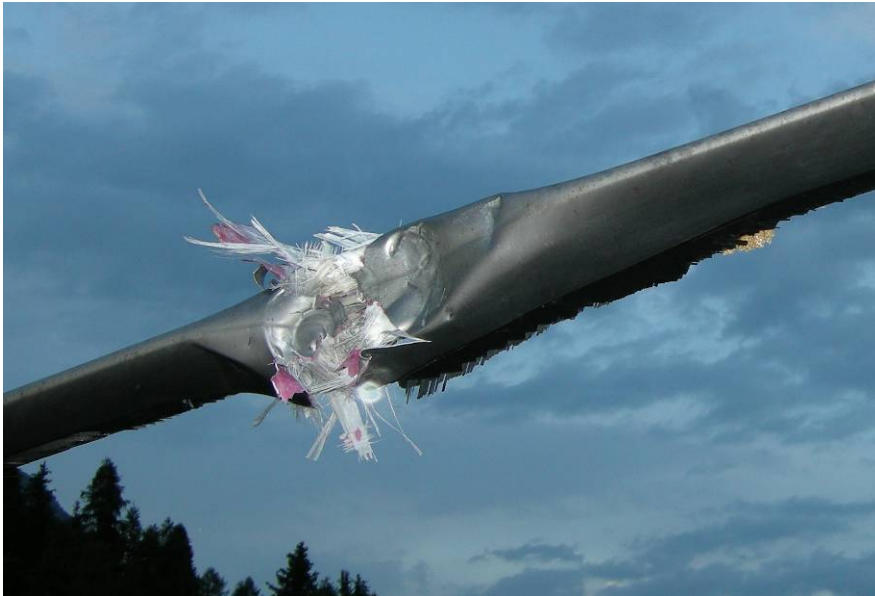
- the deformations of the metal leading edge with subsequent destruction of the rotor blade were the result of a collision of the rotor blade with the torn-off drag damper (Red);
- the damage to the tail boom was caused by parts of the rotor blade which were flung away;
- no material foreign to the helicopter was found in the rotor area.

Figure 8: Deformations of the metal leading edge of the destroyed rotor blade

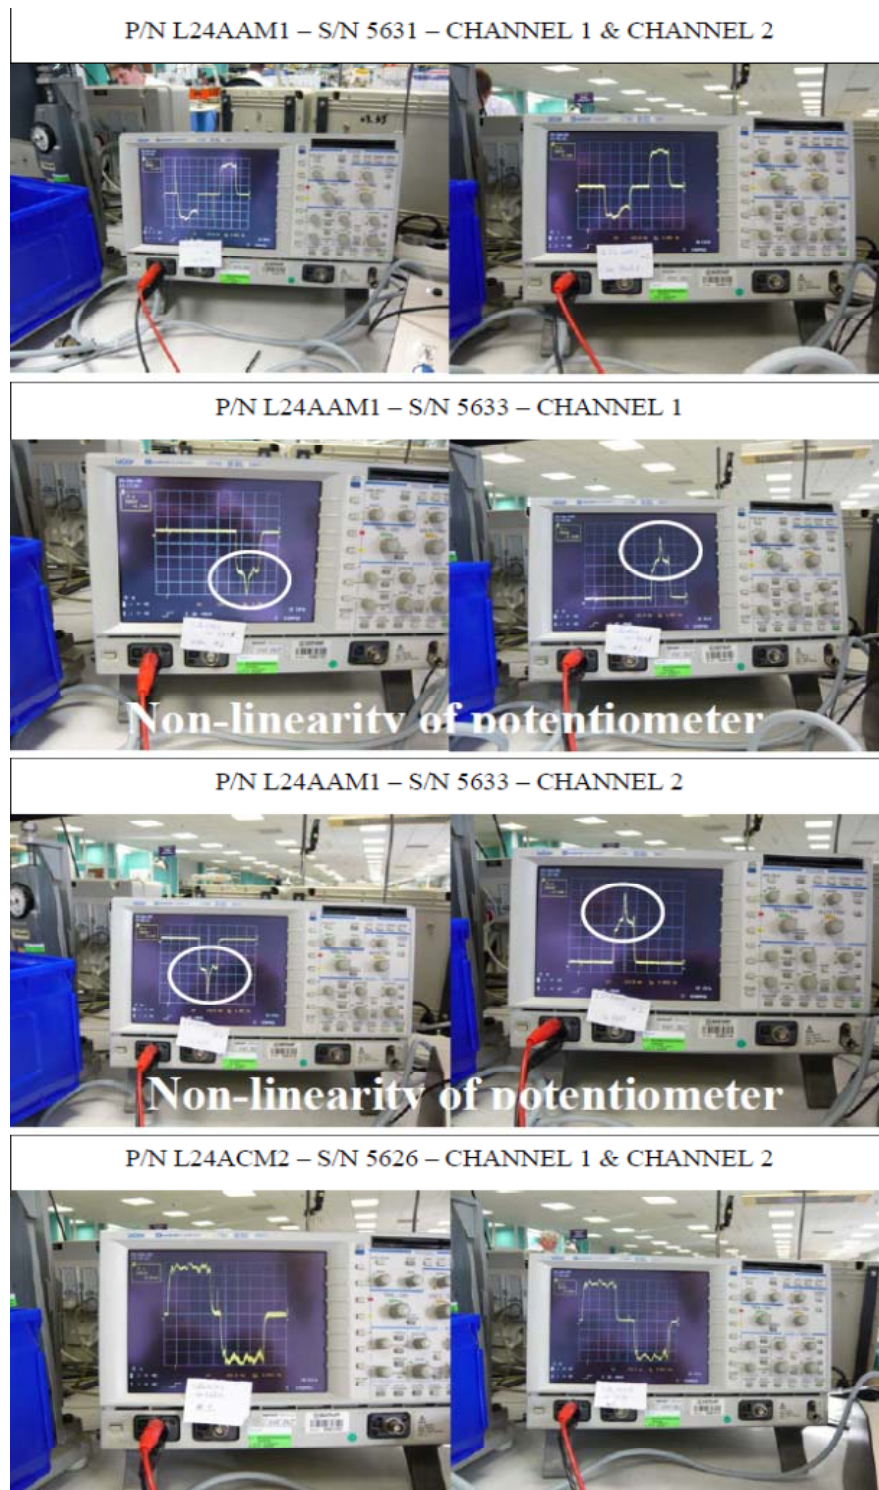
We have observed, a non-linearity potentiometer response on center position (loss of electrical continuity).

Figure 9: Potentiometer examination of the three serial actuators. The defect in the two potentiometers (channels 1 + 2) in serial actuator P/N L24AAM1-S/N5633 is detectable from the spiked trace (white circles).

The examination found that the serial actuator P/N L24AAM1 S/N 5633 was defective.

The position signals which are provided to the autopilot are sensed by linear potentiometers. The resolution of these signals is low. The linear potentiometers are subject to mechanical wear. When potentiometers are worn (on the examined potentiometers the wear was predominantly in the neutral area) then the position signal is not clearly defined. Such ambiguity of the sensed signal was found on potentiometers. Any ambiguity of the sensed signal leads to undesirable and uncontrolled effects on the autopilot, which may lead to critical oscillation of the helicopter (see also p.34 *Auto-Pilot system impact:*). Ambiguity of the sensed signal is also possible if there is play in the mechanical transmission elements. The investigations revealed that there was no play in these elements. It is noteworthy that the defect in the serial actuator P/N L24AAM1 S/N 5633 was not detected by the system test. This possibly resulted in oscillations of this serial actuator.

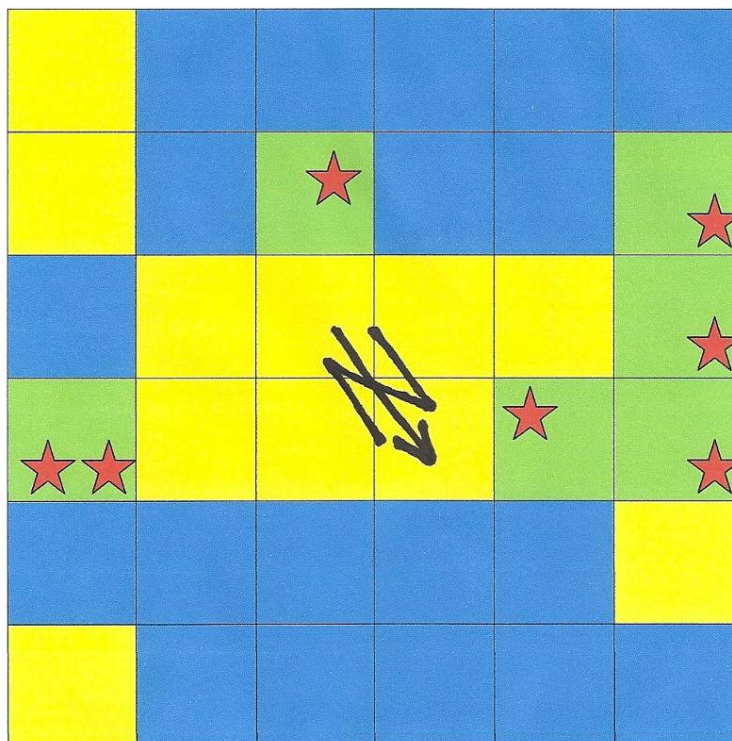
After the incident of 8 October 2009, the helipad at Samedan Hospital was re-examined. It was noted that since the re-commissioning on 14 August 2008, the following defects had arisen:

- 9 loose fixings
- 11 gratings with slight play
- 6 gratings with play

Figure 10: Samedan helipad, condition of the 36 gratings (G) after the incident on 8 October 2009
