Final Report No. 2125 by the Swiss Accident Investigation Board SAIB

concerning the accident involving the
Robinson R44 II helicopter, registration
HB-ZJG

on 25 August 2010

Giirebad, Pfyn/TG

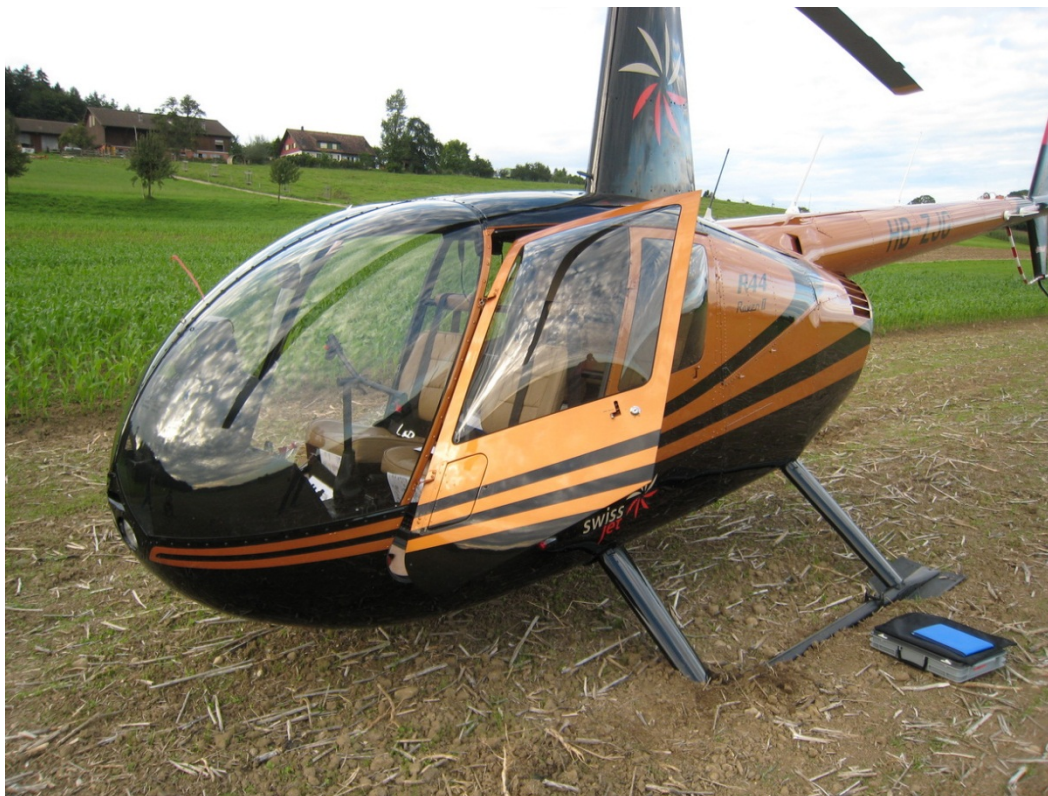
As they slid, the front tubes of the two landing skids dug a few centimetres into the dry, loose soil (Annex 1). In the course of the deceleration, a main rotor blade struck the tail boom and seriously damaged it (Annex 2). The crew did not notice this.

Annex 1: Final position of the helicopter with embedded landing skids

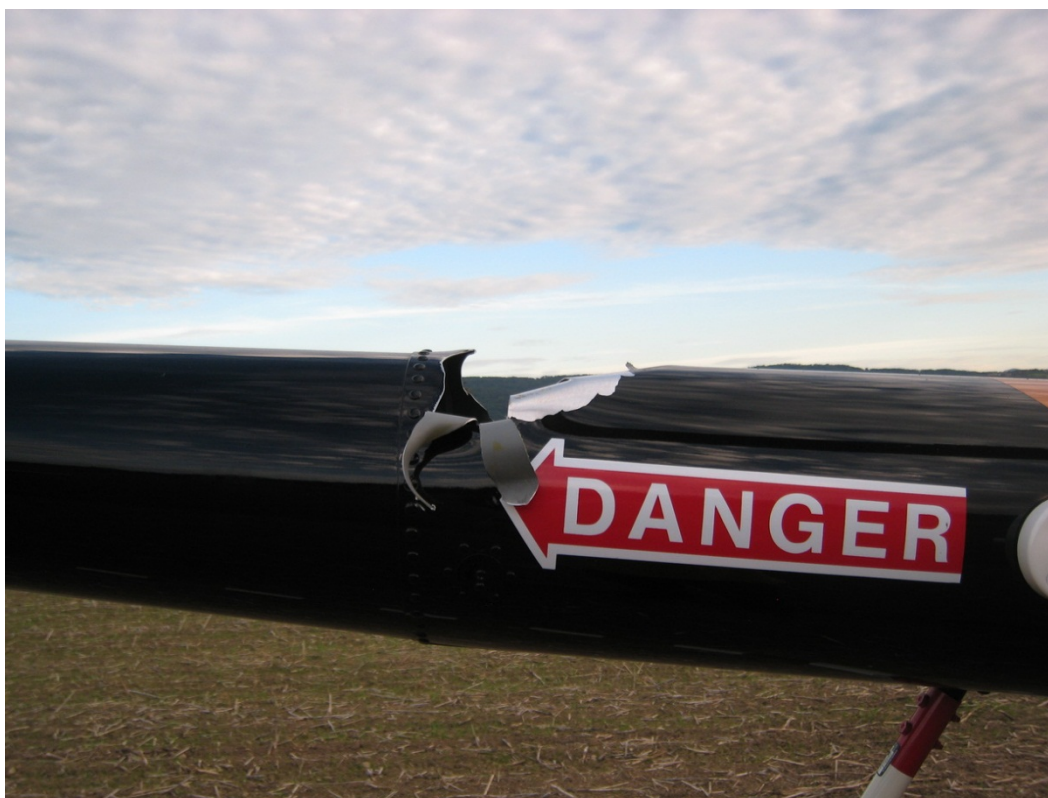
- The selected site was suitable for an autorotation exercise.
- The engine shut down after the initiation of the autorotation exercise.
- At the time of the engine failure, the situation was favourable with regard to a safe landing.
- An inadequate forward control input to the cyclic led to first contact with the ground in a nose-up attitude.
- Pulling back on the cyclic during the slide resulted in the main rotor blade striking the tail boom.

The accident is attributable to the fact that a main rotor blade struck the tail boom of the helicopter, because inappropriate control inputs were made during the final phase of the autorotation.

Annex 2: Point of impact of main rotor blade with tail boom

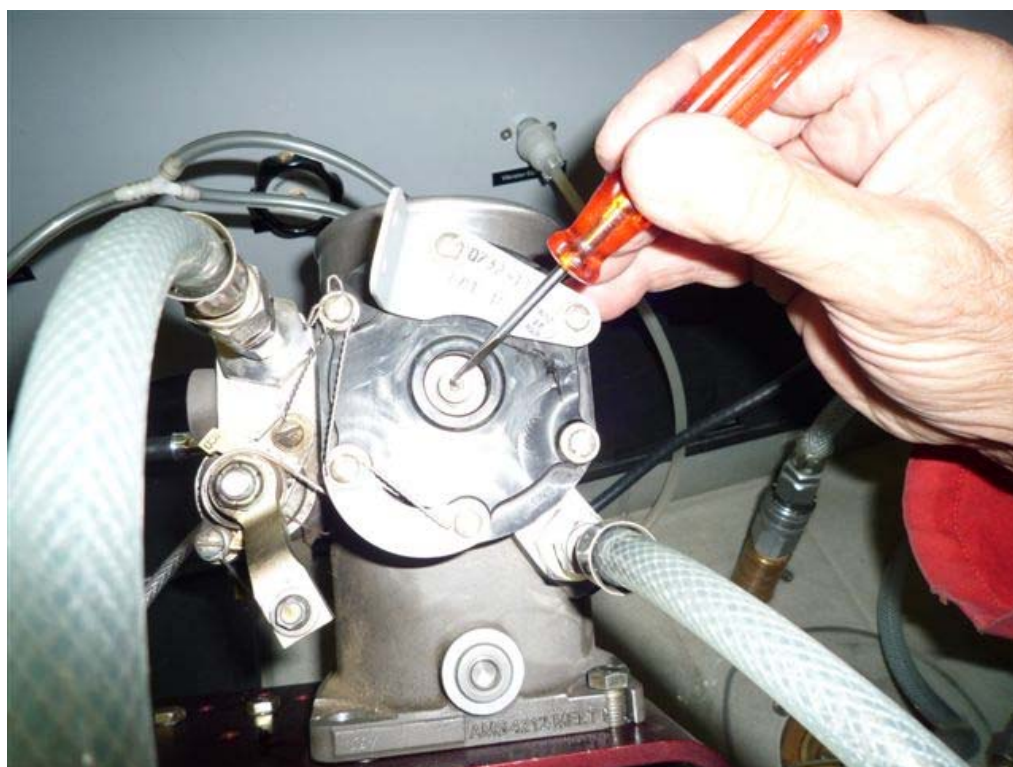
When the injection unit was dismantled, a non-centred built-in membrane was found. In certain flight conditions, this could lead to the above-mentioned fuel flow instability. The incorrect centring of this membrane must have occurred during the most recent assembly of the injection unit. According to the technical documentation for helicopter HB-ZJG, the fuel injector servo had not been removed since the delivery of the helicopter from the factory.

In idling mode, the non-centred membrane in the fuel injection unit could occasionally lead to an excessively high fuel flow and hence an excessively rich mixture. This in turn could lead to unstable idling, making shutdown of the engine during autorotation more likely.

The engine failure during the autorotation exercise, which was due to a technical defect in the fuel injection unit, contributed considerably to the accident.

Annex 5: Non-centred membrane in the fuel injection unit
