# **Final Report No. 2134 by the Swiss Accident Investigation Board SAIB**

concerning the serious incident involving a  
B737-800 aircraft, registration D-AHLR

on 7 June 2009

65 NM on radial 135° of the GVA  
(Geneva) VOR

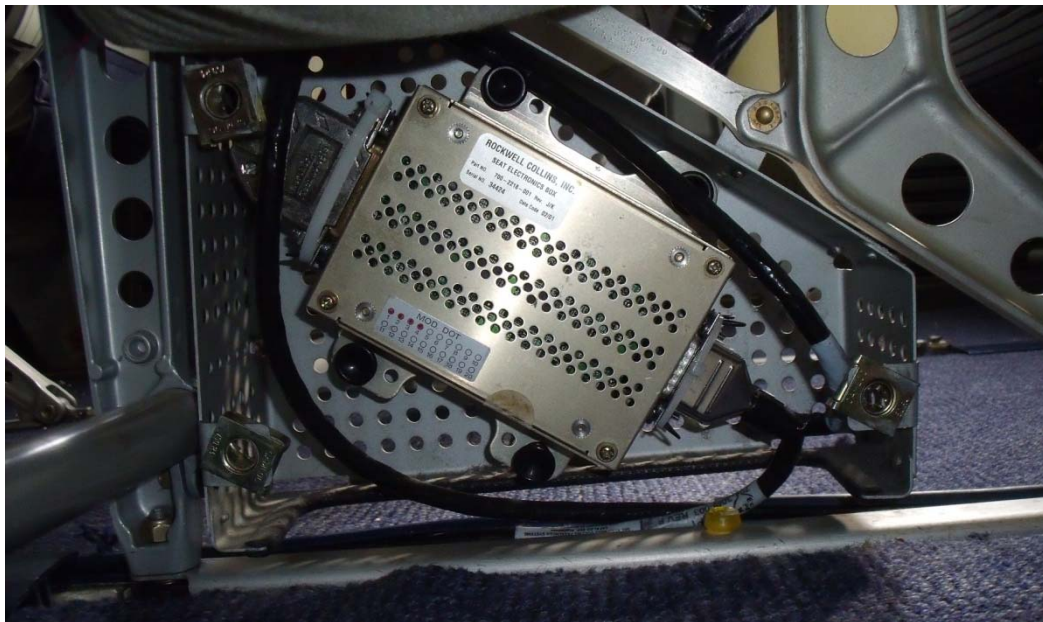
The aircraft did not suffer any damage. Only the seat electronic box (SEB) of the audio system intended for passengers in seats D, E and F of the 5<sup>th</sup> row was out of service.

Fig. 2: Position of the Seat Electronic Box (SEB) under seat 5E

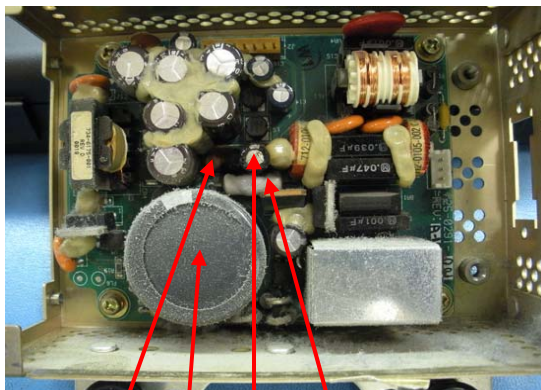
Capacitor C12 and R7 showed signs of severe heat damage. Damage was also found at the filtering inductor FL2 and capacitor C7. All these components C7, C12 and FL2 are adjacent to R7. Failures of R7 and fuse F1 led to the discovery of a bad switching controller U2. Significant dust contaminants accumulated on pins 2 and 3 of the component U2. A low-impedance reading measured between pins 3 (Drain) and 2 (Source) of U2 in the board indicated an electrical short.

Fig. 4: FL2 C7 C12 R7, positions of the damaged elements

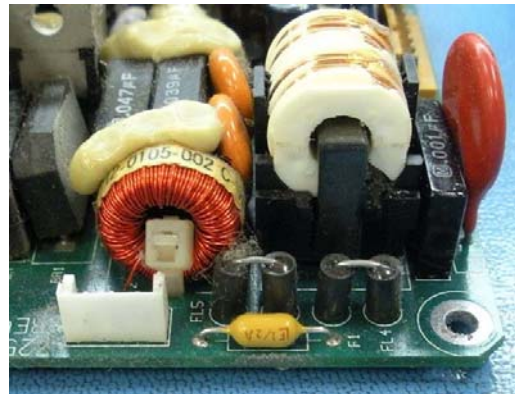
Fig. 5: Position F1 shows the installation of the fuse calibrated at ½ Amp.

Fuse F1 measured opened, but F2 checked OK with an Ohmmeter. There appeared to be an error in the installation of F1 and F2 fuses. A ½ Amp fuse was used at the location F1 when it was supposed to be a ¾ Amp device as called out in the BOM (Bill of Materials). Similarly, F2 was called out as a ½ Amp fuse in the BOM but the actual part was found to be a ¾ Amp fuse.

Once the U2 shorted between pins 2 and 3, heavy current resulted in a flow through the main fuses F1 and F2. They were part of the circuit to protect against power supply failure. If F2 were a ½ Amp fuse, it could have an opened circuitry thus possibly saving U2 and its main regulator. However with a higher amperage fuse at F2, input voltage dropped further leaving the by-pass FET Q1 opened for R7 in the path of the high return current. Due to excessive current through R7, the resistor was overheated that in turn caused severe damages to its adjacent components C7, FL2 and C12. F1 eventually opened at the input connector J1 because it had a lower trip current, but U2 and the PCB (Printed Circuit Board) were already damaged.

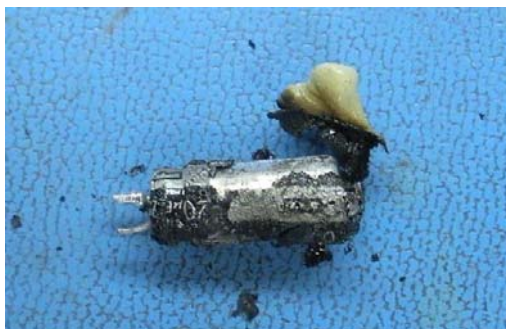
Fig. 6: Capacitor C12 overheated

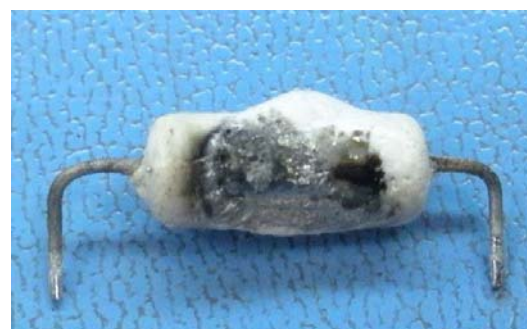
Fig. 7: Capacitor R7 damaged

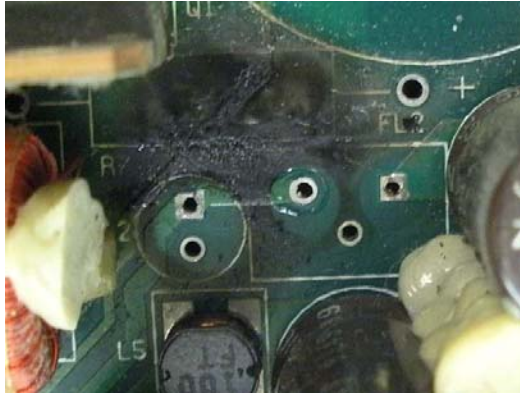
Fig. 8: Damaged printed circuit in the area in which capacitor R7 was fitted

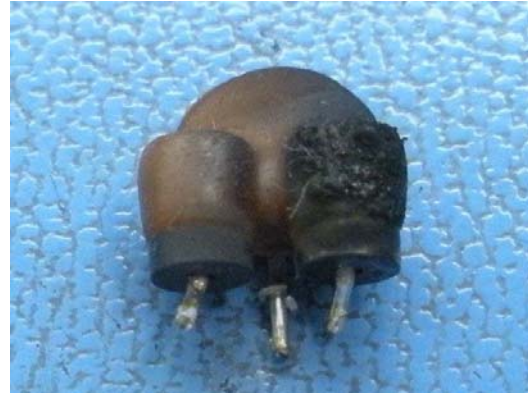
Fig. 9: Damaged inductor FL2
