Final Report no. 2136 of the Swiss Accident Investigation Board SAIB

concerning the serious incident - airprox
involving the Airbus A320-214 aircraft, registration HB-IJH,
operated by Swiss International Airlines
under radio callsign SWR 1326
and the Airbus A320-214 aircraft, registration HB-IJW,
operated by Swiss International Airlines
under radio callsign SWR 202W
on 15 March 2011
at Zurich airport

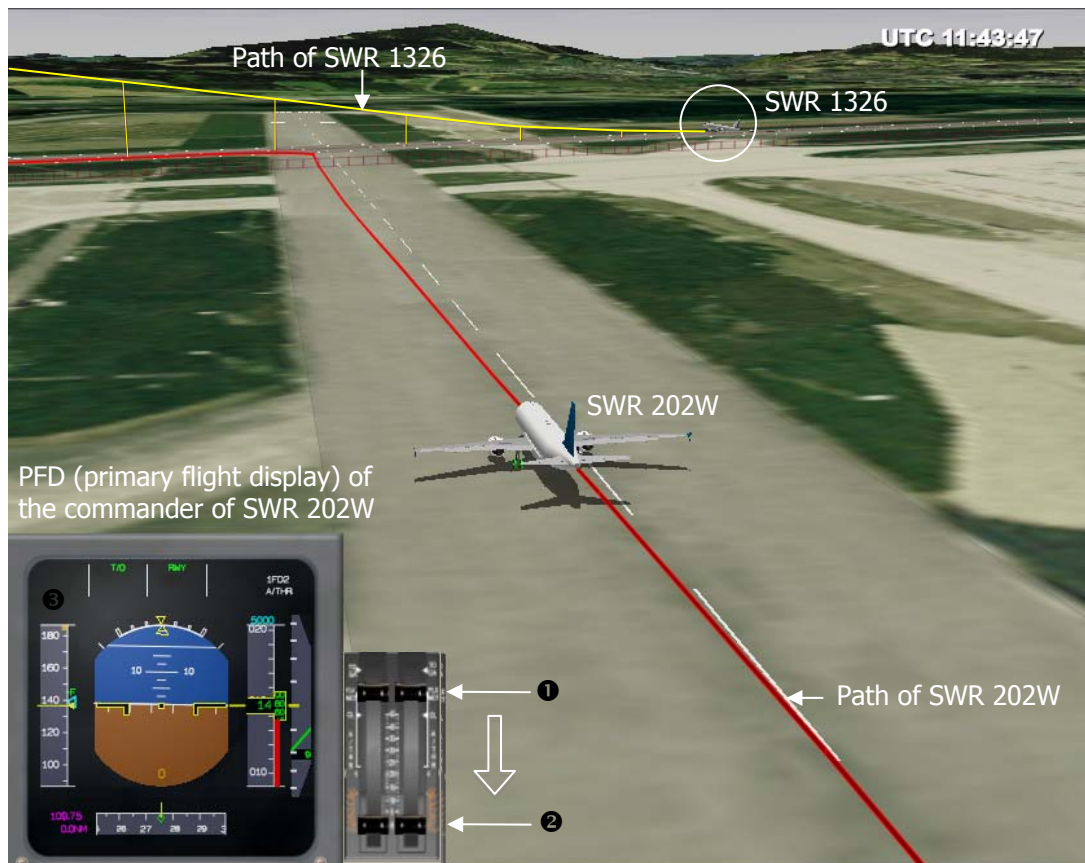
According to his statement, the ADC air traffic control officer was surprised by the alert and believed in the first instant that it was a "false alarm with a vehicle". In addition, he stated that SWR 1326 was no longer present in his mental plan at this point in time. He checked whether a vehicle was close to the runways or whether a landing aircraft was on runway 16. He then realized the two aircraft which were simultaneously on their take-off rolls on runway 16 and runway 28. At 11:43:49 UTC he gave the crew of SWR 202W the order: "Swiss two zero two whiskey, stop immediately!" The crew did not respond to this order, since two seconds before they had seen the aircraft taking off from runway 16 and had immediately initiated an aborted take-off (cf. figure 2 and chapter 1. 5.4). When the abort was initiated, SWR 202W was rolling at a speed of 135 kt and SWR 1326, which was lifting off, had a speed of 162 kt. SWR 202W was approximately 550 m before the intersection of runways 16/28.

Figure 2: Take-off roll of the two aircraft reconstructed from the flight recorders. Line of sight along runway 28. Time 11:43:47 UTC, when the crew of SWR 202W noticed SWR 1326 and initiated the aborted take-off.

- ❶ Throttles in take-off position
- ❷ 1 second later: throttles in idle position
- ❸ Speed indicator

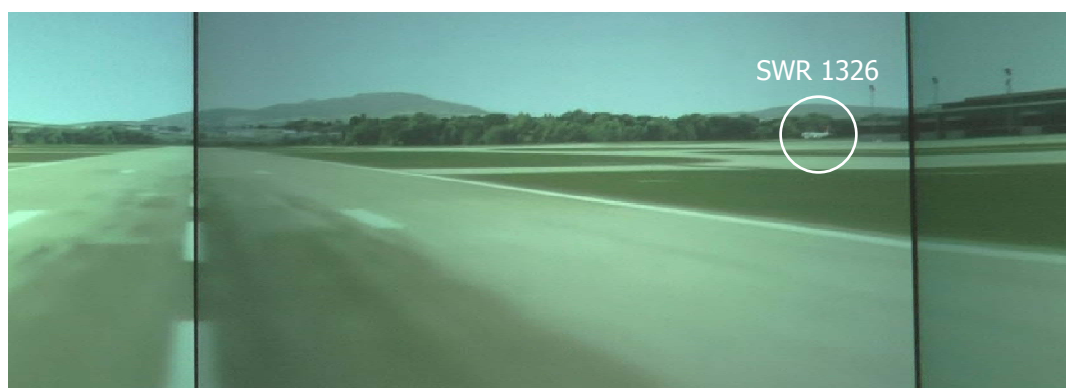
Figure 3: View from the cockpit of SWR 202W at the same time (11:43:47 UTC). The picture was taken in the tower simulator (TOSIM).

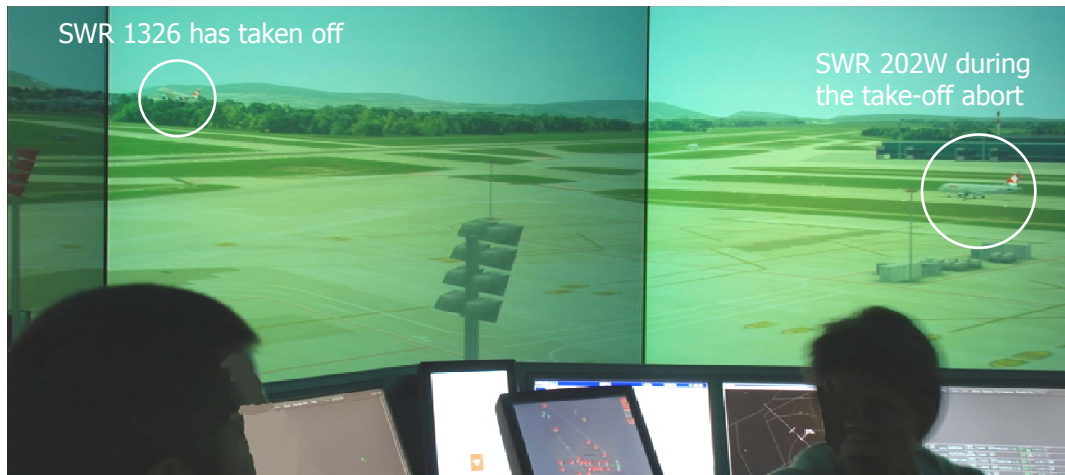
Figure 4: View from the tower, from the ADC workstation, shortly after the aborted take-off of SWR 202W. The picture was taken in the tower simulator (TOSIM).

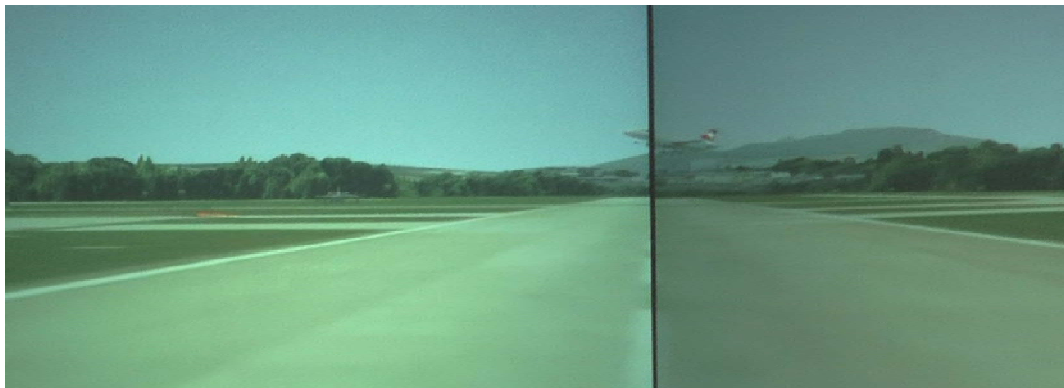
Figure 5: At the same time: View from the cockpit of SWR 202W after the aborted take-off was initiated. The picture was taken in the tower simulator (TOSIM).

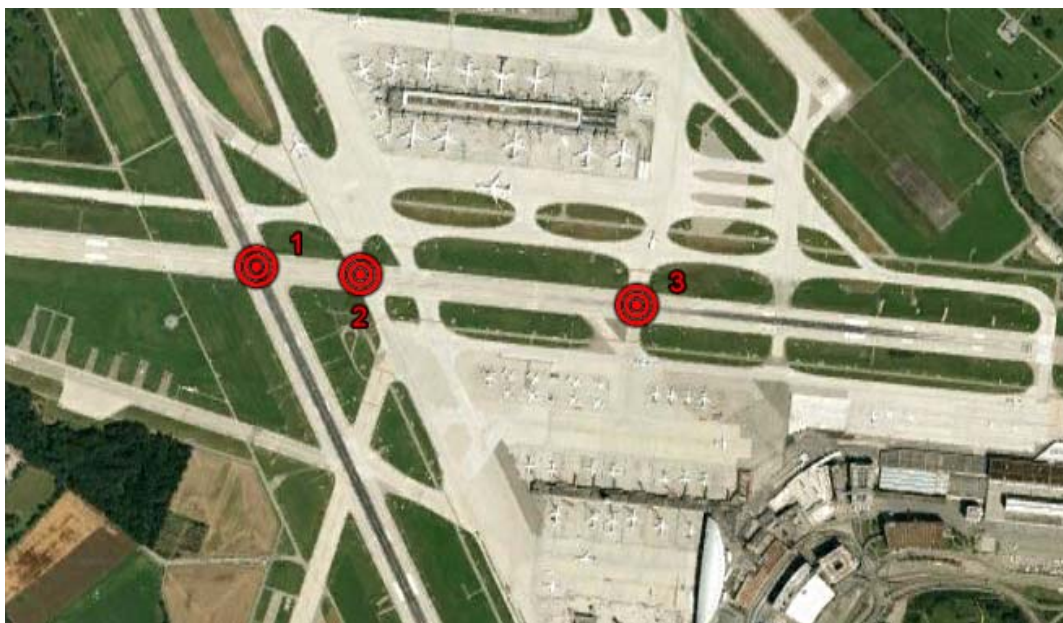
Figure 14: Critical intersection points on the ground

In summary, the impression is created that the previously implemented improvement in the operation of Zurich airport has been able to eliminate only selective risks. In the SAIB's view, the constant emergence of new problems suggests that the entire system of Zurich airport is currently being operated in a manner which involves further risks inherent in the system.

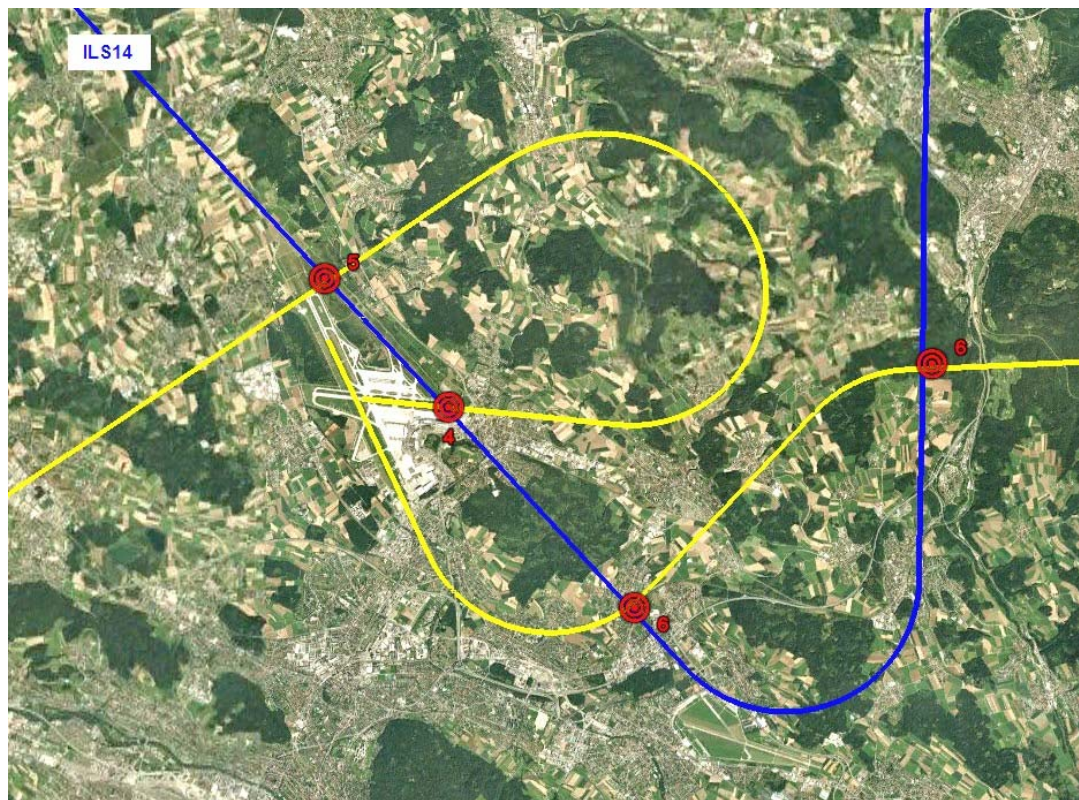
Figure 15: Critical intersection points in the vicinity of the airport

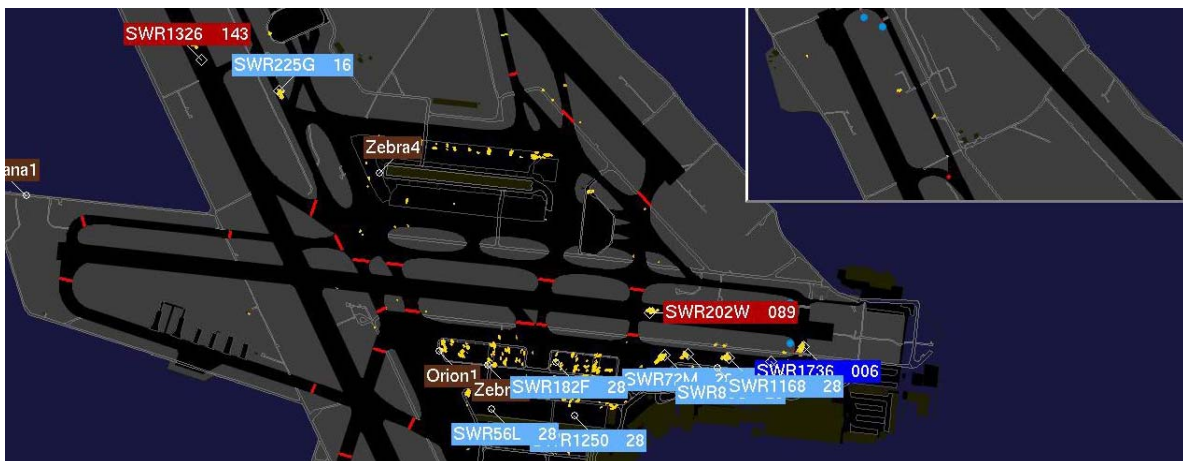
At 11:43:40 UTC, a stage 2 alert was triggered by the runway incursion monitoring and conflict alert sub-system (RIMCAS). The blue labels of the two aircraft, SWR 1326 and SWR 202W, on the SAMAX screens changed their colour to red and the acoustic "RIMCAS" alarm sounded (cf. Annex 1). According to the SAMAX recordings, aircraft SWR 1326 was rolling at a speed of 143 kt and aircraft SWR 202W was rolling at 89 kt.

11:43:40 UTC: RIMCAS system generates a level 2 alert (aircraft markers turn red)

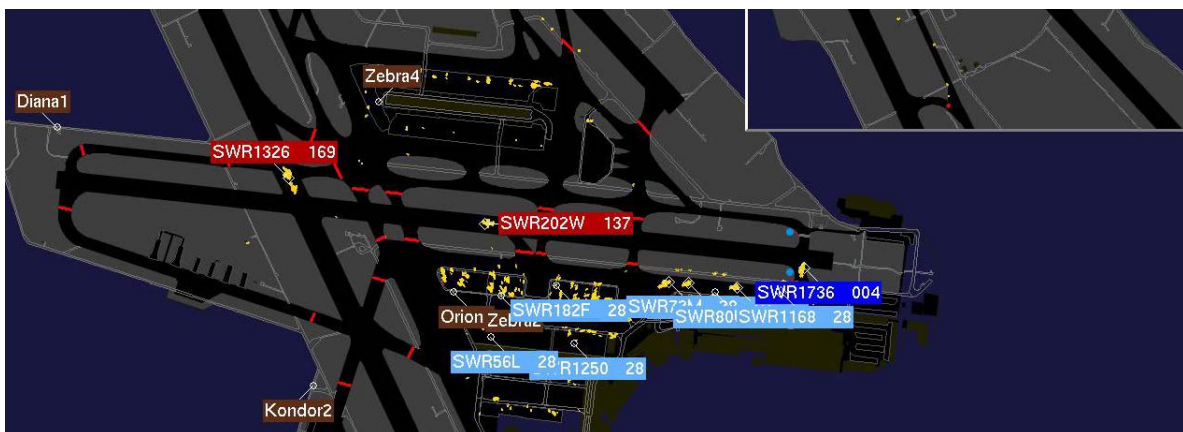
11:43:49 UTC: SWR 202W receives the instruction: "Swiss two zero two Whiskey stop immediately."

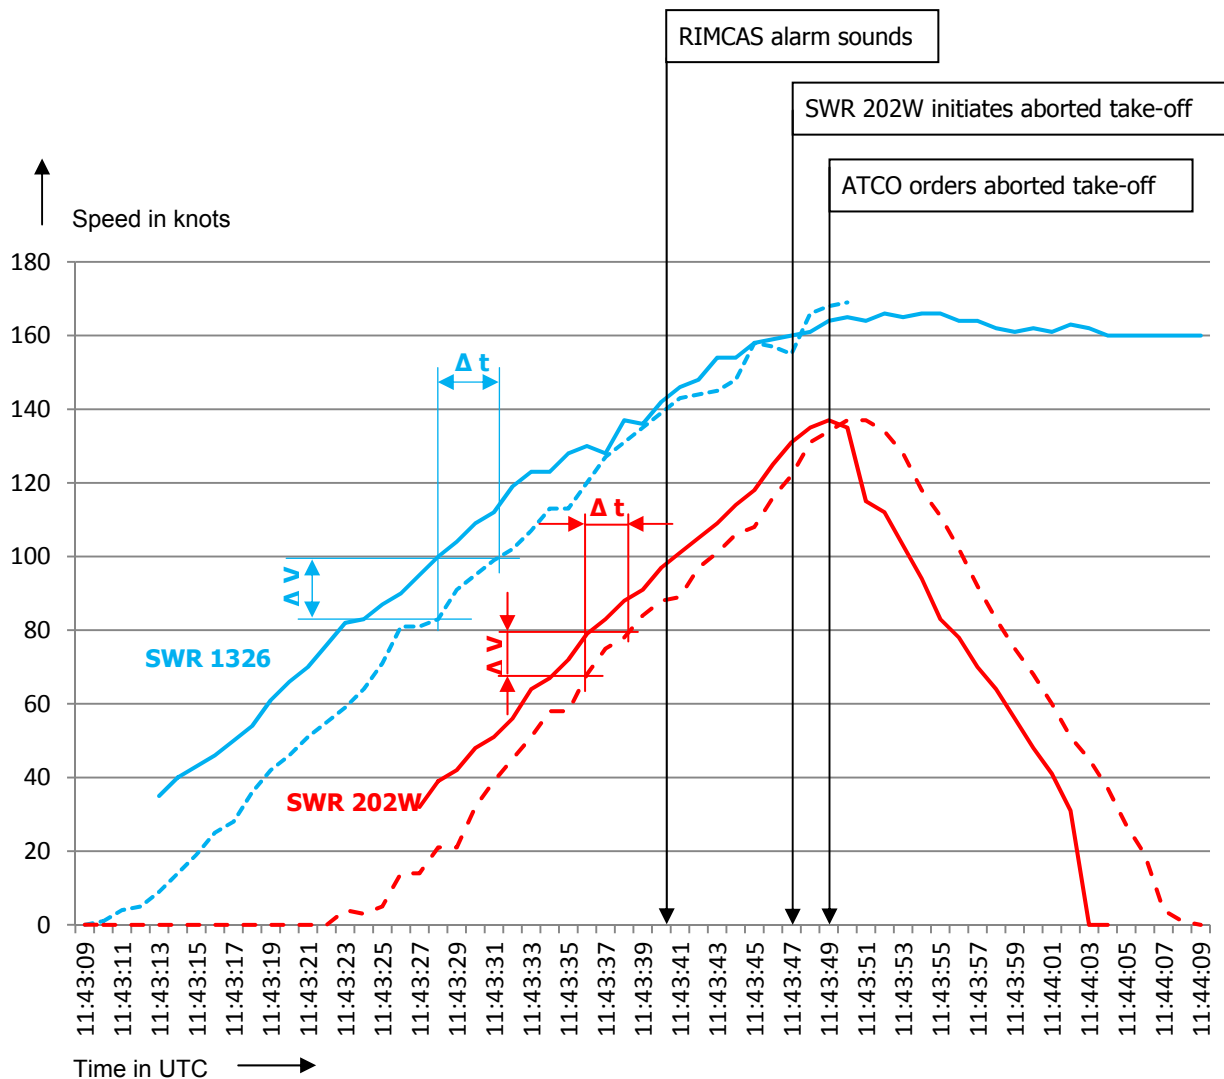
Annex 4: Speed plot of the two aircraft

Example: SWR 1326 at 100 kt has a RIMCAS speed indication of 83 kt (100 kt is displayed 3 seconds later; $\Delta V = 17$ kt, $\Delta t = 3$ seconds)

SWR 202W at 80 kt has a RIMCAS speed indication of 69 kt (80 kt not displayed until two and a half seconds later; $\Delta V = 11$ kt, $\Delta t = 2.5$ seconds)
