# **Final Report No. 2137 by the Swiss Accident Investigation Board SAIB**

concerning the accident involving the  
Robinson R22 Beta II helicopter,  
registration HB-ZGR

on 9 April 2009

Bern-Belp airport (LSZB)

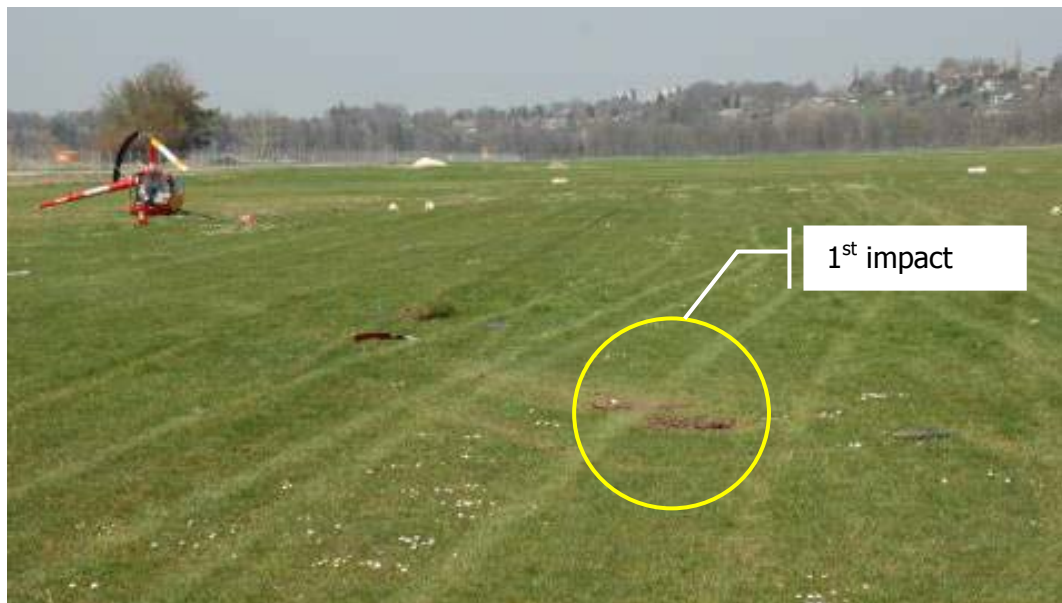
**Picture 1** – Witness marks of the first impact

The helicopter's landing skid structure had been deformed outwards by the impact. The witness marks on the underside of the airframe and the engine area indicate a heavy impact with the turf. The tail rotor bracket was bent and the tail rotor shaft was torn out. When the main rotor blades made contact with the ground, the engine was delivering power, because although the drive belt was intact, it was separated from the drive shaft and the cooling fan was twisted in the direction of rotation of the engine. The lower structure of both pilots' seats was deformed.
