Final Report No. 2138 by the Swiss Accident Investigation Board SAIB

concerning the accident involving the
Eurocopter SA315B Lama helicopter,
registration HB-XII

on 8 July 2009

Dufourspitze, Zermatt/VS

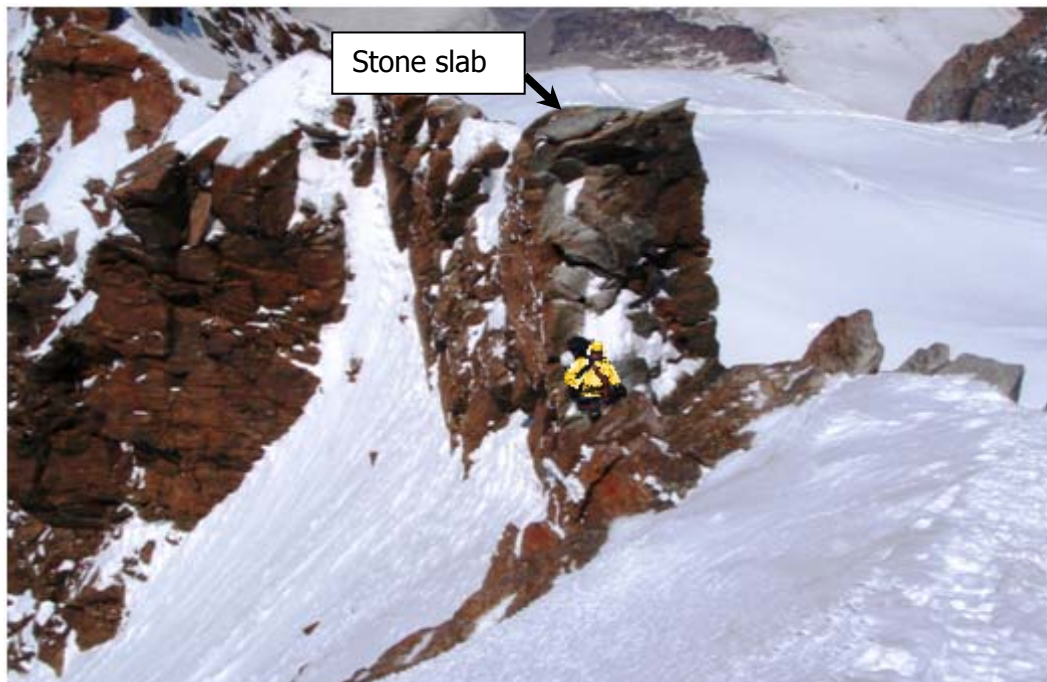
For the evacuation, the mountain guide found an exposed rock pillar a few metres high, with a relatively flat surface extending approximately 1 metre by 2 metres. On top of this pillar, there was also a large flat stone slab measuring approximately 150 x 50 cm. The pillar and the slab can be seen on a photograph which was taken during the ascent to the summit (figure 1).

Figure 1: Pillar and stone slab

To belay himself, the guide wound the rope several times around the stone slab lying on the pillar. From an estimation of the dimensions of the stone slab with the aid of figure 1, it can be concluded that the stone slab weighed between 500 kg and 700 kg. According to a mountaineering and rock-climbing expert, this type of belay is normal and comprehensible.

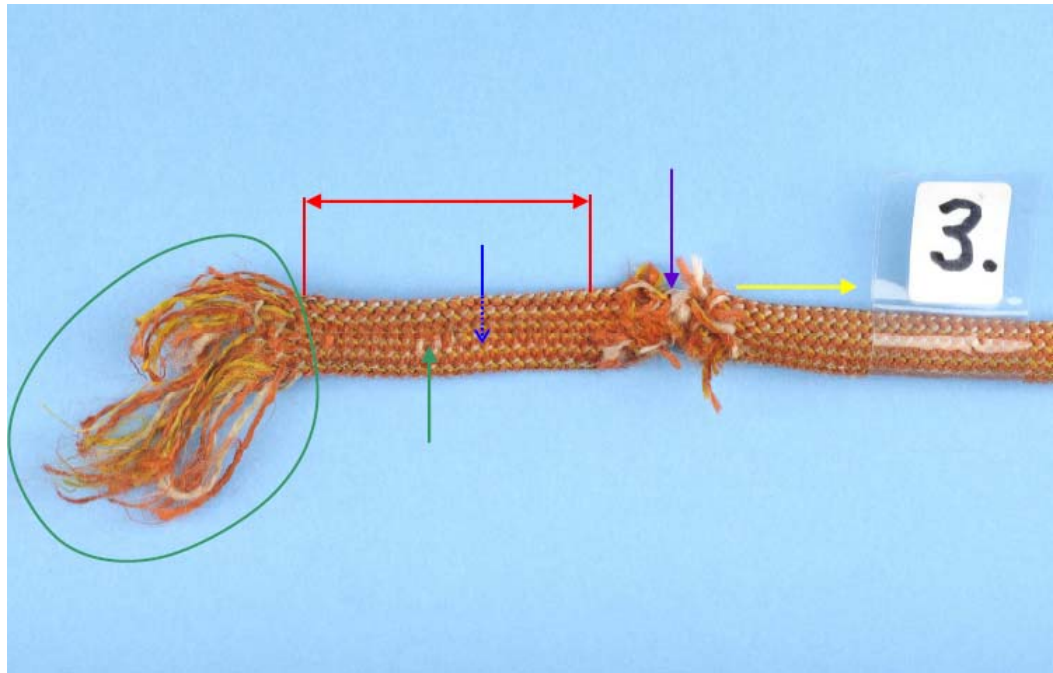
The rope was examined forensically by the Scientific Forensic Services Zurich City Police (WD - Wissenschaftlicher Dienst). The total length was 34 metres. The point at which it was severed was of particular interest; it was 13.7 metres from the knot to which the guide was attached (figures 2 and 3). At this location (the section marked in red), the sheath of the rope had been permanently deformed (flattened) and exhibited a frayed tear in the sheath (encircled in green). The core of the rope was severed at the other end of the deformed section, where the rope sheath was also cut through over about $\frac{3}{4}$ of its circumference (the purple arrow).

Figure 2: Top view of the flattened section of the severance location (mountain guide side)

The permanent deformation (flattening) of the rope at the point at which it was severed could not be reproduced either during the dynamic tests in the drop tower or when subjected to an impact while under static tensile load. The persons in the helicopter did not notice any unusual change in load during the lift, and neither the suspended rescue specialist nor the climber on the ground (who was attached to the rope) noticed any tension on the rope. Consequently, it is unlikely that the helicopter, apart from lifting it, exerted any tension on the rope, which, for example, could have displaced the stone slab. It is most probable that the rope was hit by chance by the stone slab when it first hit below the pillar, and in the process was deformed and severed.

- It is probable that the rope was hit by chance during this first impact of the stone slab below the pillar and in the process was deformed and severed.

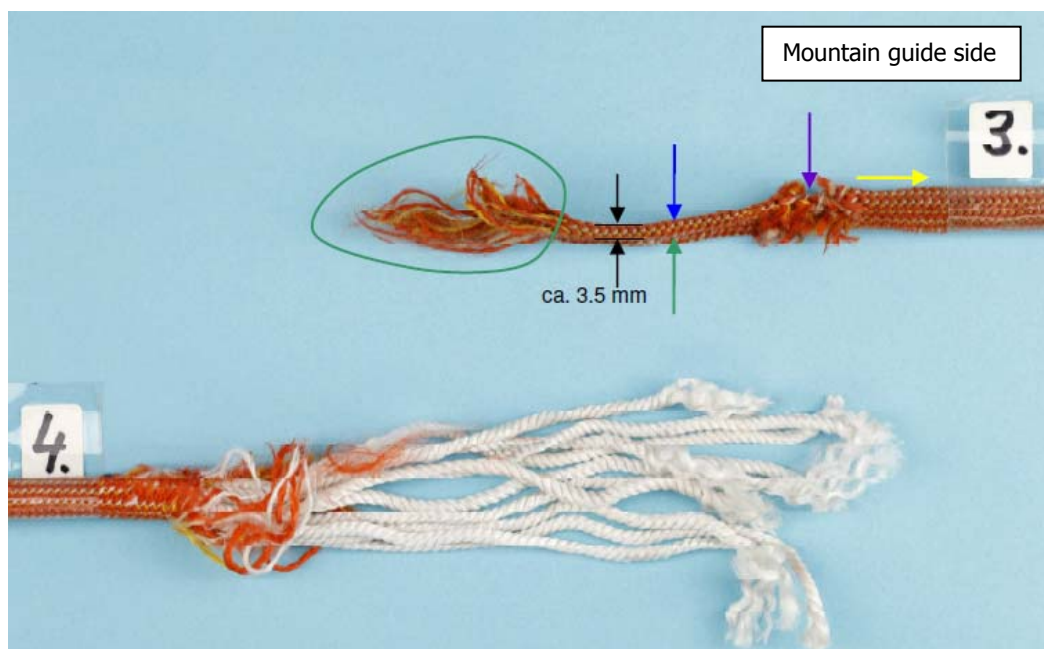
Figure 3: Side view of the deformed severance location (mountain guide side) and opposite end

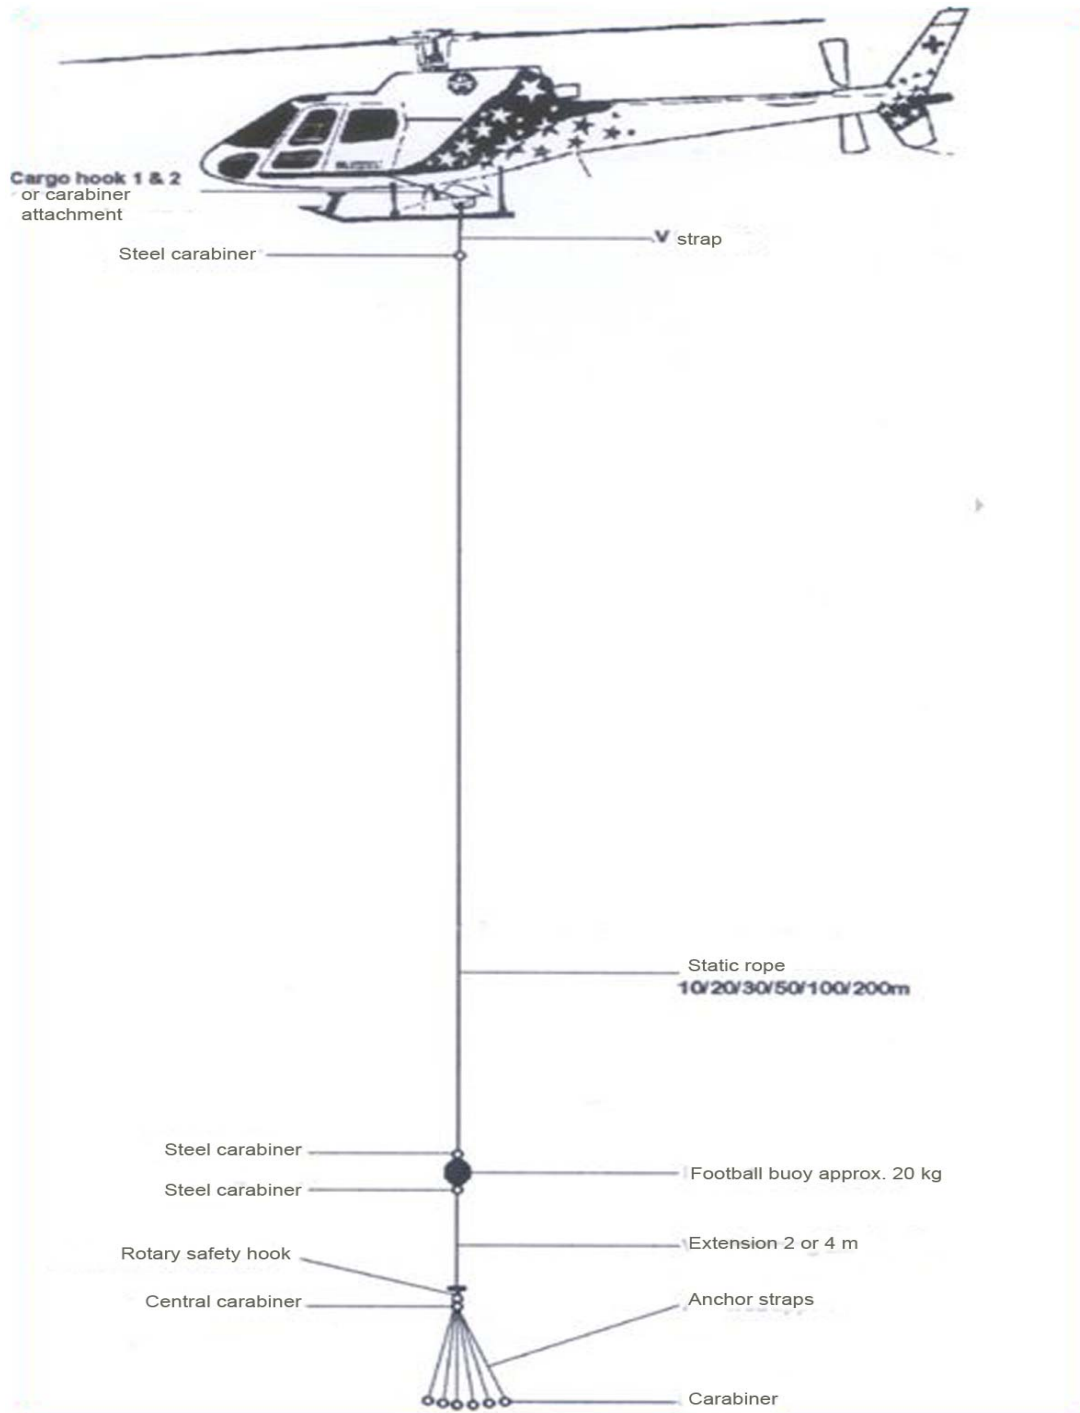
The helicopter was equipped with a so-called MERS (Multilateral Evacuation and Rescue System). From the helicopter's cargo hook, a 30 m line was doubled to form a 15 metre length from which a weighted football buoy was suspended; anchor straps were in turn connected to this (figure 4). The resulting length from the helicopter to the attachment points was 20 metres. Of the six anchor straps, four attachment points were open, in order to attach the patient, the rescue specialist and their backpacks.

Figure 4: Multilateral Evacuation and Rescue System (MERS)

The use of the Multilateral Evacuation and Rescue System was not in accordance with the procedure described in the operator's Code of Practice.

The instructions for personnel must include the procedure not only for normal operations but also for abnormal situations. The Code of Practice does not contain any instructions about how to proceed if for example it is detected during lifting that the load is not free.
