Final Report No. 2143 by the Swiss Accident Investigation Board SAIB

concerning the accident involving the
Piper PA-28-161 aircraft,
registration HB-PPG

on 24 March 2009

Bellechasse (LSTB) airfield,
Bas-Vully municipality/FR

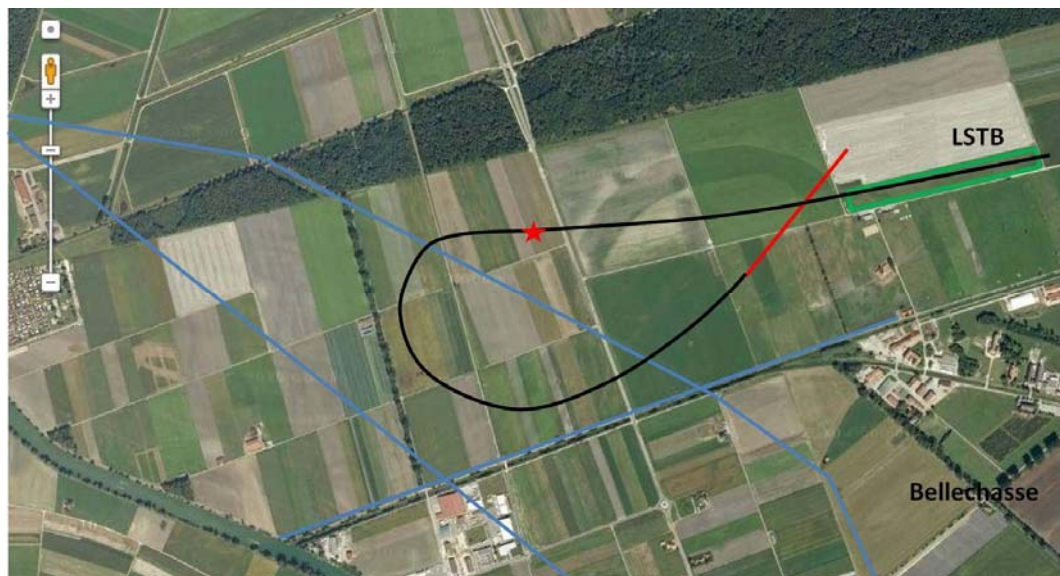
20 to 30 seconds during the climb after the go-around, there was a sudden power loss at approximately 400 ft AGL. *"Sudden rumbling or rattling, reminded of mechanical noise, with vibrations."* The manipulations on the power lever had no effect; the engine was no longer providing power. In accordance with standard SAT procedures, the flight instructor assumed control of the aircraft. Given the inappropriate emergency landing surface directly ahead, with woods and high-voltage

The aircraft was not able to reach the grass runway and touched down just short of the threshold of runway 08. After touchdown at approximately 14:35, the aircraft collided with a pasture fence in farmland and came to a standstill after approximately 400 m, in a damaged state. The instructor saw the fence only at the last moment; due to the rapid change of events he landed without flaps.

Figure 1: Situation overview, emergency landing of aircraft HB-PPG
Black: Flight path according to instructor's statement
★ Approximate location of power loss
Red: Landing roll according to traces
Blue: Power lines (high and medium voltage)

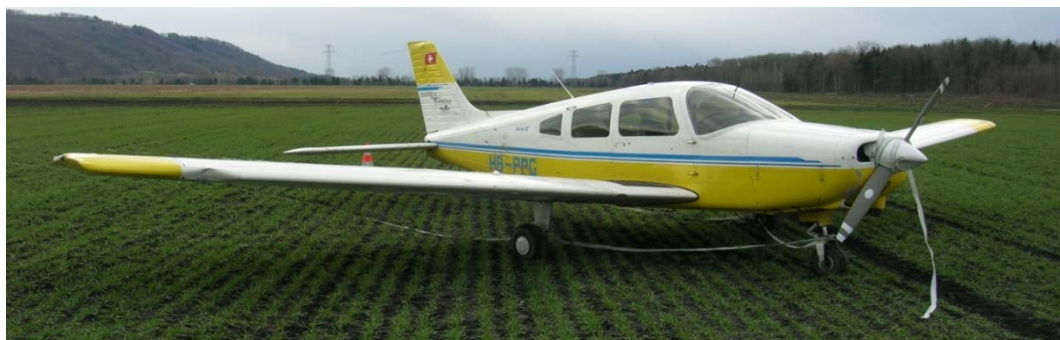
Figure 2: Final position of the damaged aircraft HB-PPG

The aircraft was damaged as a result of the collision with the pasture fence. The wires of the fence were torn and coiled up by the spinning propeller.

The leading edges of both wings were damaged by the collision with the fence posts, as was the propeller spinner.

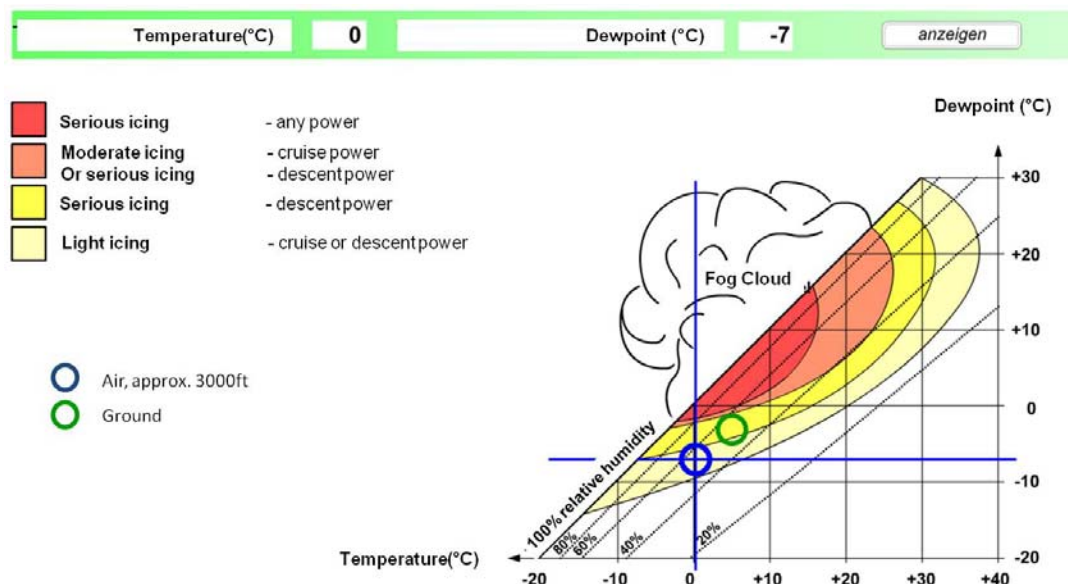
Under the given conditions, carburettor icing was possible. Figure 3 shows an analysis based on the conditions prevailing on the day of the accident. In the wake of the cold front which passed before noon the temperature and dew point have changed approximately 1, respectively 0.2 °C per 100 m altitude. This is due to the well mixed convective boundary layer below the local cloud base. Based on temperature/dewpoint of 5/-3 °C at surface the respective values reach 0/-4 °C at 3000 ft AMSL (tolerance 1 °C). The radiosonde observation of Payerne (according to Annex 1) indicates a dewpoint of -7 °C at 3000 ft/AMSL. The difference can be explained by a higher moisture content of the air in the vicinity of the Lakes of Bienne, Morat and Neuchatel compared to the hilly surroundings of the aerological station of Payerne. The two points on the graph are therefore set at 5/-3 and 0/-7 (temperature/dewpoint in °C), respectively.

Figure 3: Probability of carburettor icing on 24.03.2009
(Source: SPHAIR training document)

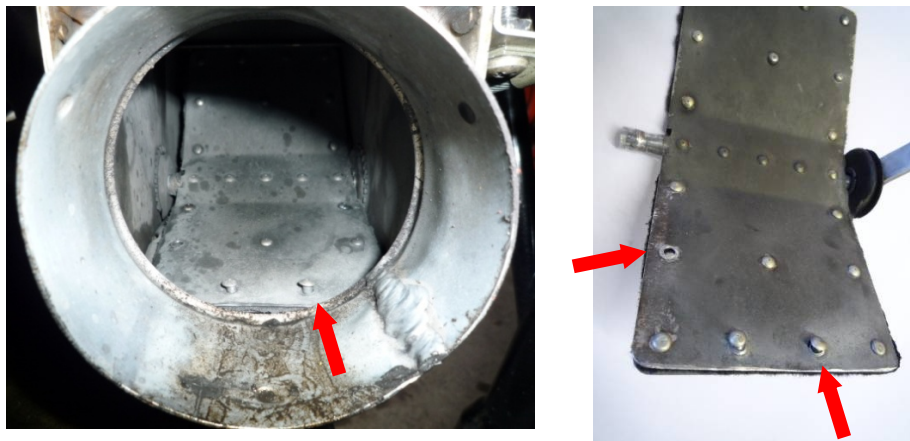
- Inlet pipes:
The seals, which connect the intake pipes to the cylinders, exhibited cracks and leaks.
- Carburettor heater air door and box:
The mechanism that allows switching of the intake air from normal operation to heating exhibited signs of wear. The flap had a lot of play; in addition, the seals which are supposed to seal the flap against the housing were missing. Some of the rivets which hold the flap together were loose; one rivet was missing and could not be found (cf. figures 4 and 5).

Figures 4 and 5: Flap, carburettor heater in assembled and disassembled condition

The aircraft's carburettor heating-system had a significantly smaller effect than usual. This can essentially be explained by the poor condition of the flap in the airbox. As a result, carburettor icing may have been possible even if the carburettor heating had been applied correctly in accordance with the procedures. Effectively, the crew was only able to apply the carburettor heat partially, which is expressly discouraged in the AFM (cf. section 1.5) because this may cause icing in other parts of the inlet system.

According to the aircraft's technical documentation, maintenance was carried out in accordance with the manufacturer's documentation. However, the defects described in section 1, in particular the defective carburettor heating, were not detected. This is surprising, since this specific point was signed off as part of the last two checks.
