Final Report no. 2145 by the Swiss Accident Investigation Board

concerning the serious incident (AIRPROX)

involving the Boeing 737-300,
callsign DLH 03K

and the Airbus A319-111 aircraft,
callsign EZY 529Y

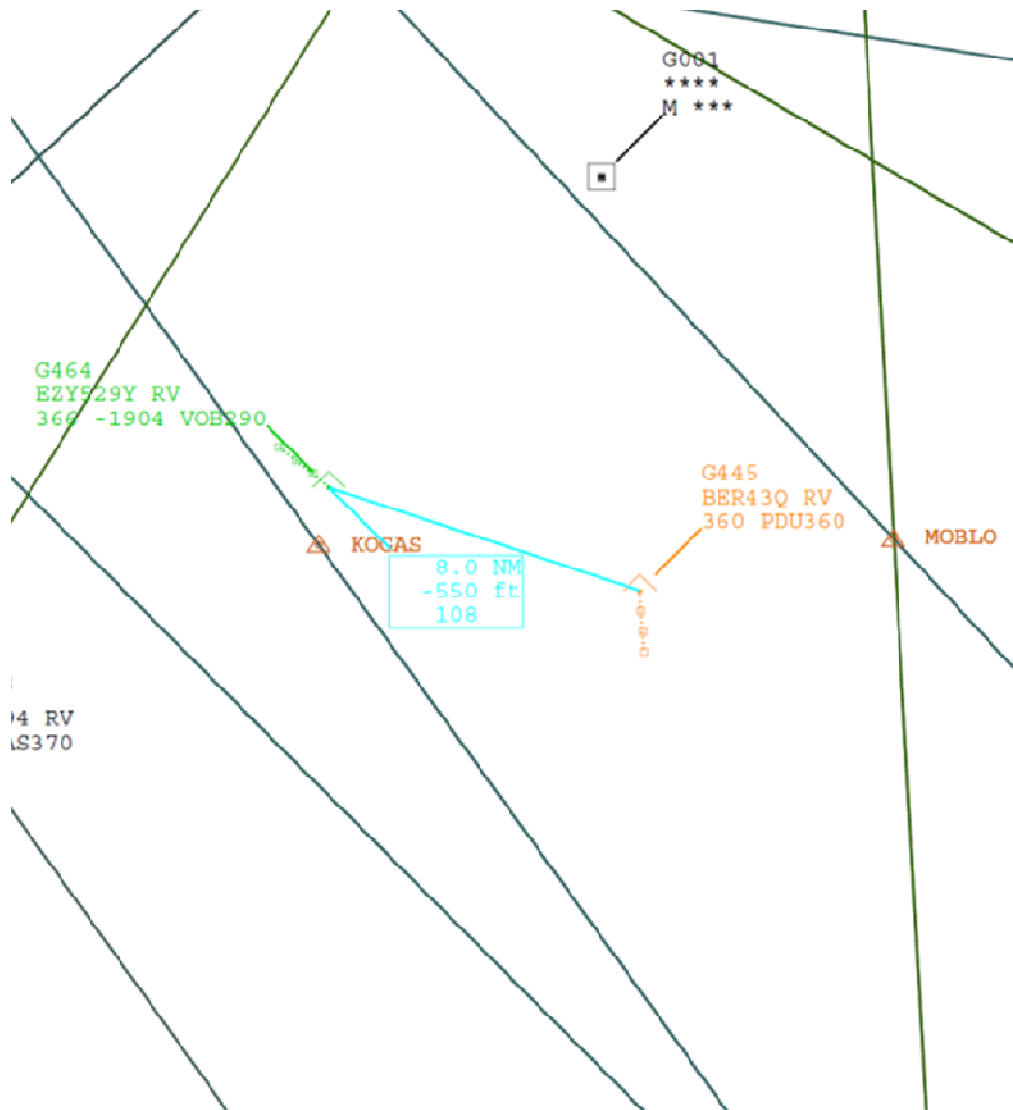
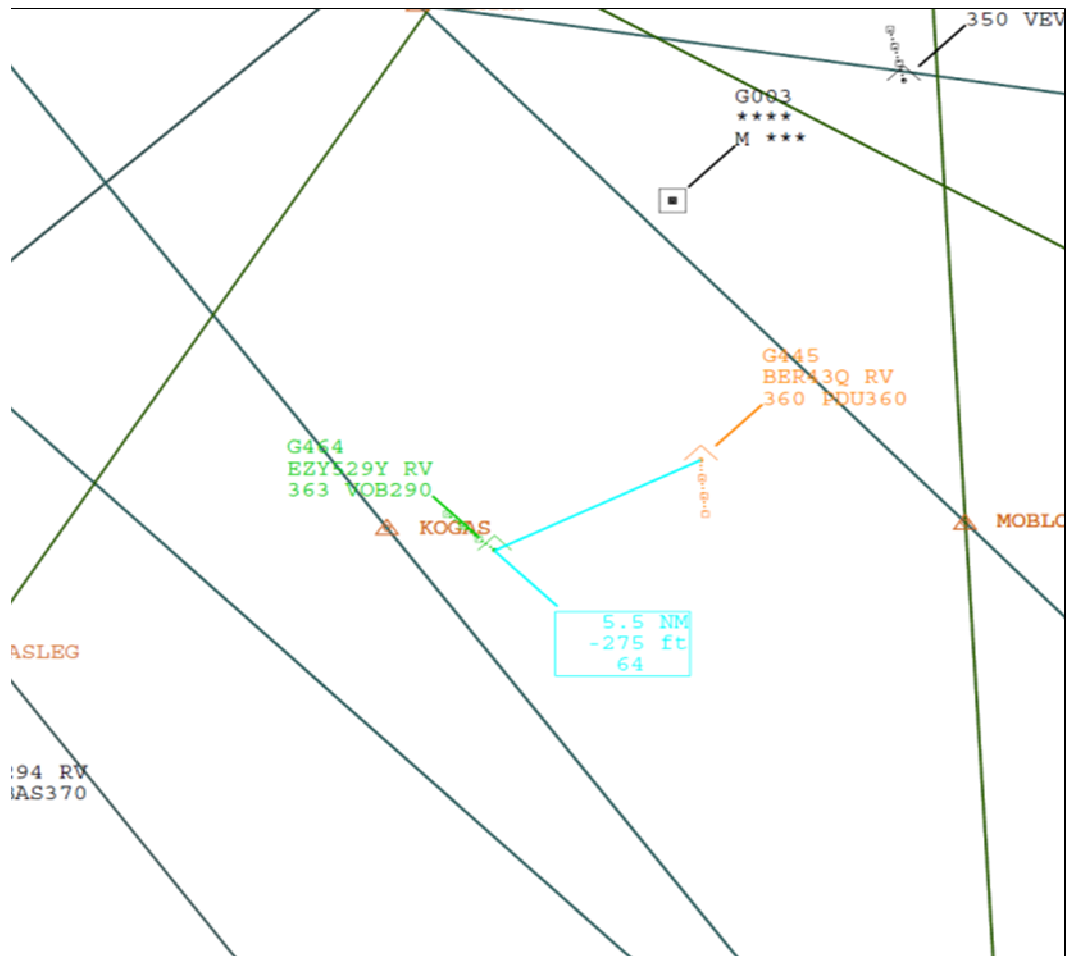
Figure 1

Recording of the radar tracks of flight EZY 529Y and the flight crossing at FL 360, in control sector L56

This traffic situation was not the cause of a loss of separation and did not generate a resolution advisory or an STCA alert.

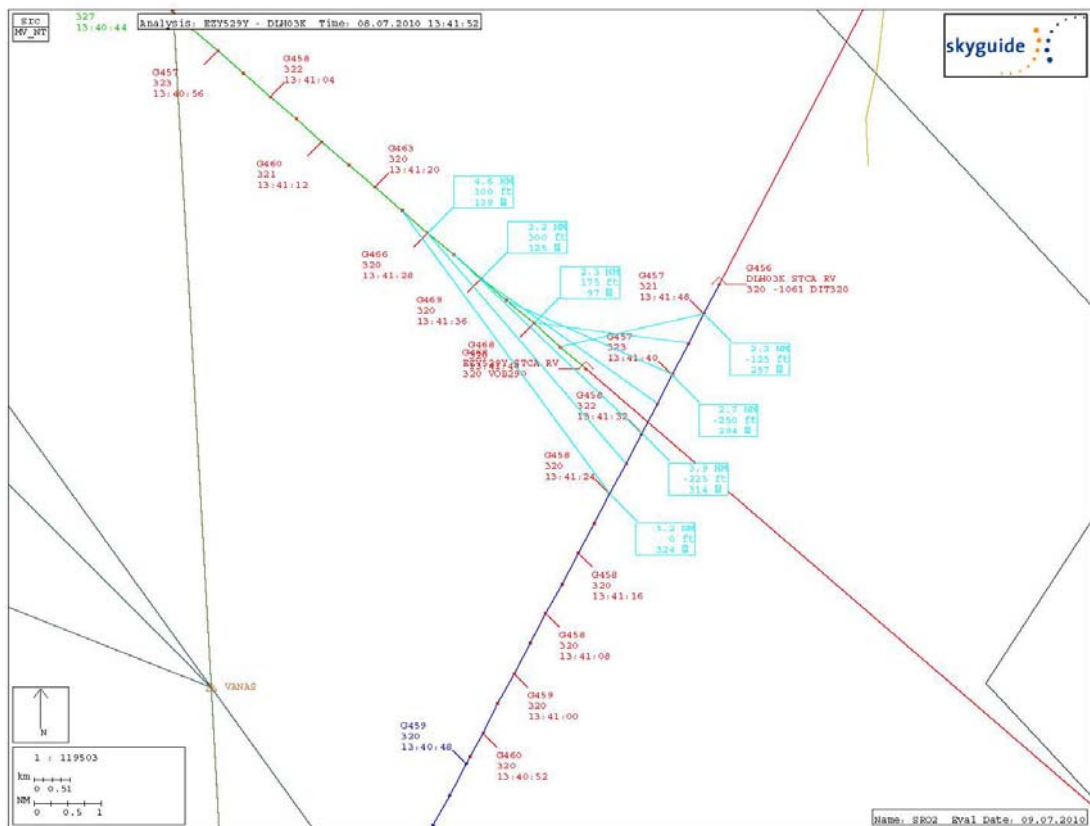
The distances between DLH 03K and EZY 529Y were at their minimum at 13:41:48 UTC; by then the trajectories of the aircraft had already become divergent and the aircraft passed with a lateral distance of 2.2 NM and an altitude difference of 125 feet.

Recording of the radar plots at the moment of the conflict in control sector L 14

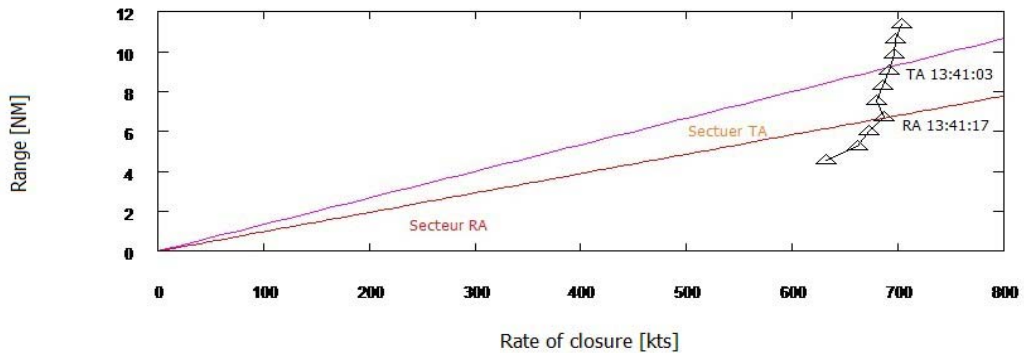
TA/RA RANGE TAU, SL7

Thus it can be determined that at 13:41:03 UTC the conditions for the triggering of a traffic advisory (TA) were met and at 13:41:17 UTC those for a resolution advisory (RA) were met. The conflict occurred 10 seconds later (13:41:27 UTC).

The "TA/RA range tau" and "TA/RA vertical tau" diagrams yield a resolution advisory at the same moment as that detected by the downlink mode S transmission of the DLH 03K transponder (13:41:17 UTC). No alert of this type was recorded for EZY 529Y and its flight crew stated that they had only received a traffic advisory.

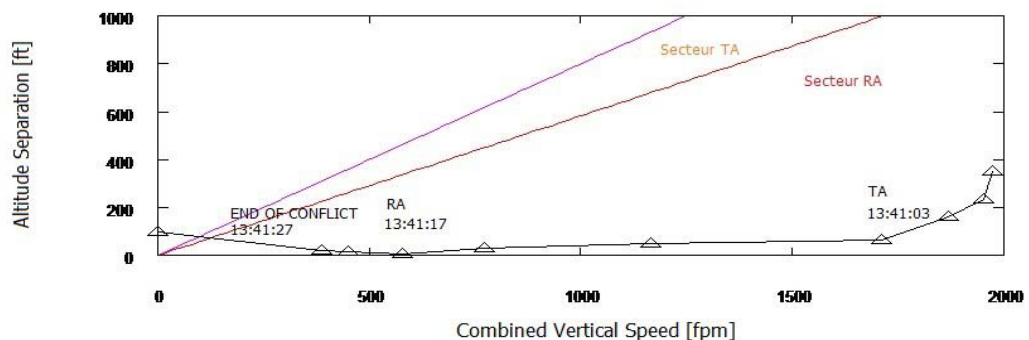
TA/RA VERTICAL TAU, SL 7

In the "TA/RA vertical tau" diagram the geometry of such an encounter is characterised by a curve of the relative positions of the aircraft which is located within the TA/RA sectors but just a few seconds from their cut-offs. The threat

detection logic of TCAS version 7.0 detects these potentially low-conflict convergences and by means of HMD (horizontal miss distance) filters reduces the triggering of RAs in relation to an intruder aircraft with a large distance to the closest point of approach.

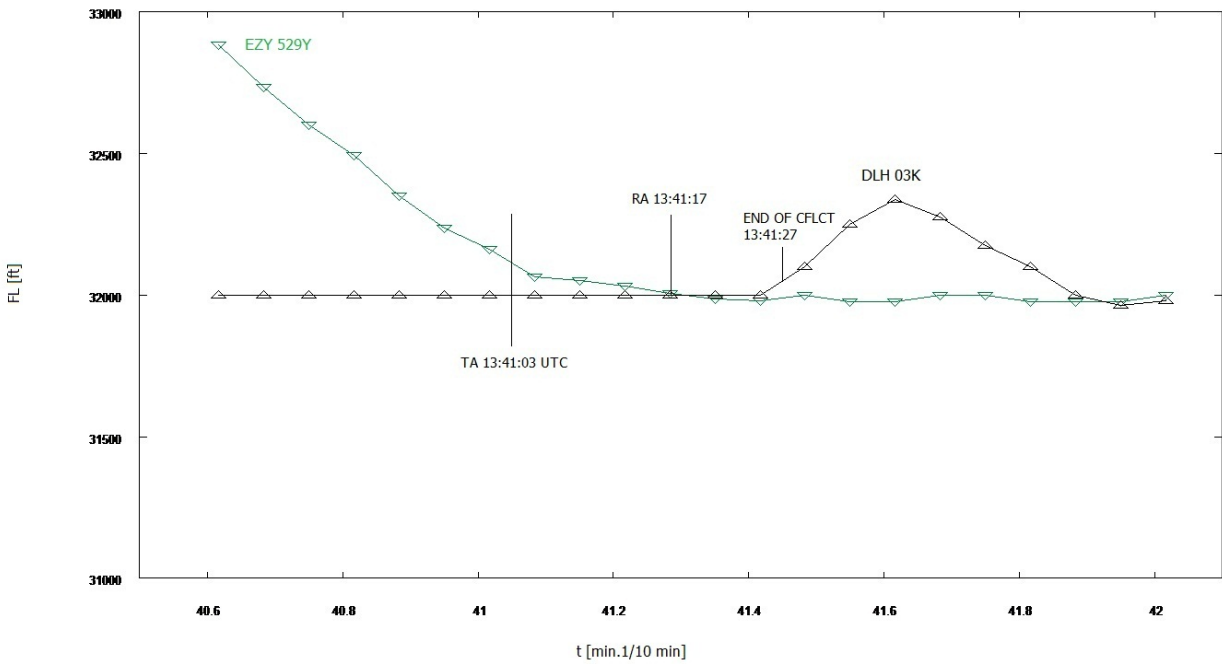
PROFILS DE VOL DE DLH 03K ET EZY 529Y

This particularity is explained by the following two mitigating factors: the flight profile diagram shows that the resolution advisory was issued onboard DLH 03K at the moment when EZY 529Y was acquiring flight level FL 320; complying with it resulted in a rapid divergence of the two aircraft, which were then no longer in conflict. The advisory ceased when DLH 03K had deviated vertically by only about a hundred feet from its cruising level. Subsequently, the plan view shows that the trajectories have a closest point of approach in excess of 2 NM, located after two aircraft crossed.

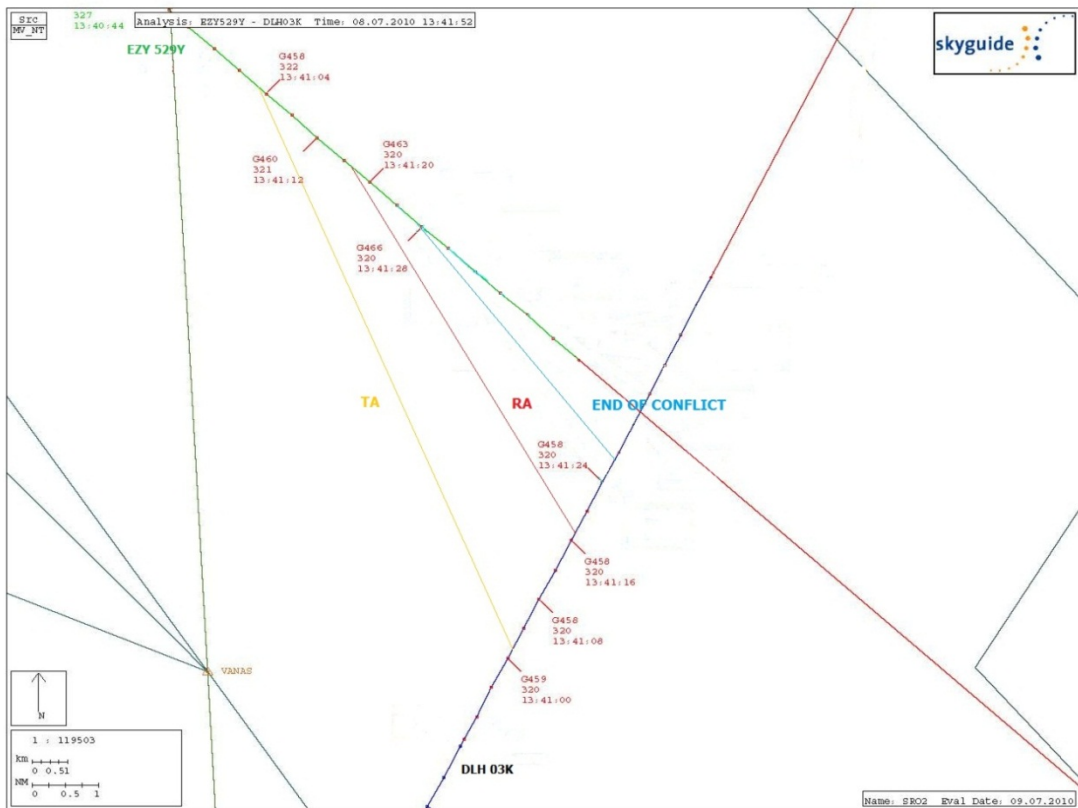
Flight profiles of the conflicting aircraft

Plan view, triggering of the traffic advisories and resolution advisories

The radar data made it possible to establish the flight profiles of DLH 03K and EZY 529Y at the time of the incident; the triggering of the traffic and resolution advisories are shown.
