# **Final Report No. 2146 by the Swiss Accident Investigation Board SAIB**

concerning the accident involving the  
Cirrus SR22 aircraft, registration N467BD

on 22 October 2008

Zurich Airport

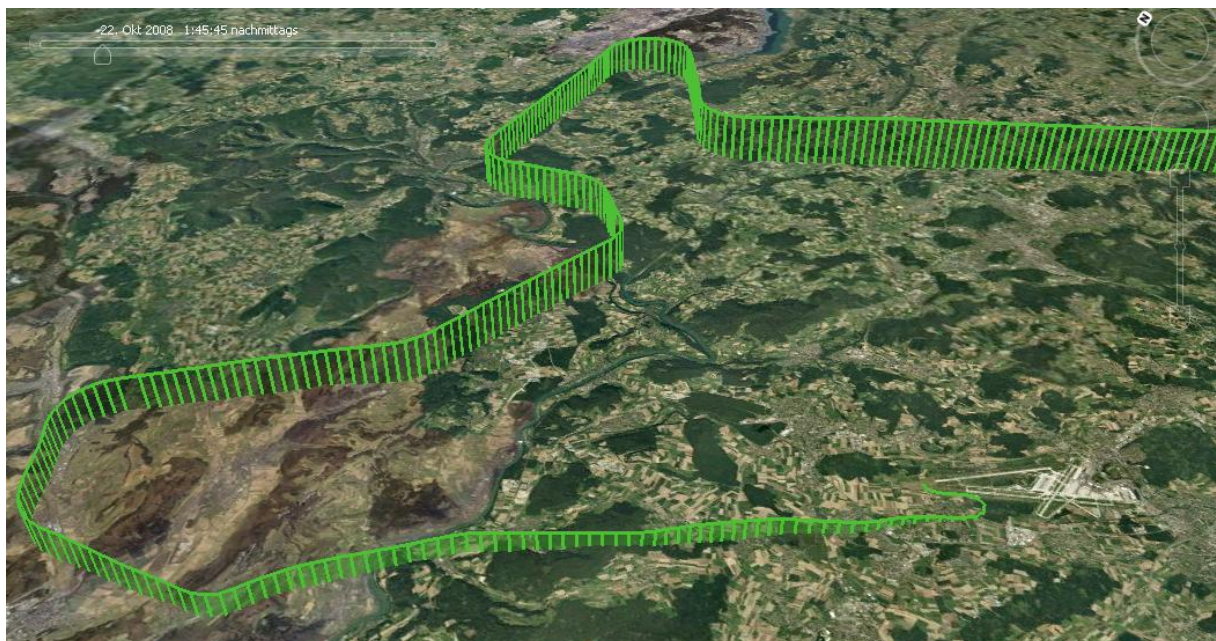
### Annex 2: Flight path according to the PFD recording

The PFD recordings also show that the pilot crossed the approach centre line of the localiser with the autopilot in the ALT – HDG mode. According to the PFD recordings the pilot never armed the approach mode. This failure is occasionally observed if pilots in this phase of flight are under a high workload. This applied to the pilot of the N467BD because some equipment has failed.

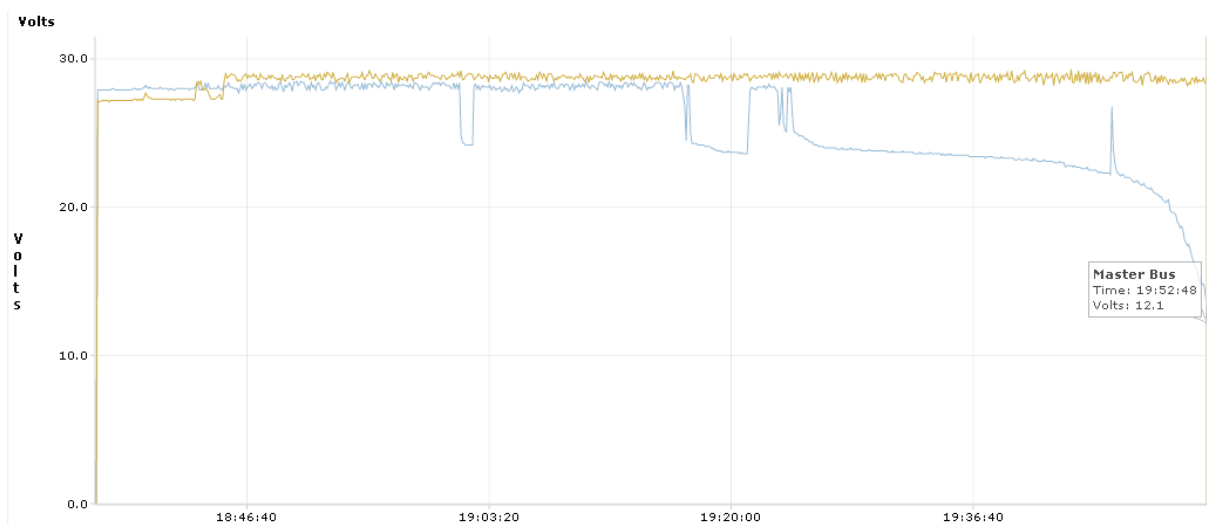
## Annex 6

According to the MFD recording, at the time of the final failure of Alternator 1 at 13:24 UTC the voltage dropped to a value of 24.7 volts within one minute. Twenty-eight minutes later, by which time N467BD was under radar vectors on the left-hand base leg on the runway 14 instrument landing system, the voltage at the main distribution bus reached 16 volts.

In any case specifying a maximum flight time of 45 minutes proved to be too optimistic. At 13:51:54 UTC, approximately 28 minutes after the definitive failure of Alternator 1, the voltage at the main distribution bus dropped to a value of 16.1 volts, at which the MFD display failed in the SAIB test. At this time, N467BD was on the left-hand base leg of the instrument landing system for runway 14, shortly before turning onto the centre line of the final approach. From this point on, due to the failure of the MFD and hence of the CMax, the pilot no longer had any documentation of the approach, i.e. he was lacking key data such as the approach minimums and the description of the go-around procedure.

Unbeknown to the pilot and without relevance to the history of the flight, the voltage at the main distribution bus at 13:52:48 UTC reached the last recorded value of 12.1 volts, at which the recording function of the MFD also failed. At this time, N467BD was on the final intercept heading of 170 degrees and should have followed the localiser of the runway 14 instrument landing system. In this flight phase, the voltage at the main distribution bus may have dropped to a range below 10 volts, due to the power consumption of the devices which were still working – the GNS 430 #2, the transponder and the Garmin 340 Audiopanel, and the pitot heating which may still have been switched on; at this point these units also failed. In the test set-up, the relay which connects Battery 1 to the main distribution bus opened at a voltage of 5.9 volts. However, this value is not relevant, because all of the consumers supplied by the main distribution bus ceased performing their functions even at higher voltages. The pilot was therefore faced with the following situation:

Recording of the voltage at the essential distribution bus (brown, upper) and the main distribution bus (blue, lower, labelled "Master Bus") by the MFD. The times at the bottom of the graph correspond to UTC +6 h. In the box: the last recording was at 13:52:48 UTC, voltage 12.1 volts.

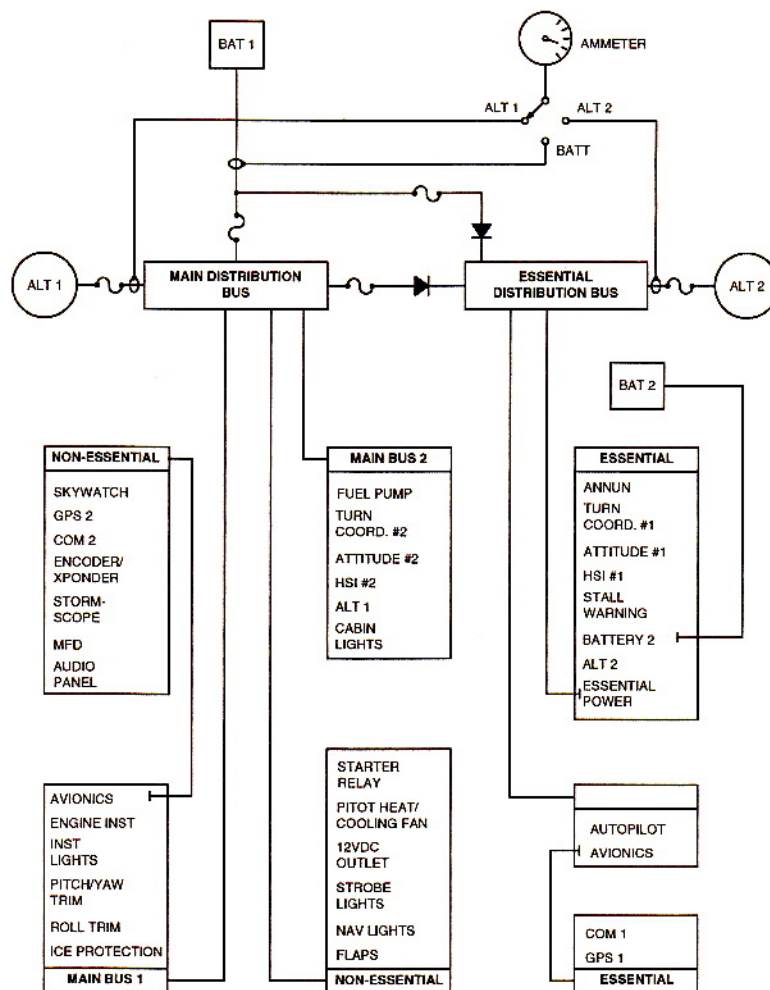
**Figure 3-2**  
**Electrical Power Distribution (Simplified)**

If Alternator 2 fails, the essential distribution bus is supplied via the diode from the main distribution bus and therefore from Alternator 1.

If Alternator 1 fails, the main distribution bus is supplied only from Battery 1, because the diode prevents supply via the essential distribution bus. The essential distribution bus continues to be supplied from Alternator 2. Therefore the electrical consumers connected to the essential distribution bus remain fully available in the case of a failure of Alternator 1 and a possible discharged Battery 1.

The following systems supplied from the main distribution bus were failing or had already just failed (cf. Appendix 7, a non-exhaustive list):

- MFD
- Garmin GNS 430 #2 (COM 2/NAV 2/GPS 2)
- Transponder
- Garmin 340 audiopanel with intercom
- Flaps
- Electrical trim, in which context it should be noted that no manual trim is available on the SR22 aircraft,
- Pitot heating
