# **Final Report No. 2147 by the Swiss Accident Investigation Board SAIB**

concerning the accident involving the  
Cirrus SR20 aircraft, registration HB-KHA

on 2 July 2006

in Val Tremola, Airolo/TI municipalit 

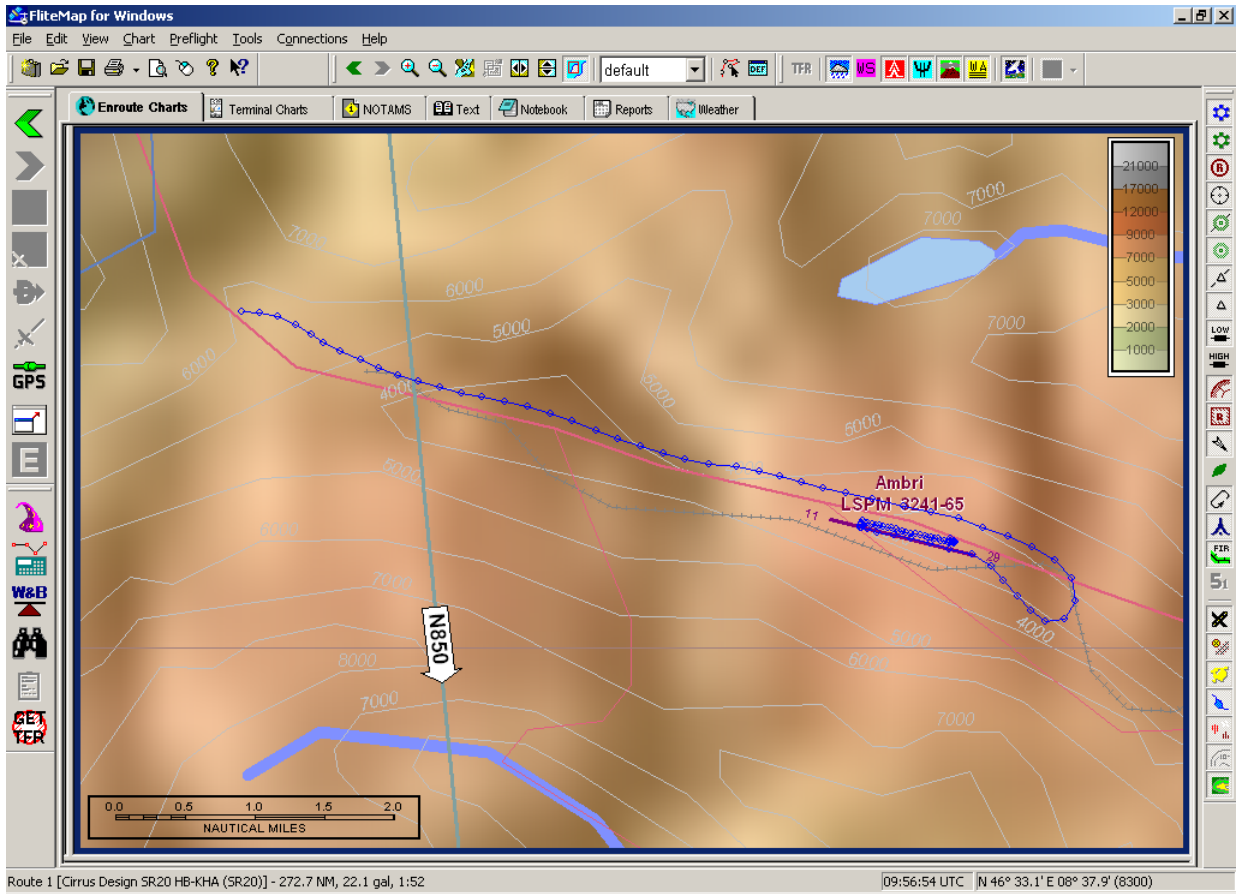
Annex 1

The flight path of HB-KHA is shown on the MFD by the blue dotted line.

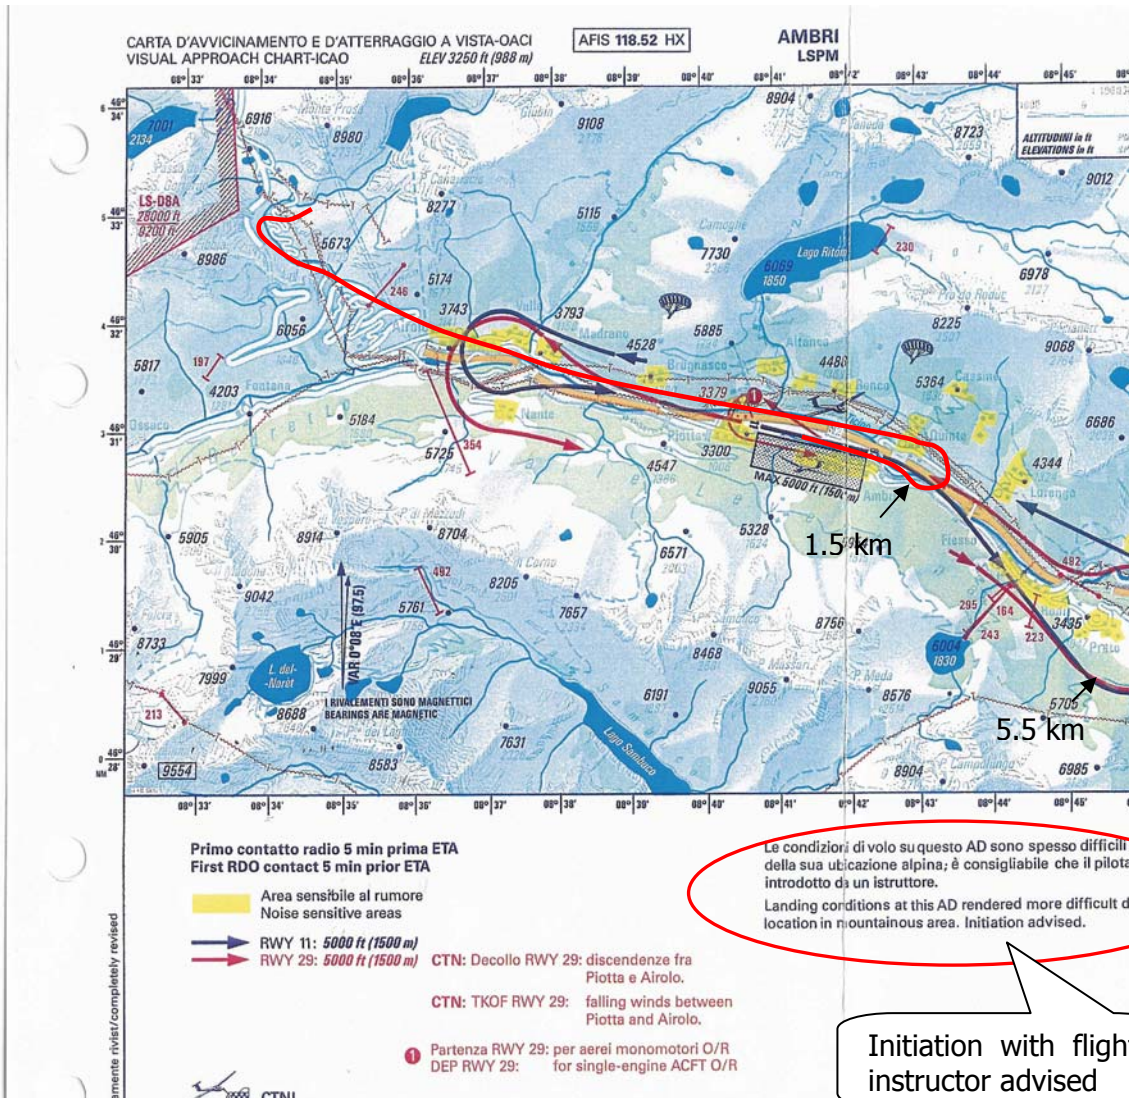
Annex 2

On 2 July 2006, the pilot took off in the single-engine Cirrus SR20 aircraft, registration HB-KHA, at 15:09 LT from runway 11 of Ambri aerodrome. After take-off the pilot made the first turn earlier than published in the VAC when he turned left in the direction of the Gotthard pass approximately 1.5 km after the end of the runway (cf. Annex 2).

The flight path of HB-KHA is shown in red on the VAC Ambri approach chart.

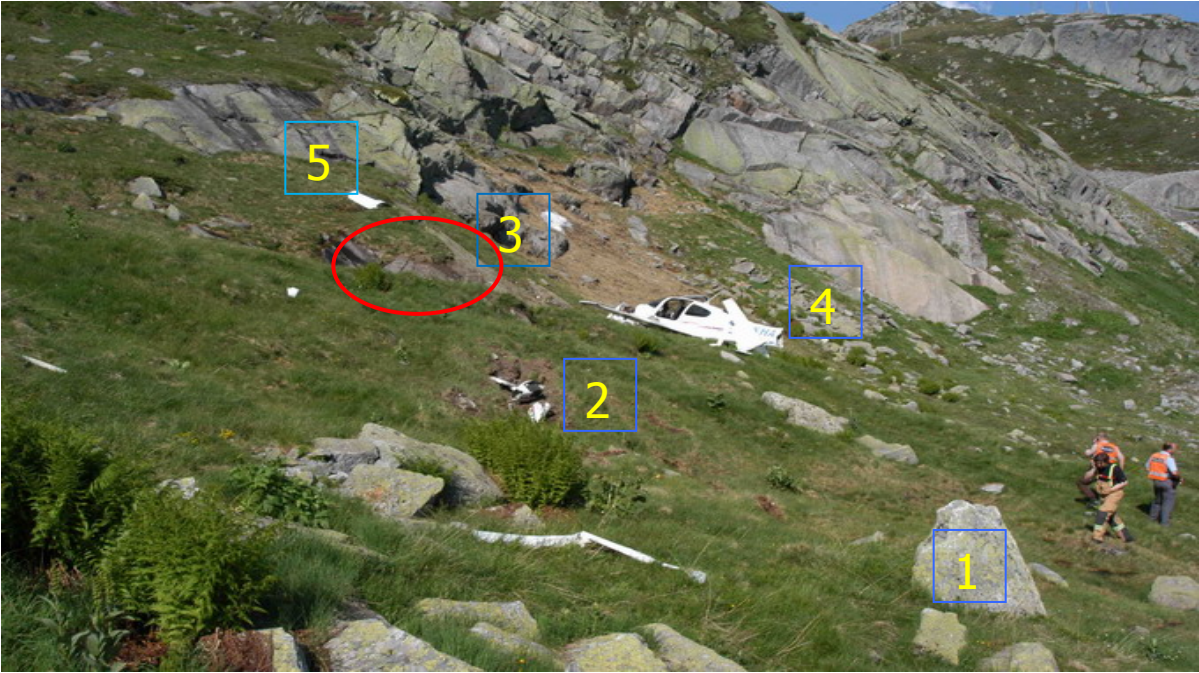
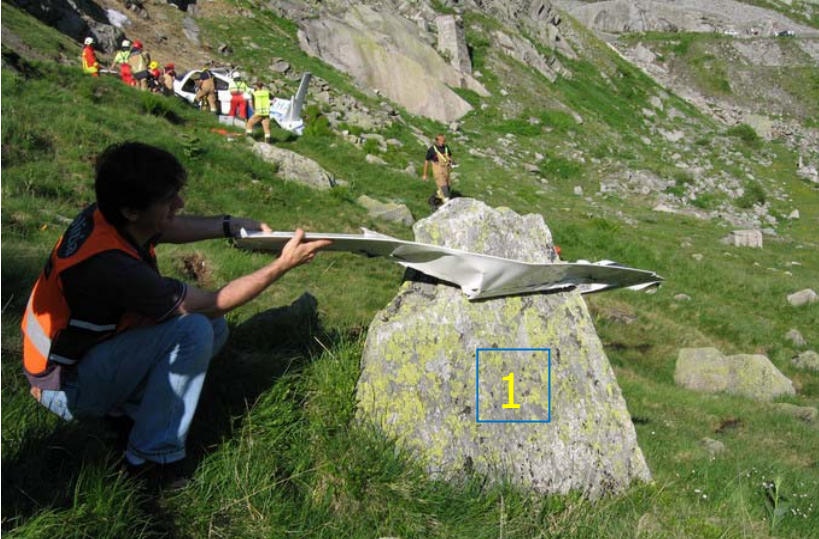
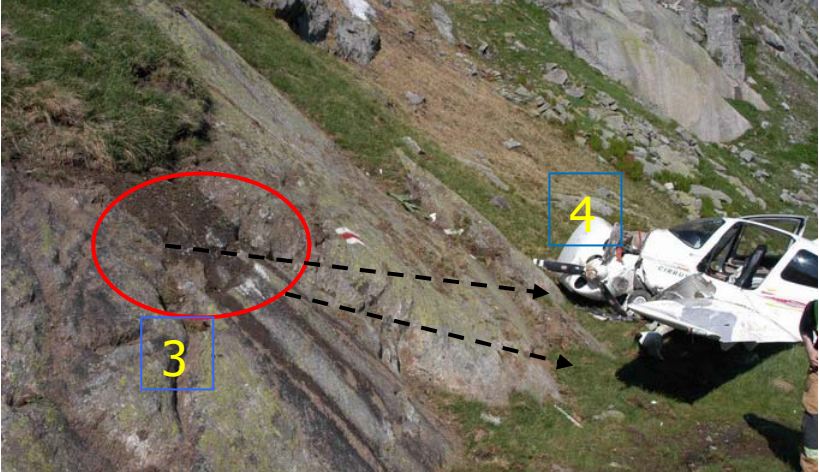
Annex 4

On impact with the rocky slope, the aircraft was pitched up and was banked approximately 30° to 40° to the right. First, the right elevator surface came into contact with a rock and the corresponding trim tab was torn off. Five metres further on, the main landing gear touched the ground for the first time; 25 metres further on the aircraft collided with a rock wall before slipping back approximately five metres and a few metres to the right.

- 1 First contact with the elevator
- 2 Contact, main landing gear
- 3 Impact, rock wall
- 4 Final position
- 5 Left door
