Schlussbericht Nr. 2148 der Schweizerischen Unfalluntersuchungsstelle SUST

über die möglichen Gefährdungen von
Rettungs- und Untersuchungsorganen
durch ballistische Fallschirmrettungssys-
teme (*Ballistic Parachute Systems – BPS*)
in Flugzeugen

Thermal behavior of BRS 440 and BRS 601 rockets

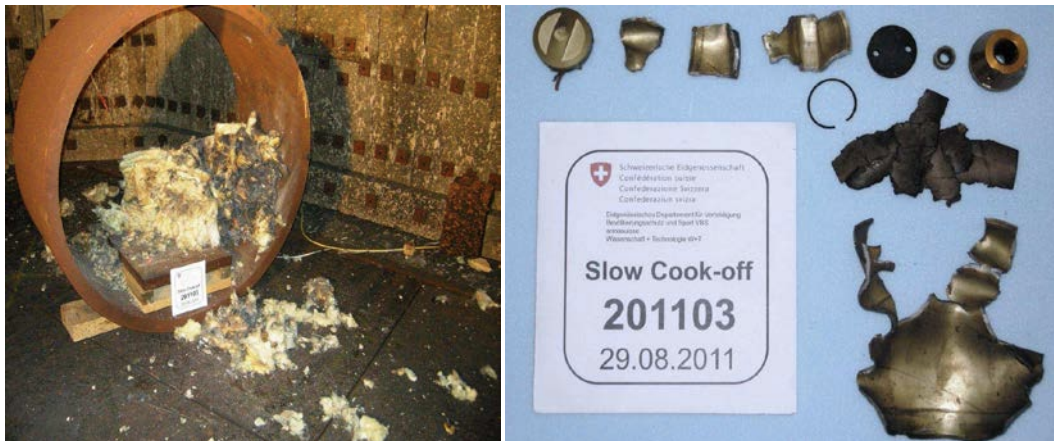
Abbildung 12: Resultat des Tests und Fragmente

Bei beiden getesteten BRS-601 Raketen kam es nach 43 resp. 69 Sekunden zu einer heftigen Reaktion in Form eines schnellen Abbrandes bzw. Explosion. Alle Explosivstoffe der Anzündeinheit und des Raketenmotors haben sich vollständig umgesetzt. Durch die Wucht der Reaktion wurde der Raketenmotor beim Test von der Halterung losgerissen und hat das im Abstand von 2 m aufgestellte 2 mm starke Aluminiumzeugenblech durchschlagen.

Bei dieser Reaktion handelt es sich um eine Explosion bei welcher das Aluminiumgehäuse des Raketenmotors in einzelne wegfliegende Fragmente zerlegt wurde.

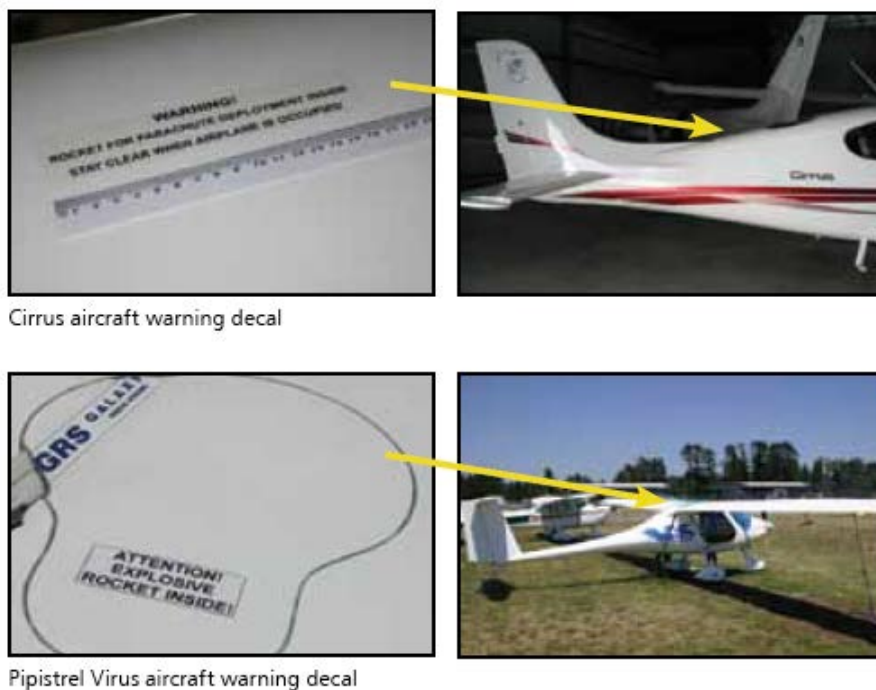
Abbildung 13: Zurzeit gültige Identifikationen von BPS-Flugzeugen

Zurzeit sind BPS-Flugzeuge mit einem kleinen dreieckförmigen Kleber mit einer Seitenlänge von ca. 40 mm versehen. Der Kleber warnt vor den Gefahren, welche von einem BPS ausgehen und gibt der Rettungsmannschaft den Hinweis, vor Aufnahme der Rettungsarbeiten am Wrack die auf dem Kleber aufgedruckte Telefonnummer in den USA anzurufen.

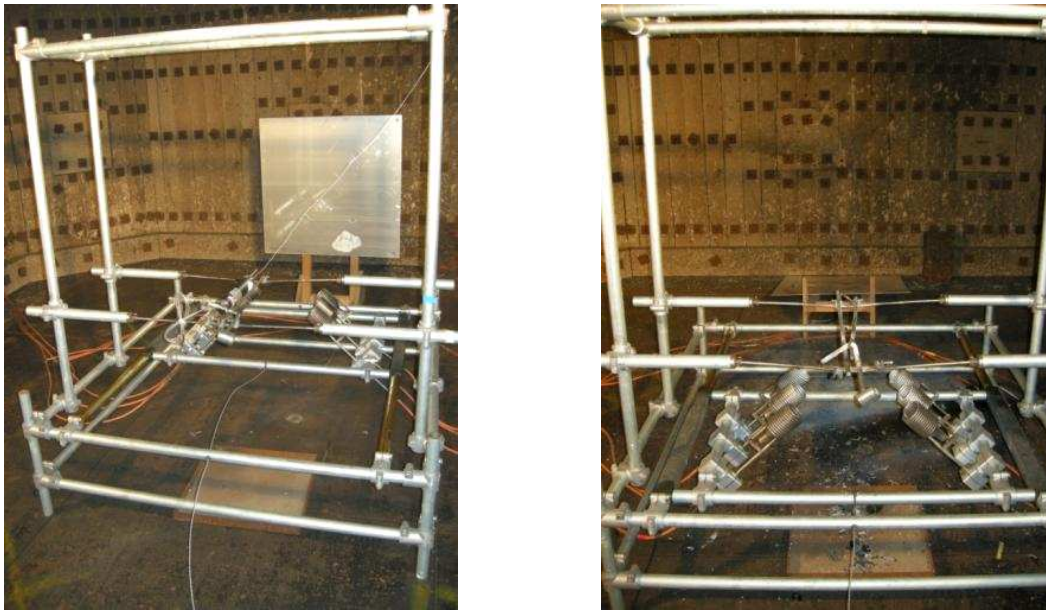
Test Nr. / Rocket	Mean Temp. [°C]	Time to Reaction [s]	Type of Reaction ¹	Remarks
V01/ BRS 440 Nr. 2	1045	145	Type V-IV Fast burning towards deflagration	End cap was axially ejected out of the rocket casing with high velocity. The main part of HTPB cylinder of the rocket motor did not react. Both percussion cups of the Igniter did not react.
V03/ BRS 440 Nr. 3	1085	129	Type V-IV Fast burning towards deflagration	The end cap was axially ejected out of the rocket casing with high velocity. One wire cut and the second wire almost cut. No unreacted rocket motor parts left. Igniter including primary booster remained unreacted.
V02/ BRS 601 Nr. 1	1050	43	Type V-IV Fast burning towards deflagration	The rocket was axially ejected apart from the fixation and penetrated the 2 mm thick aluminum witness plate (see Fig. 7). The outer casing of the rocket was ejected to the opposite witness plate which resulted in a crack into the plate. All parts of the rocket motor and igniter did react.

Fig. 4: FCO test V01 of BRS 440; before (left) and after the test (right).

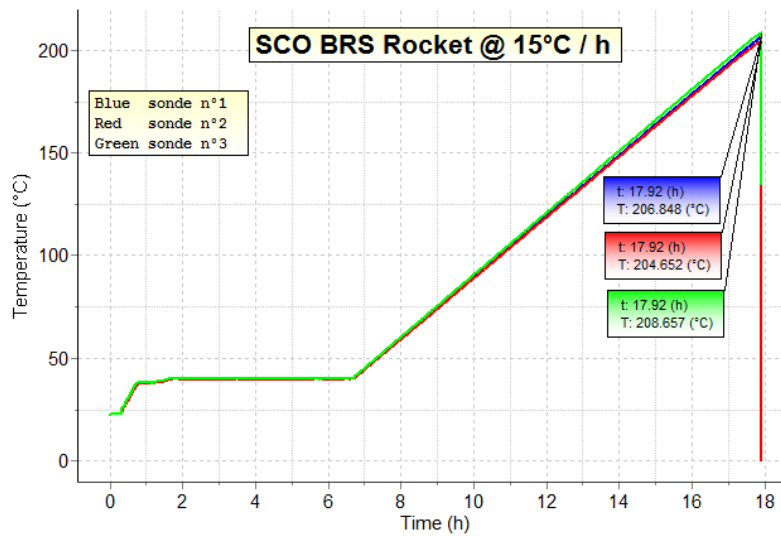
Fig. 9: SCO heating curves for the BRS 440 rocket at 15°C per hour.

The violent reaction corresponds to a type IV – III started after 18 hours at a temperature of around 207°C. The differences in temperature between the three probes originate most probably by the geometry of the rocket and the heating system which is not fully symmetrically.

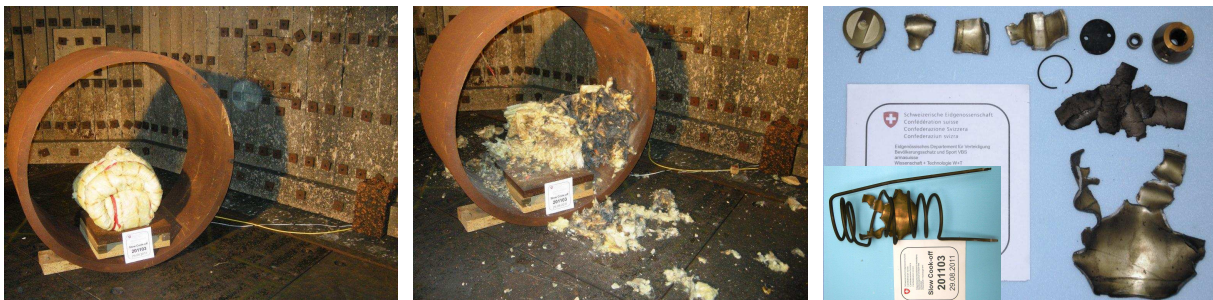
Fig. 10: SCO of the BRS 440 rocket; respectively before and after test and the fragments.

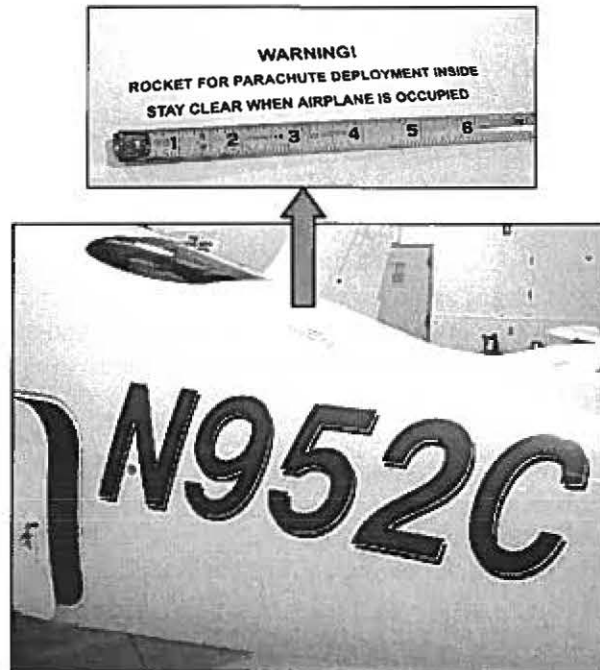
Figure 1. CAPS warning label for Cirrus SR20 and SR22 airplanes

accompanied by a safety alert symbol,¹³ that advises readers of the hazard and is written in black letters against an orange background. The second panel should contain a message that informs readers of the consequences of not taking precautions to avoid the hazard and provides instructions for avoiding the hazard.¹⁴ ANSI Z535.4 also states that the message panel should be legible from a minimum safe viewing distance. Finally, the third panel should contain a safety pictorial that rapidly conveys information about the nature and consequences of the hazard to people who do not or cannot read the message panel.
