Schweizerische Unfalluntersuchungsstelle SUST
Service d'enquête suisse sur les accidents SESA
Servizio d'inchiesta svizzero sugli infortuni SISI
Swiss Accident Investigation Board SAIB

Final report No. 2148

On potential risks of ballistic parachute systems (BPS) in aircraft to rescue and investigation crews

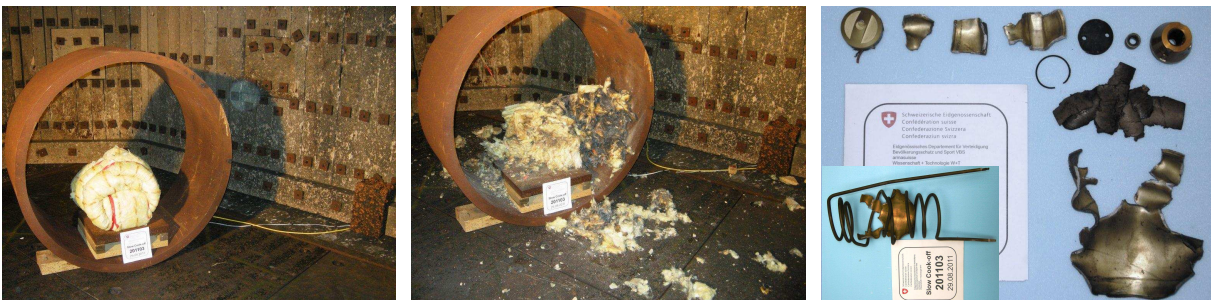
Fig. 10: SCO of the BRS 440 rocket; respectively before and after test and the fragments.

The violent reaction corresponds to a type IV – III started after 18 hours at a temperature of around 207°C. The differences in temperature between the three probes originate most probably by the geometry of the rocket and the heating system which is not fully symmetrically.

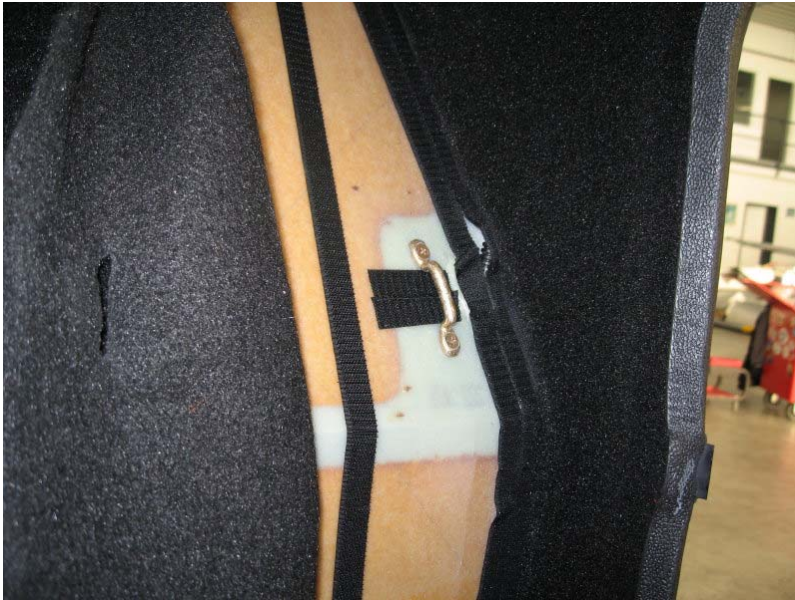
Kabelzug sichtbar
