# **Final Report no. 2150 of the Swiss Accident Investigation Board, SAIB**

concerning the accident involving the  
Piper PA46-500TP Meridian aircraft,  
registration N747AW

on March 8, 2011

on the aerodrome of  
Lausanne-La Blécherette (LSGL) / VD

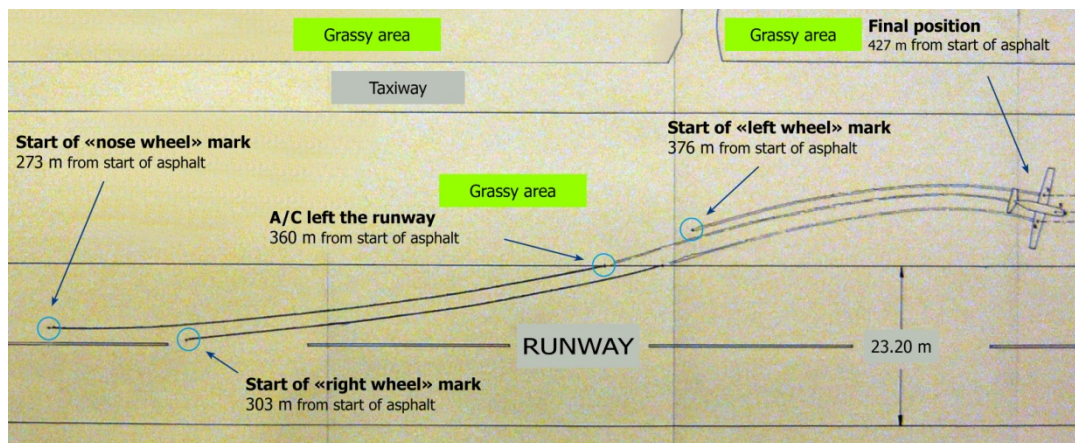
Fig. 1a: Wheel marks found on the runway and grass area

- The check recommended by the manufacturer in case of steering difficulties was not carried out.
- The nose wheel and the right main wheel left marks on the runway.
- The meteorological conditions played no part in the history of the accident.

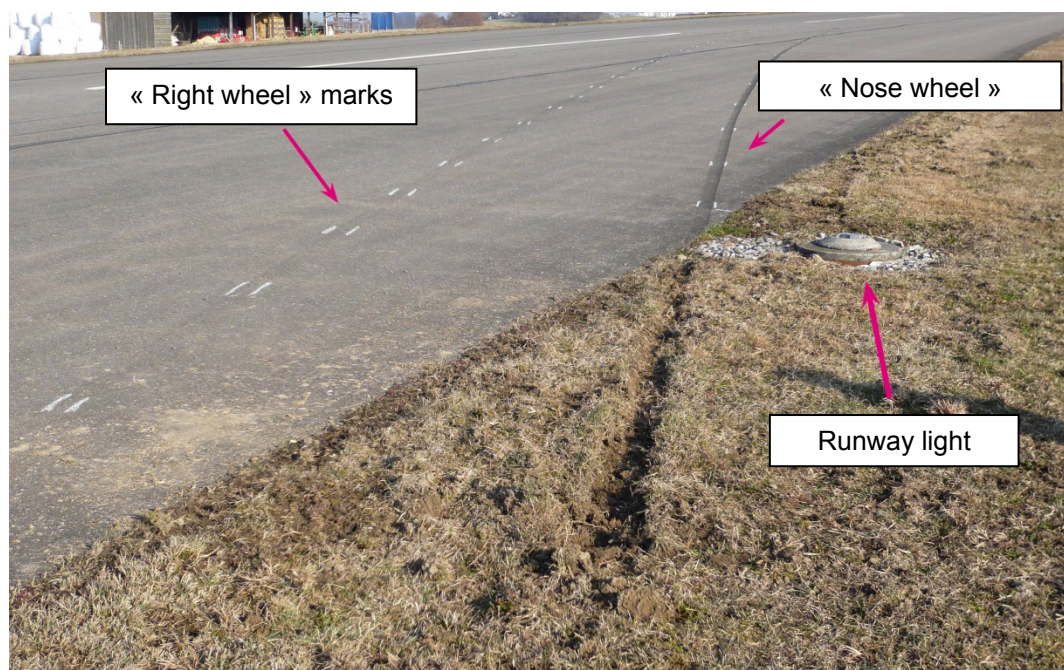
Fig. 1b: Details of the wheel marks

The front tyre treads exhibited asymmetric wear and one of the ridges of the profile was missing. The tyre exhibited very pronounced wear on the right outer edge. This friction wear shows that the wheel in its maximum left position while still turning skidded on the runway. This matches the marks found on the runway.

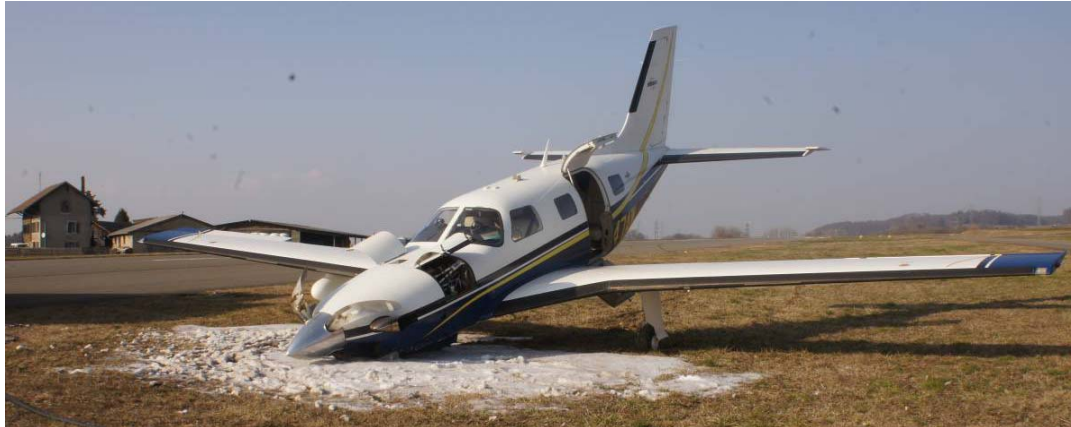
The nose gear leg collapsed and folded under the fuselage. Damage was found on the front of the fuselage and on the nose gear doors.

The four propeller blades were damaged on their leading edges and were bent backwards, indicating that reverse mode had not been activated when the aircraft left the runway. The turbine was badly damaged by the impact. An oil leak caused minor pollution of the ground.

Fig. 2: Final position of aircraft N747AW

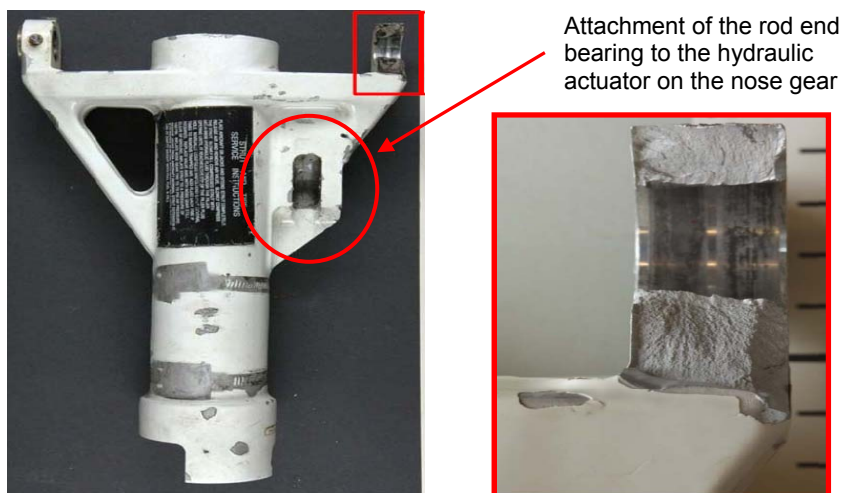
The upper part of the right trunnion assembly on the turbine-mounting frame was fractured (Fig. 3). The actuator rod end bearing fractured on the gear leg side (Fig. 4). These fractures were inspected and analysed using macroscopy. As a result of a shock, the rod end of the hydraulic actuator fractured on its attachment to the trunnion. The expert analysis revealed no evidence of material fatigue.

Fig. 3: Attachment of the actuator and fracture of the right attachment of the trunnion assembly with its detail

The macroscopic examinations of the fractures to the rod end bearing of the hydraulic actuator and the right mounting of the trunnion assembly indicated that these fractures occurred when the aircraft left the runway at Lausanne-La Blécherette. Expert analysis revealed no evidence of metal fatigue.

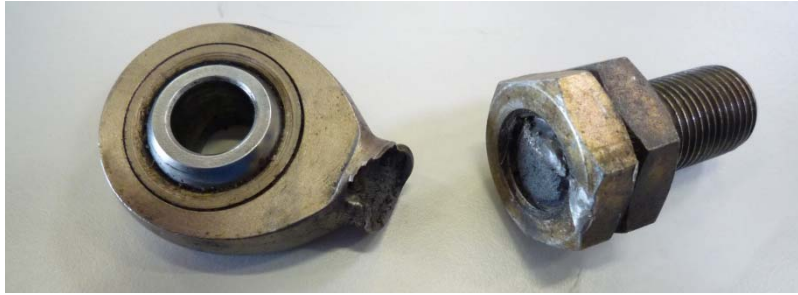
**Fig. 4:** Rod end bearing of the nose gear actuator

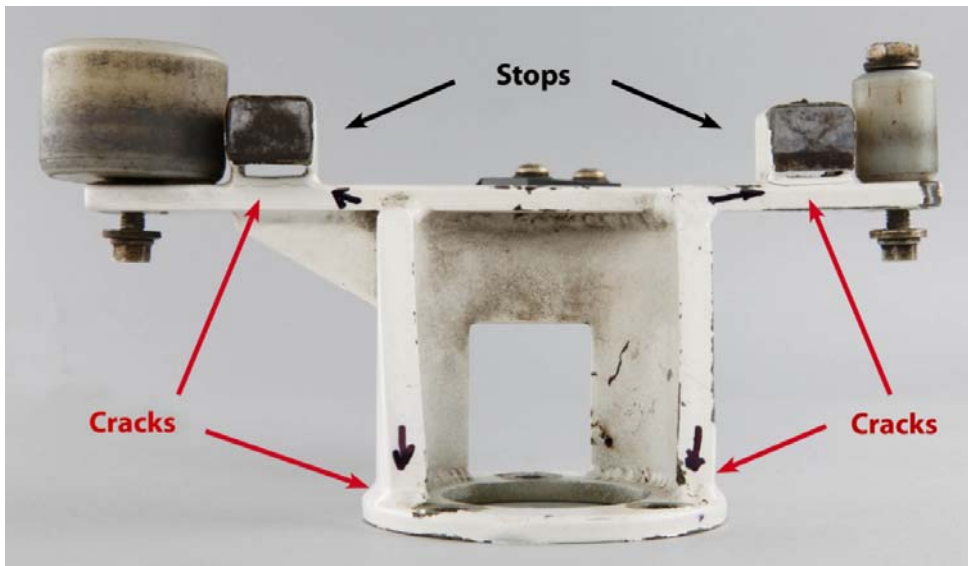
Several defects were found. The steering horn, mounted on the upper part of the gear, exhibited multiple cracks on the two stops and on the mounting plate. The fixing screws of the nylon guide rollers were slightly bent. The counterpart of the steering horn, the arm assy shows marks caused by the stops and the nylon guide rollers (Fig. 6). Some bushes of the torque link mounting shafts (Fig. 7) were cracked.

**Fig. 5:** Steering horn with the nylon guide rollers

The cracks on the stops of the steering horn, the deformations of the fixing screws of the nylon rollers transmitting the movements of the steering pedals and the marks on the arm assy, attest to the stresses to which the entire steering system had been subjected. The collapse of the gear towards the rear increased the distance of the steering horn from the arm assy (see Figs. 6 and 7). The anomalies are therefore not attributable to the aircraft leaving the runway and consequently predate it. The last technical intervention on 22 November 2010 did not reveal any defects. The latter therefore probably occurred between 22 November 2010 and the day of the accident. They may have produced excessive play in the nose gear steering system.

The observed anomalies were probably caused during hard landings on the nose wheel. On 7 February 2011 such a landing occurred with aircraft N747AW on Saanen aerodrome.

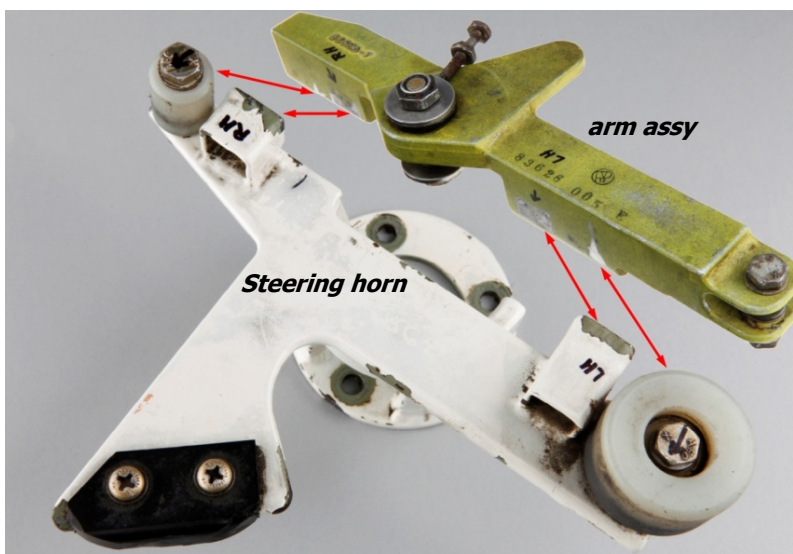
**Fig. 6:** Steering horn with nylon guide rollers and his counterpart arm assy

Two nylon rollers (Figs. 5 and 6) are mounted on the upper part of the nose gear, on the steering horn. They are used to transmit the movement of the rudder pedals to the front wheel. When the nose gear is extended and locked, these two rollers press against the arm assy. Excessive play between the rollers and the arm assy allows the front wheel to oscillate which may lead to steering difficulties.

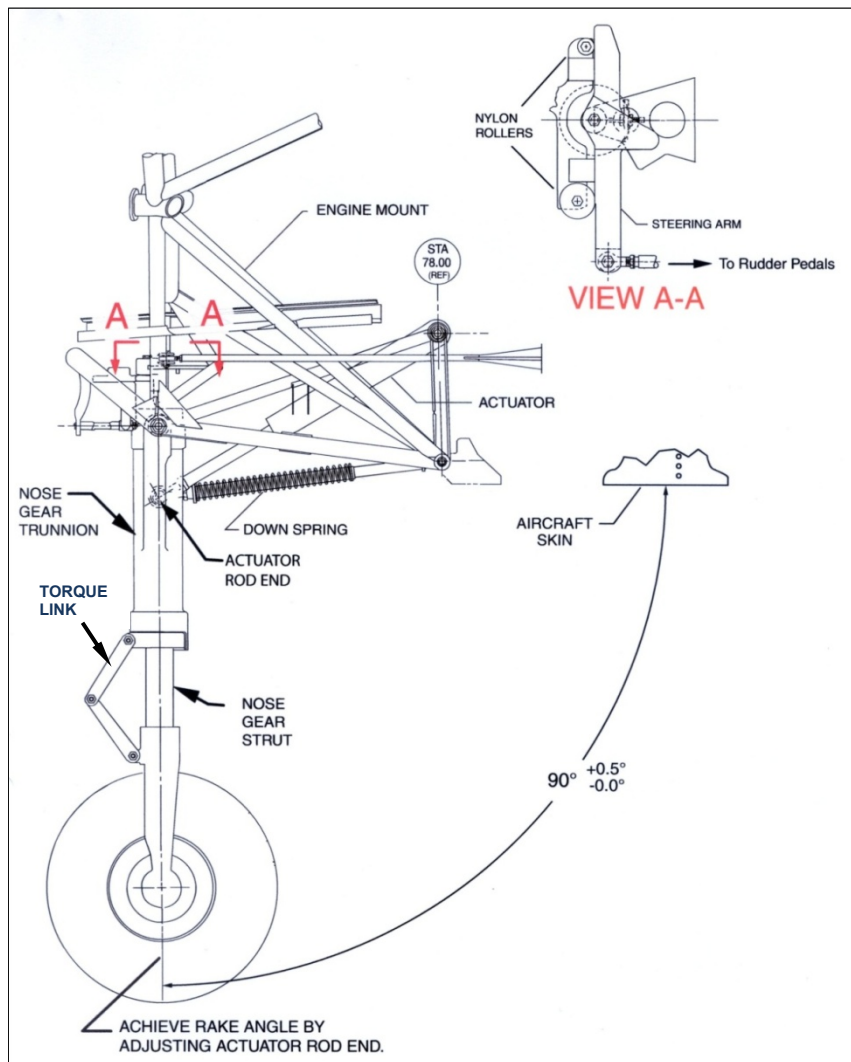
Fig. 7: Nose gear of the Piper PA46-500TP, view from the left

Section 32-20-00 of the maintenance manual specifies a rake angle of  $90^\circ$  with a tolerance of  $+0.5^\circ / -0.0^\circ$  for the adjustment of the angle between the extended nose gear and the underside of the fuselage (Fig. 7).

Because of the damage sustained during the accident, the angle of  $90^\circ$  could not be verified.
