Final Report No. 2153 by the Swiss Accident Investigation Board SAIB

concerning the accident involving the
Agusta helicopter A109K2,
registration HB-XWM

on 24 November 2009

at the former Airport
Interlaken / BE

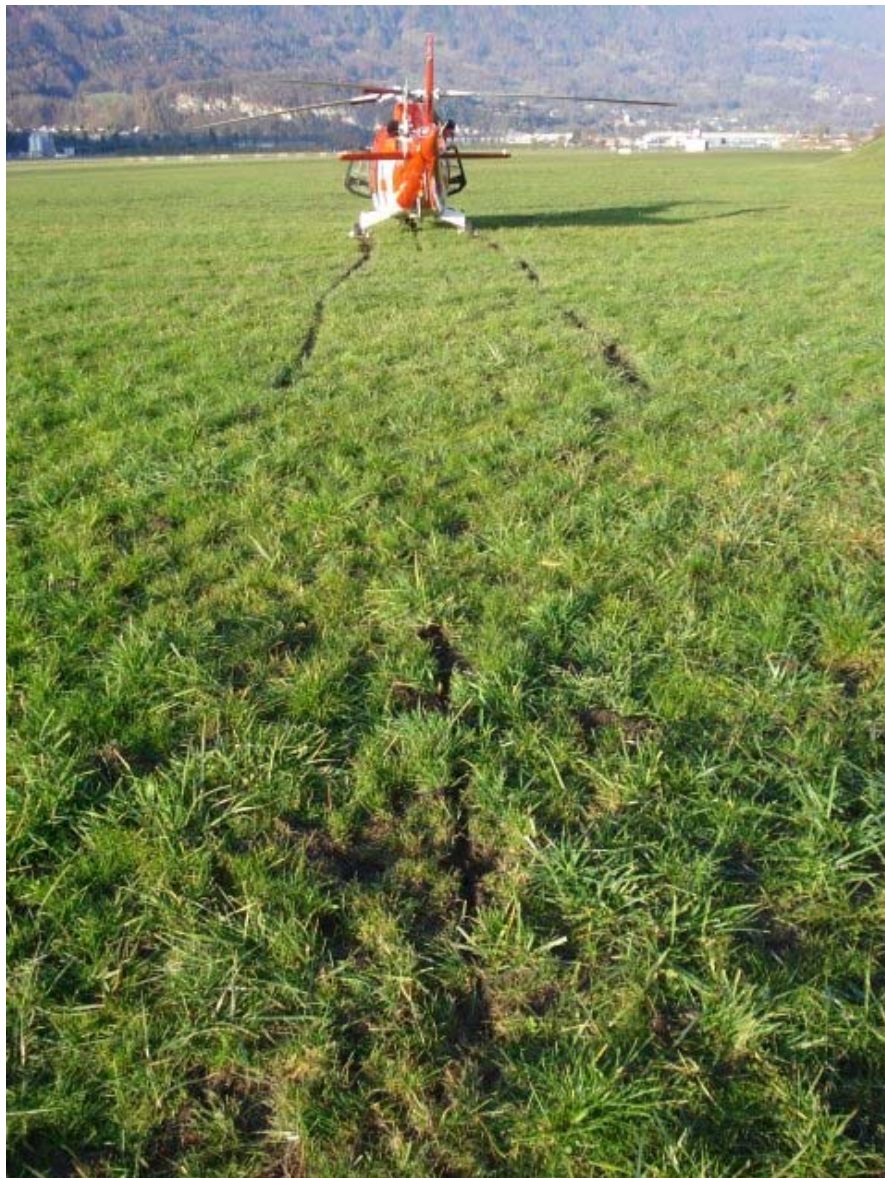
As the helicopter neared the ground, it began to pitch up somewhat. It then made an uncontrolled landing with a forward speed of about 40 kt on the grass in an approximately horizontal attitude. The tail rotor protection bracket contacted the ground.

Fig 1: Final position of the helicopter and traces on the ground

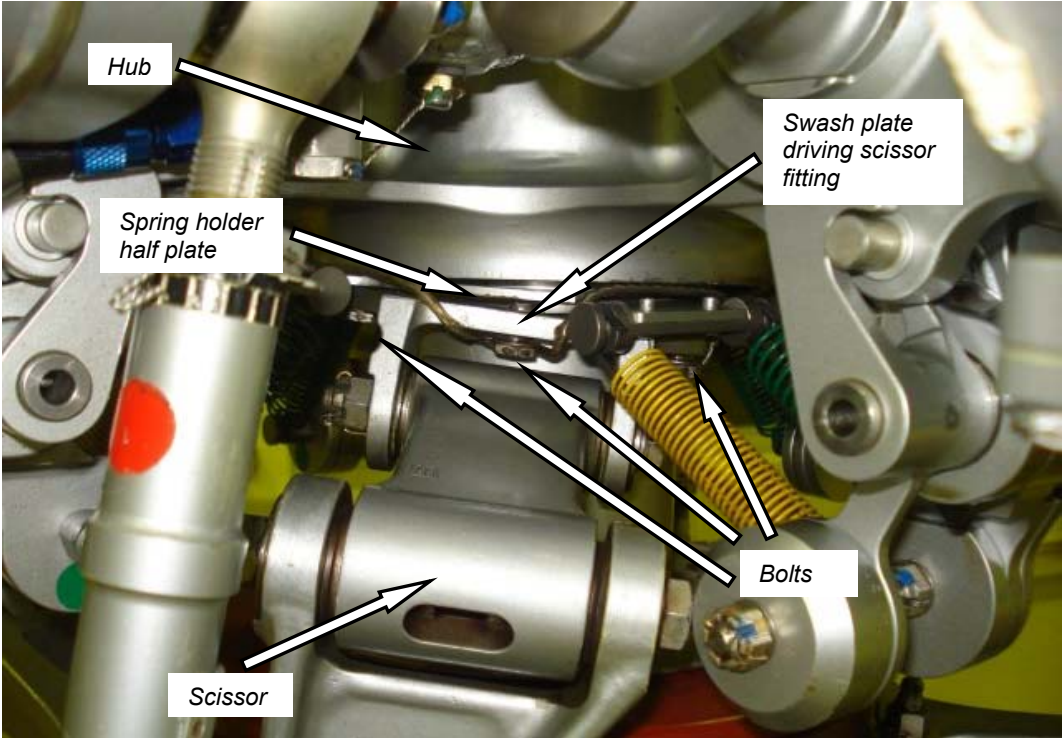
Two of the three bolts fixing the swash plate driving scissor fitting to the hub of the main rotor head were fractured. The third bolt was bent.

Fig 4: View of main rotor head with fractured bolts

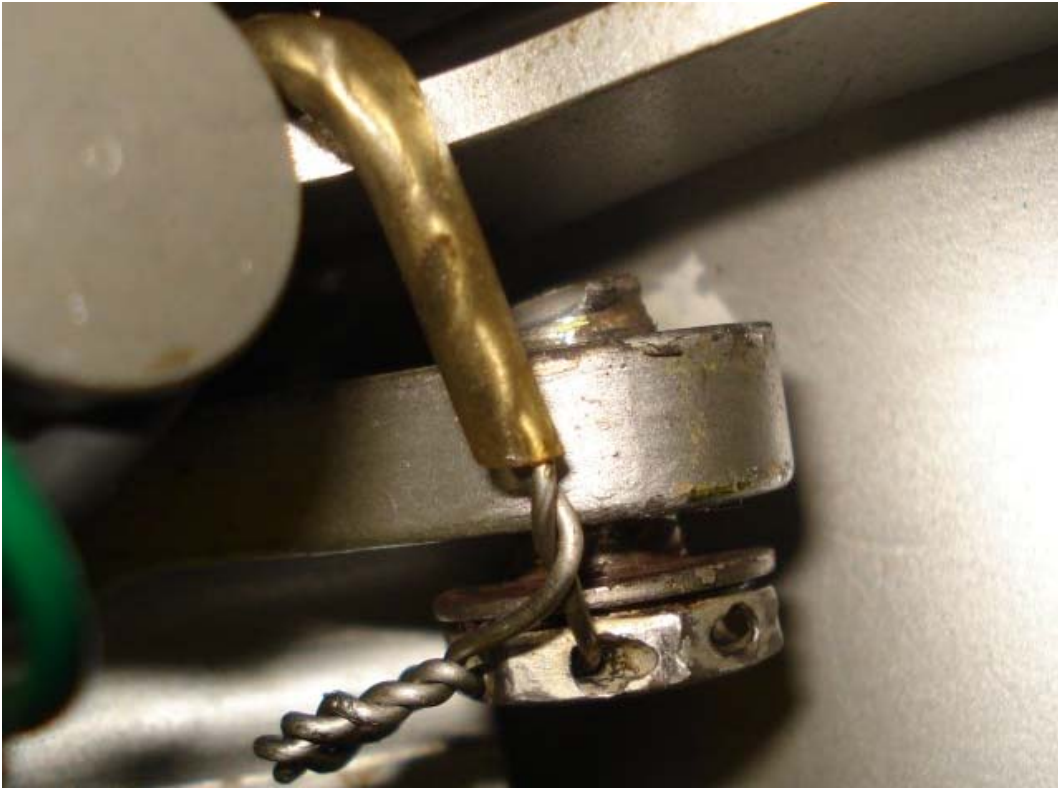
Fig 5: View of fractured bolt in situ

The reason for the fracture of the bolts was that, during the overhaul of the main rotor hub, the bolts that fixed the swash plate driving scissor fitting to the hub had been installed with only **one** washer.

As a result, despite correct tightening torque, the swash plate driving scissor fitting was connected with inadequate clamping force to the main rotor hub assembly, and, as a result, that the operating forces between the helicopter control system and the swash plate driving scissor fitting were transferred to the hub by the bolts and not by clamping friction as designed.

In collaboration with the manufacturer, immediate measures were taken to ensure that the swash plate driving scissor fitting fixing bolts were replaced on all rotor heads and reinstalled with **two** washers. This was to permit immediate continued operation of the fleet before the corresponding alert service bulletin and the urgent emergency airworthiness directive were issued by EASA. See Annexe 4.

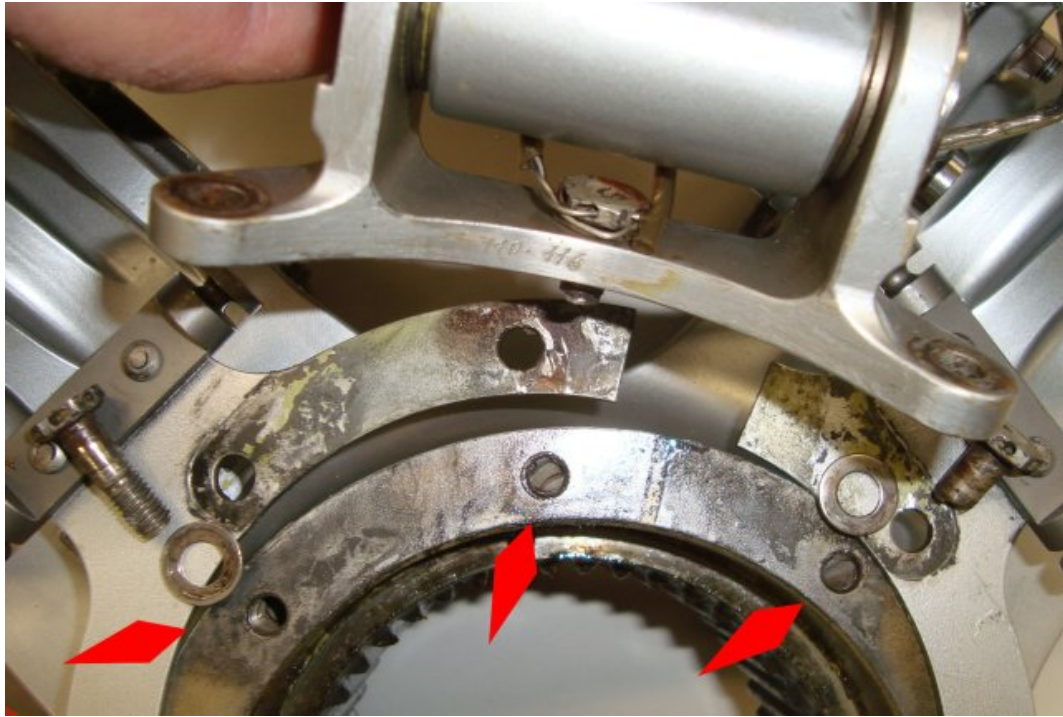
Fig 6: View of the hub assembly with spring holder half plate fitting and bolts

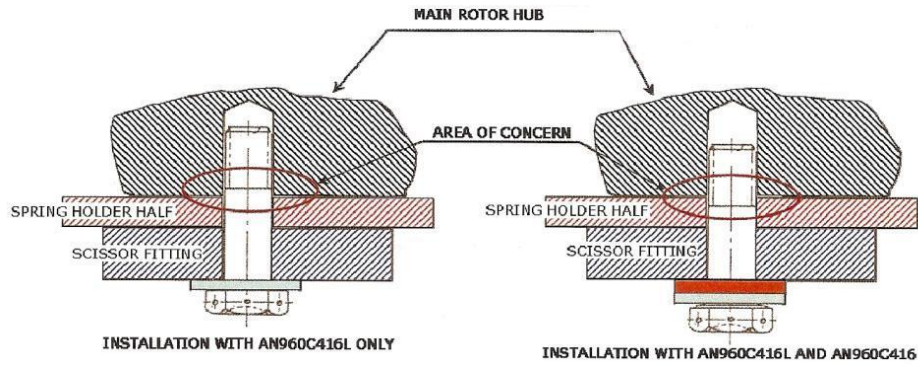
Already on the day of the accident, 24 November 2009, it was established that two of the three bolts that fixed the swash plate driving scissor fitting P/N 109-0110-67-111 to the hub of the main rotor head had fractured. All three bolts (P/N 109-0101-78-5) had been installed with **one** AN960 C416L 0.8 mm thick washer each.

A subsequent investigation by REGA indicated that in contrast to the affected helicopter HB-XWM in three other helicopters of the A109K2 fleet the same bolts were each fitted with **two** different washers AN960 C416L and AN960 C416 with a total thickness of 2.3 mm.

On three further helicopters of the A109K2 fleet, it appeared that, like the aircraft involved in the accident, the bolts had been fitted with only **one** washer.

Fig 7: Comparison of installation with one or two washers.

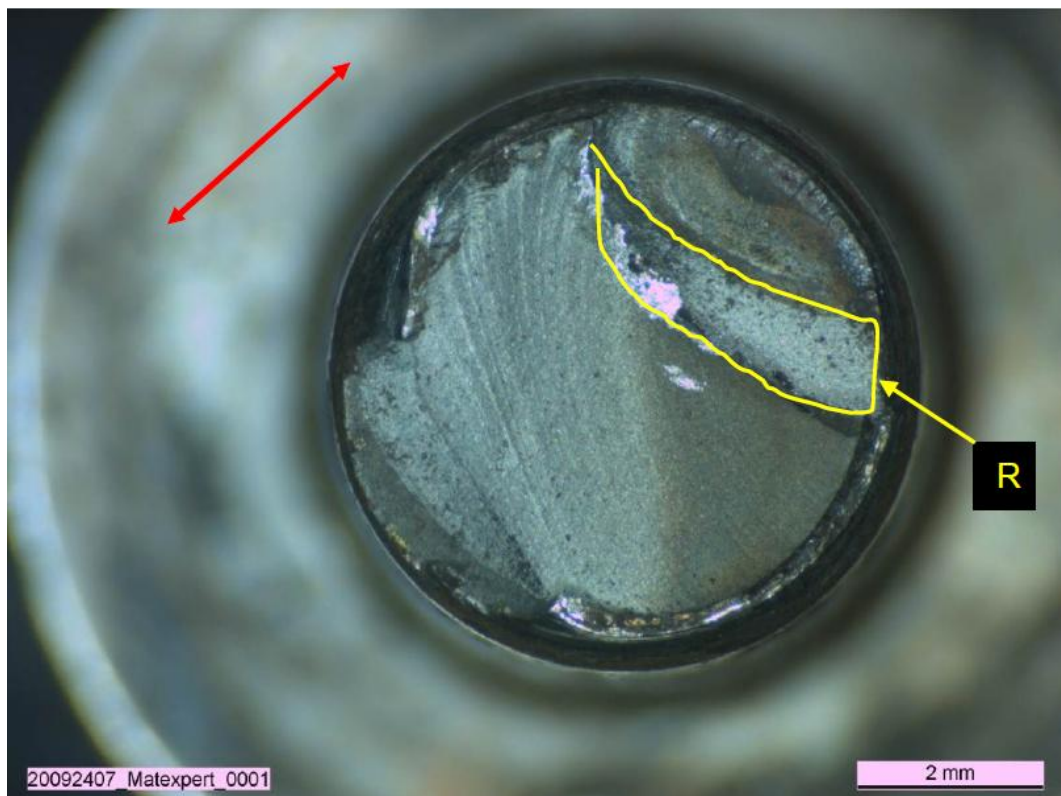
Investigation of the fracture surfaces showed a fatigue fracture of both bolts due to two way cyclic bending stresses.

Fig 8: Micrograph of the fracture surface of bolt no. 1

R: Final fracture surface, the remaining fracture surface indicates fracture by cyclic two way bending

The results of the material investigation have confirmed that the fracture of both fixing bolts could be attributed to fatigue caused by alternating bending stress.

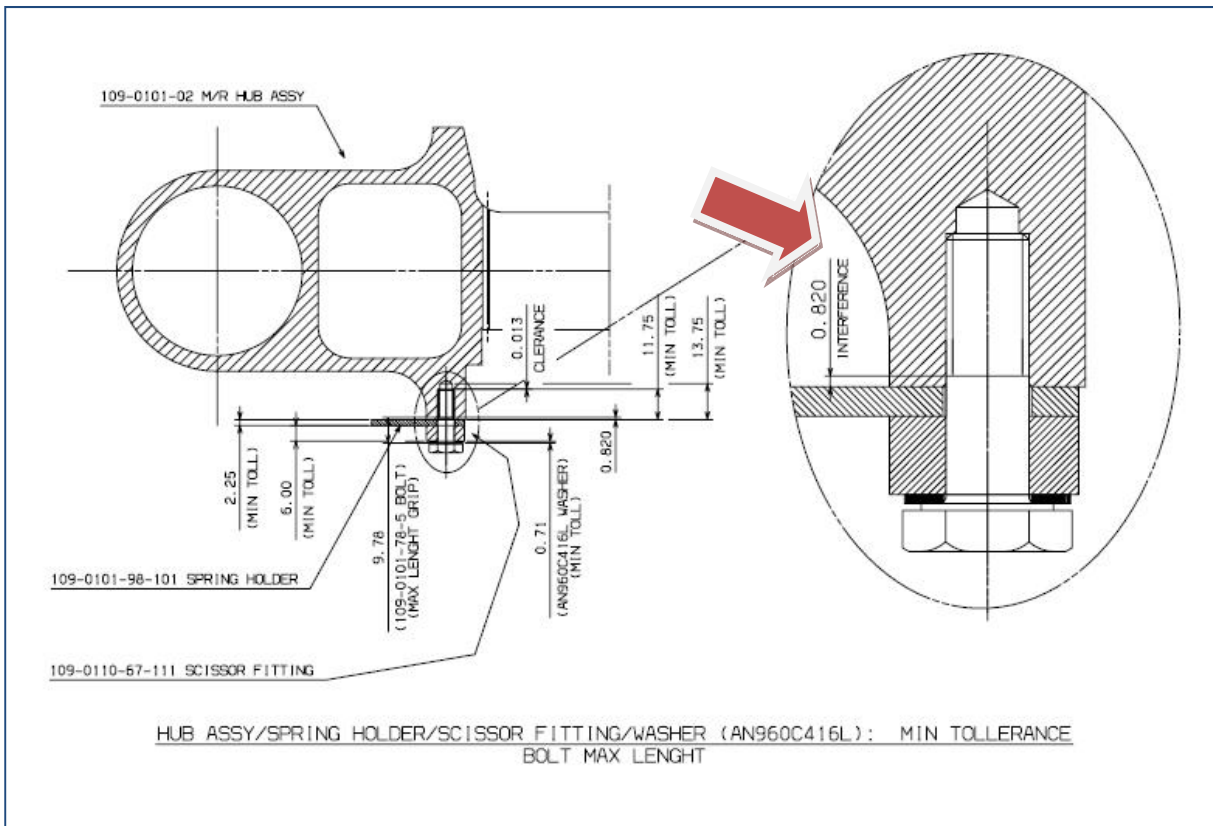
Assembly with only one washer at minimum tolerance of the components = NOT OK

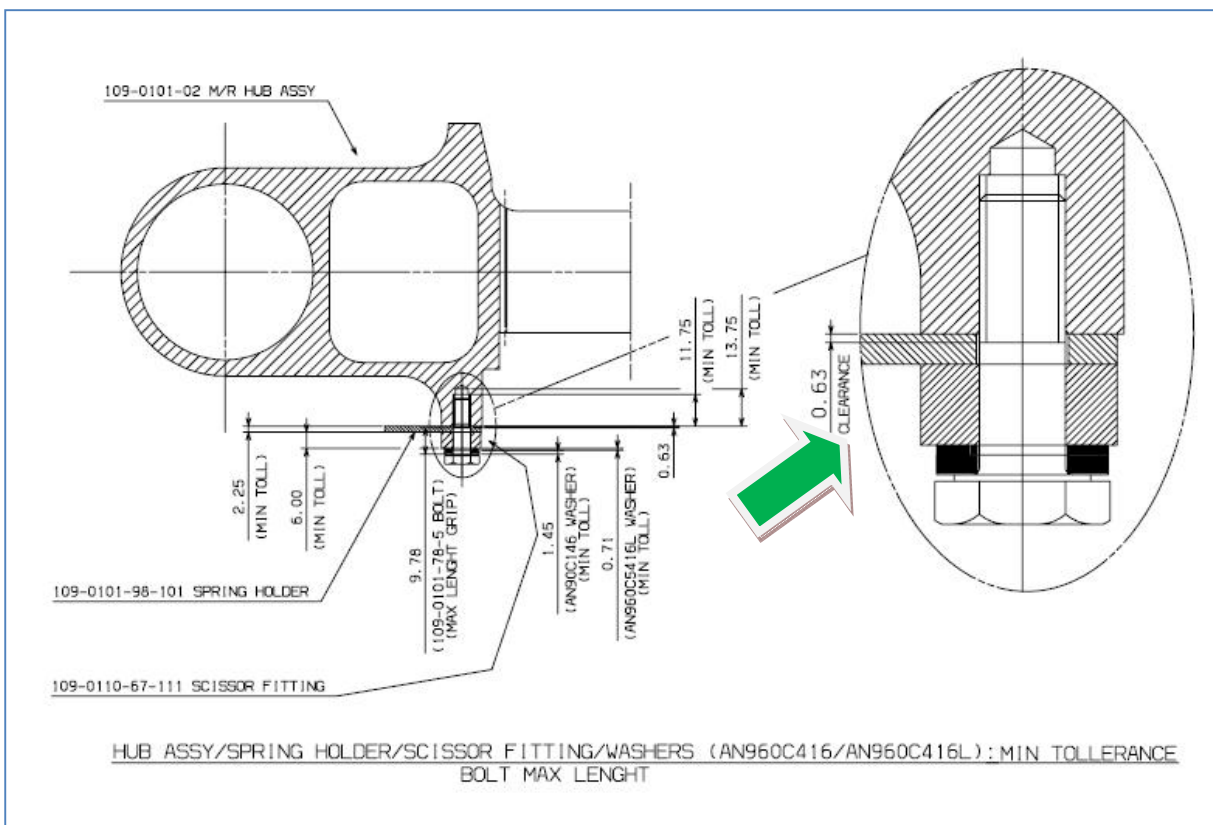
Assembly with two washers at minimum tolerance of the components = OK

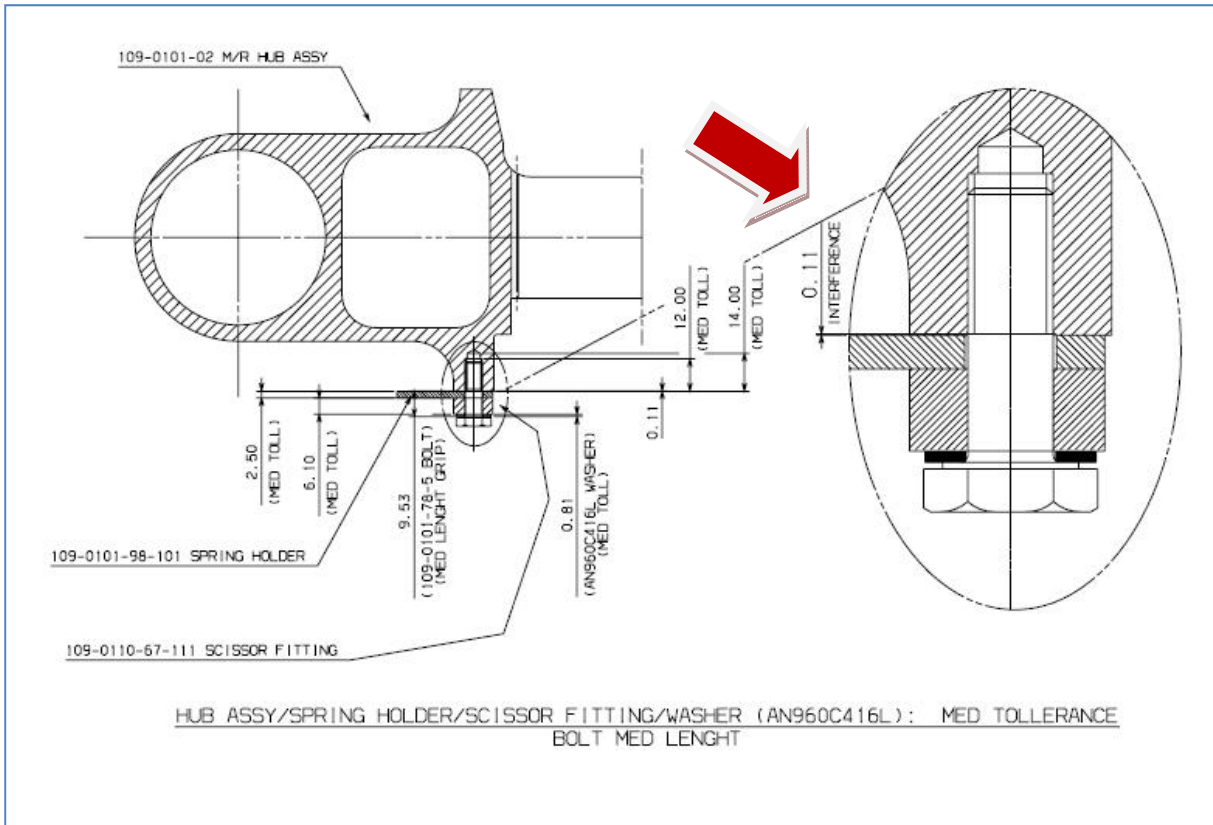
Assembly with only one washer at medium tolerance of the components = NOT OK

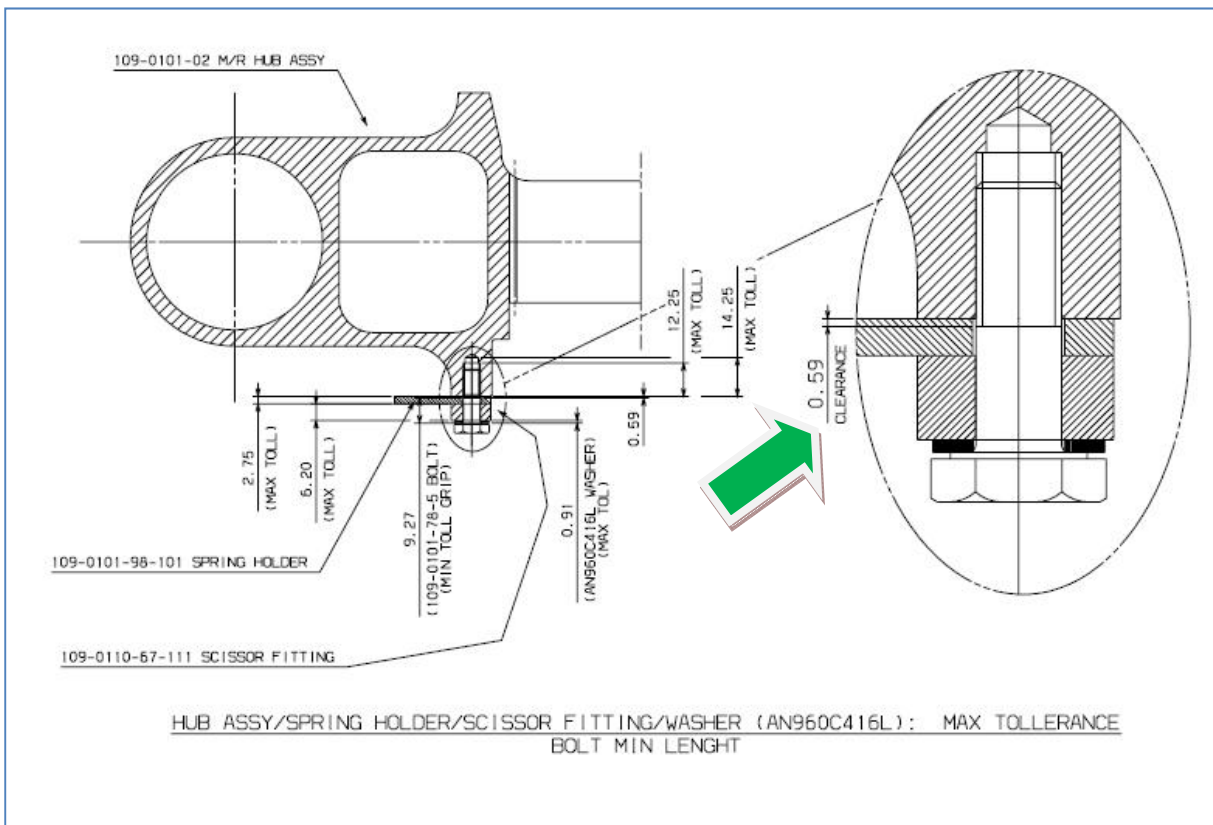
Assembly with only one washer at maximum tolerance of the components = OK
