# **Final Report No. 2158** **by the Swiss Accident** **Investigation Board SAIB**

concerning the serious incident involving the  
AVRO 146-RJ100 aircraft, registration HB-IXP,  
under flight number LX 5187

on 20 July 2011

at Zurich-Kloten airport

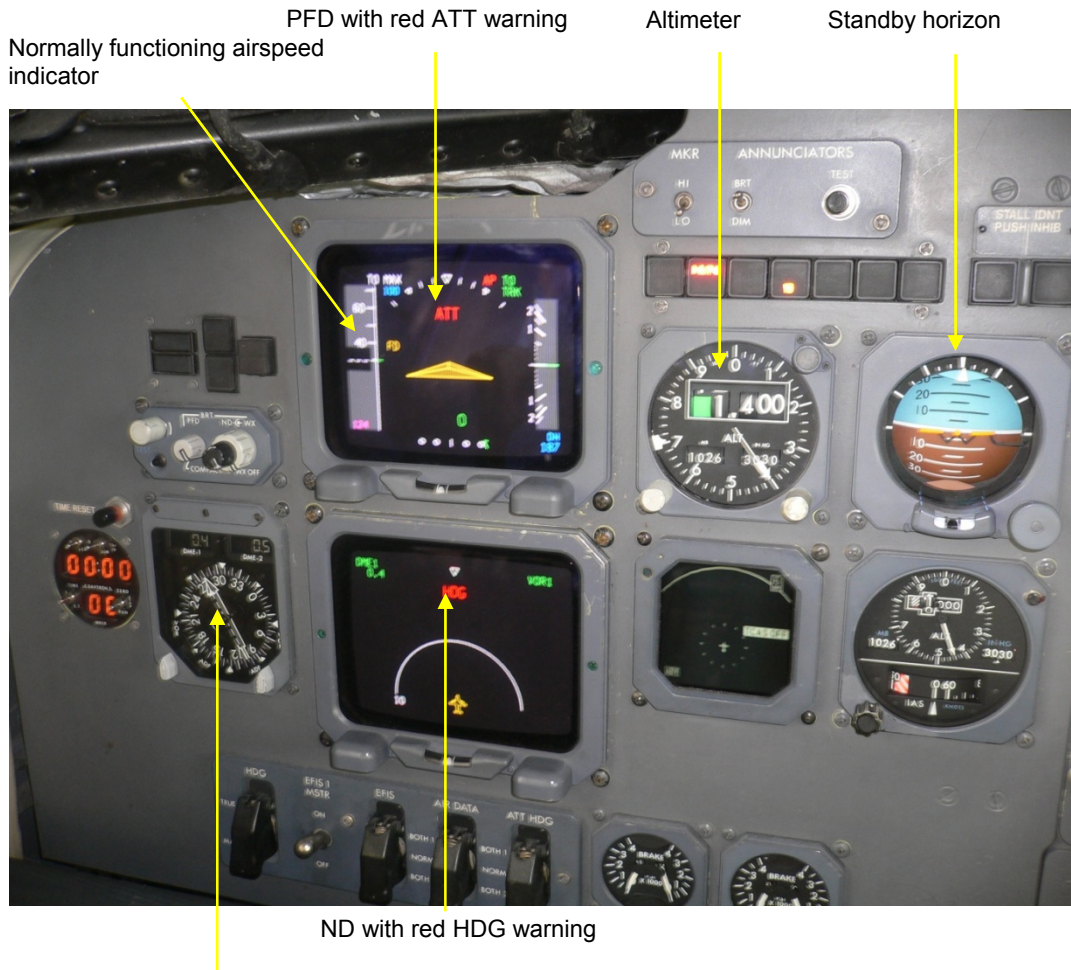
**Figure 1:** Instrument display on the commander's side (The values shown in the figure do not correspond to those which were displayed at the time of the serious incident).

DBI (distance bearing indicator) with normally functioning heading and normally functioning VOR bearing pointer

It is obvious that the crew, on the approach on runway 14 in Zurich, when the FD, AT, and AP failed, thought at first that the problem after the take-off in Nuremberg was recurring and was due to the selection of the FGC 2. A few seconds later the indications on the commander's PFD and ND failed and the red ATT and HDG warnings appeared (cf. chapter 2.1.2, figure 1). This was a clear indication

The acoustic "bank angle" warning caused by the IRU 1 confused the copilot and he looked at the commander's instruments, which because of the fault which had occurred showed a bank angle which corresponded with the acoustic warning. According to his statement, the PFD on his side showed "wings level" i.e. no bank angle. Now he no longer trusted his own instruments. A comparison with the standby instruments would have shown the crew that their indications corresponded with the display on the PFD on the copilot's side.

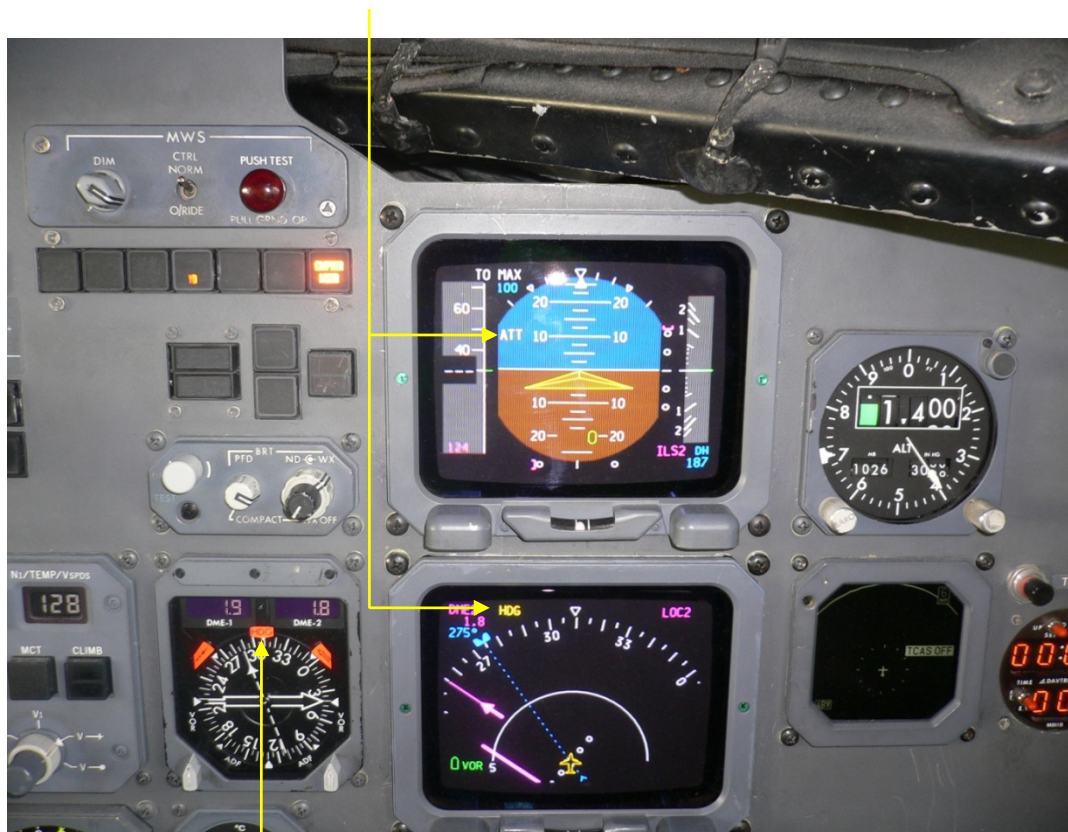
At the same time, on the copilot's side the ATT and HDG displays appeared in yellow, to draw attention to the different signals. The indications to fly the aircraft remained. Only the heading indication in the DBI on the left of the ND showed the red heading flag, because the corresponding information was supplied by the IRS 1 (cf. figure 2 and chapter 1.6.2.6).

DBI (distance bearing indicator) with red heading flag

The two red bearing flags on the left and right indicate that the VOR bearing pointers, which are referenced to the compass rose, are no longer providing a reliable indication. The distance to the respective VOR/DME station is displayed normally.

Hence all the necessary data was available to fly the aircraft manually on the ILS using raw data (cf. chapter 2.1.2, figure 2). Even a landing would have been possible given the prevailing weather conditions. The flying situation was basically comparable to that which the copilot had experienced on the occasion of the refresher in the year 2010 (cf. chapter 1.17.4).

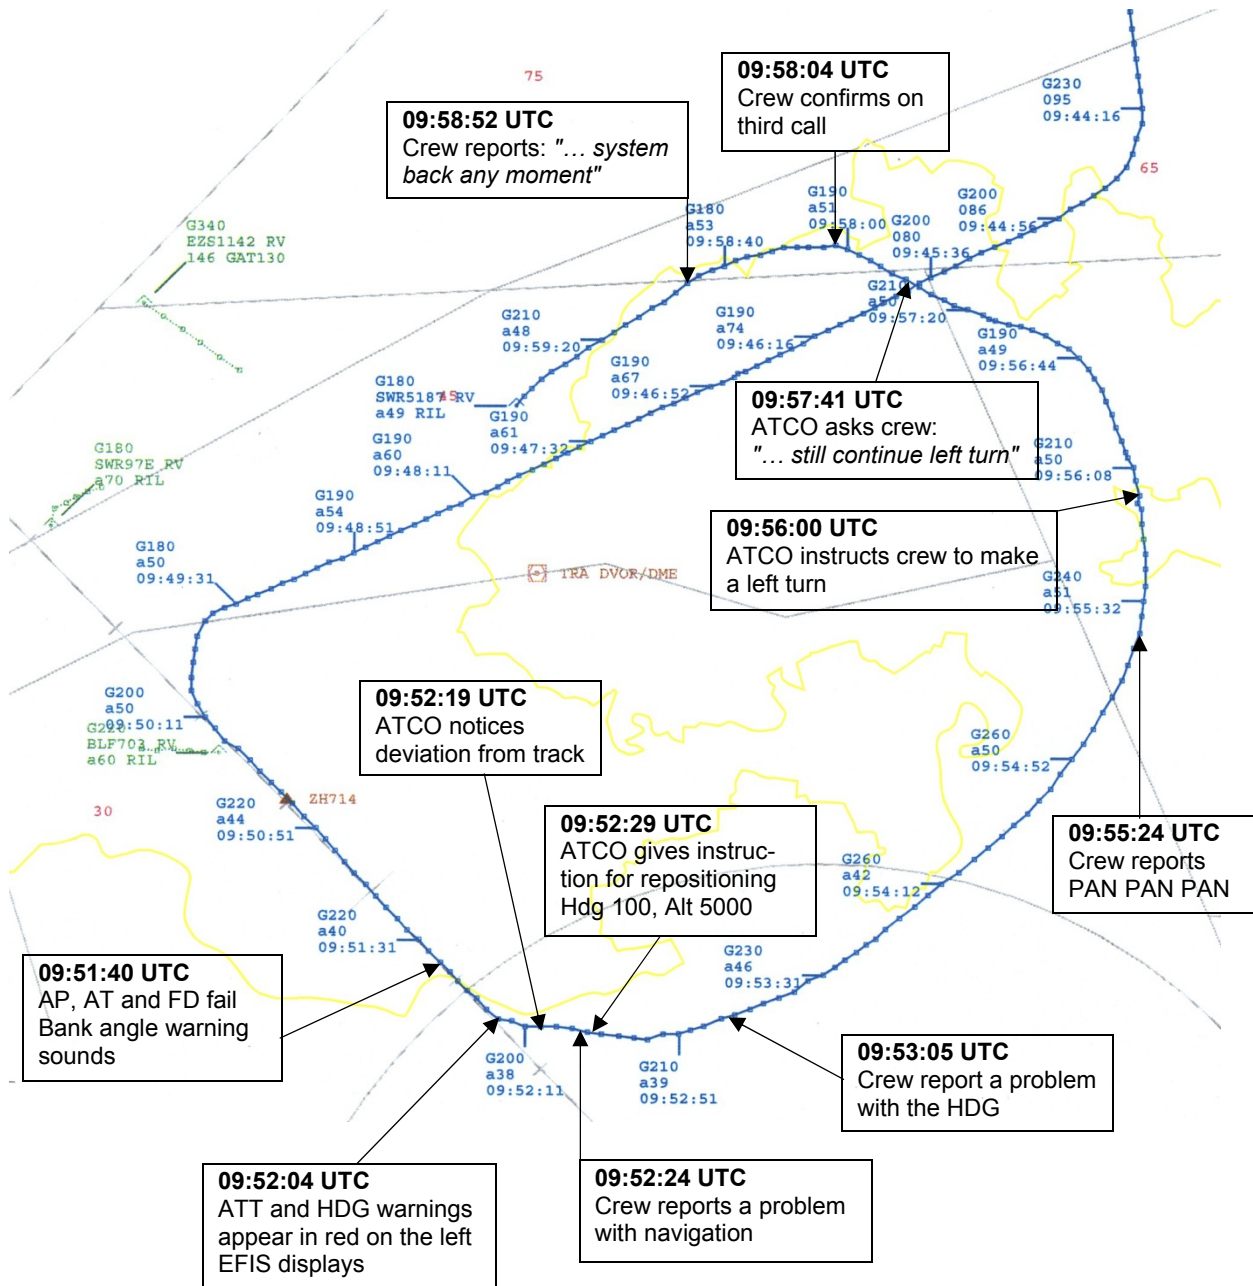
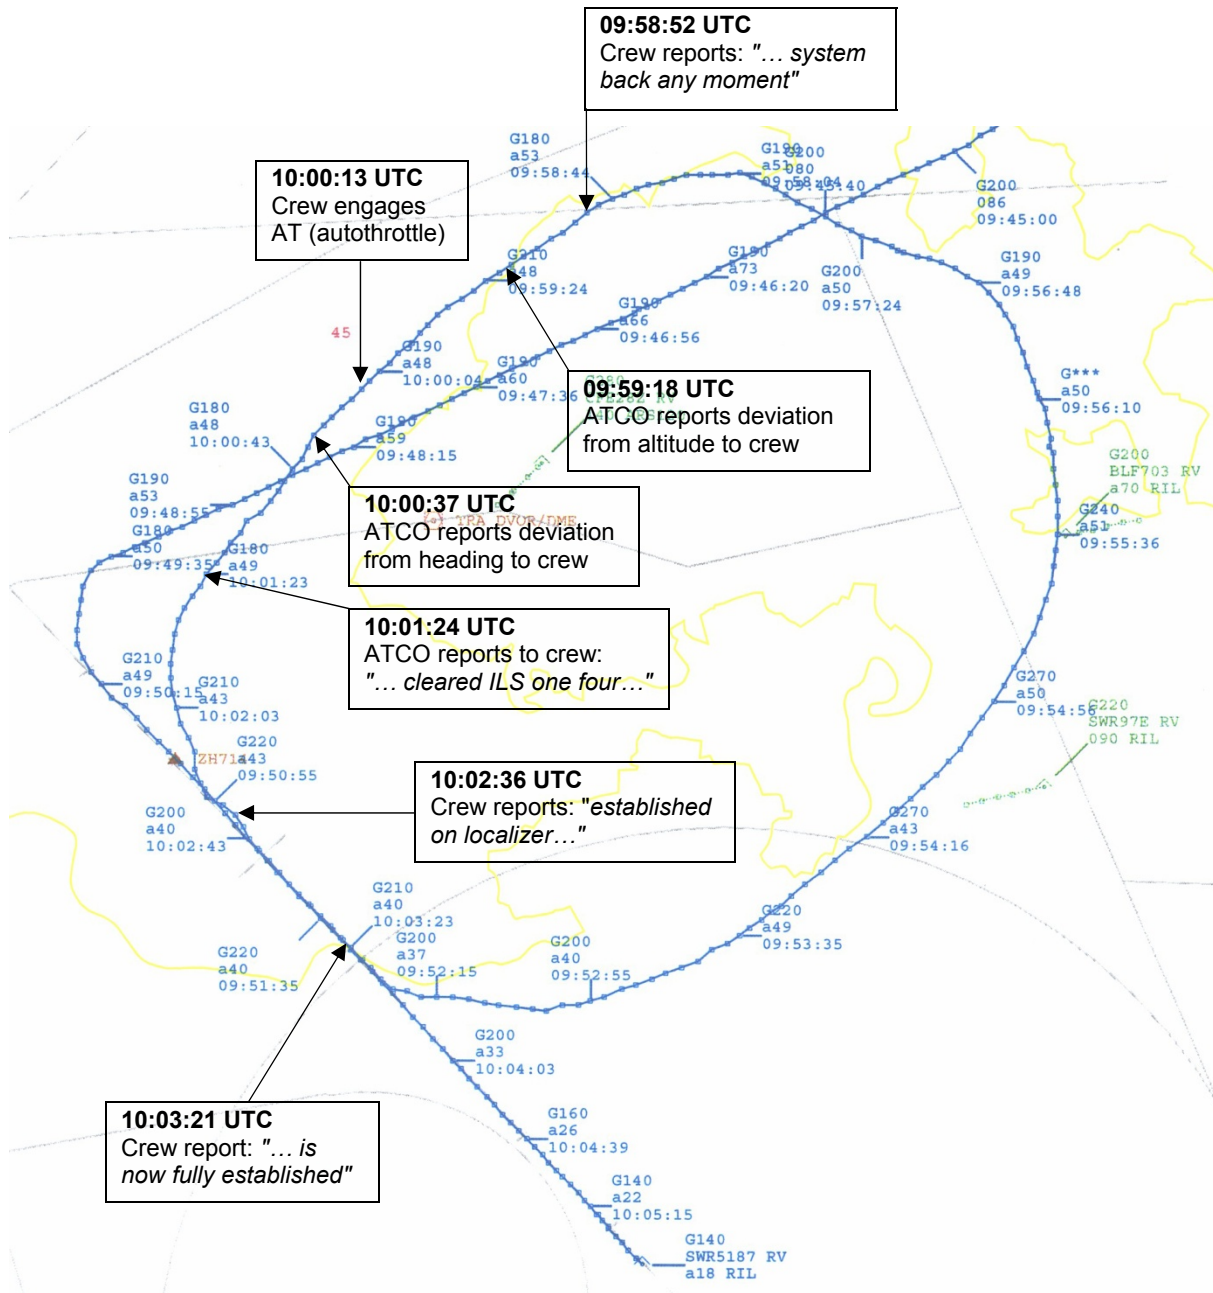
Annex 1: Flight path on approach

The ATCO observed that the aircraft's radar symbol was moving away from the approach centerline to the east and was showing a continuation of the descent. Immediately after the *"affirm"* report from the crew, the ATCO therefore gave the instruction: *"I see you left of the centerline, turn immediately right and climb immediately to four thousand feet."* At this time the aircraft was located 0.45 NM to the east of the approach centerline at a distance of approximately 6 NM from the runway 14 threshold and at an altitude of 3300 ft AMSL. With reference to the glide slope, it was therefore flying approximately at the nominal glide angle. According to his own statements, by means of this instruction the ATCO intended to bring the aircraft back onto the approach centerline. The crew then answered that they had a navigation failure, whereupon the ATCO, with a view to a repositioning, instructed the crew to climb immediately to an altitude of 5000 ft QNH and to fly a heading of 100 degrees (cf. Annex 1).

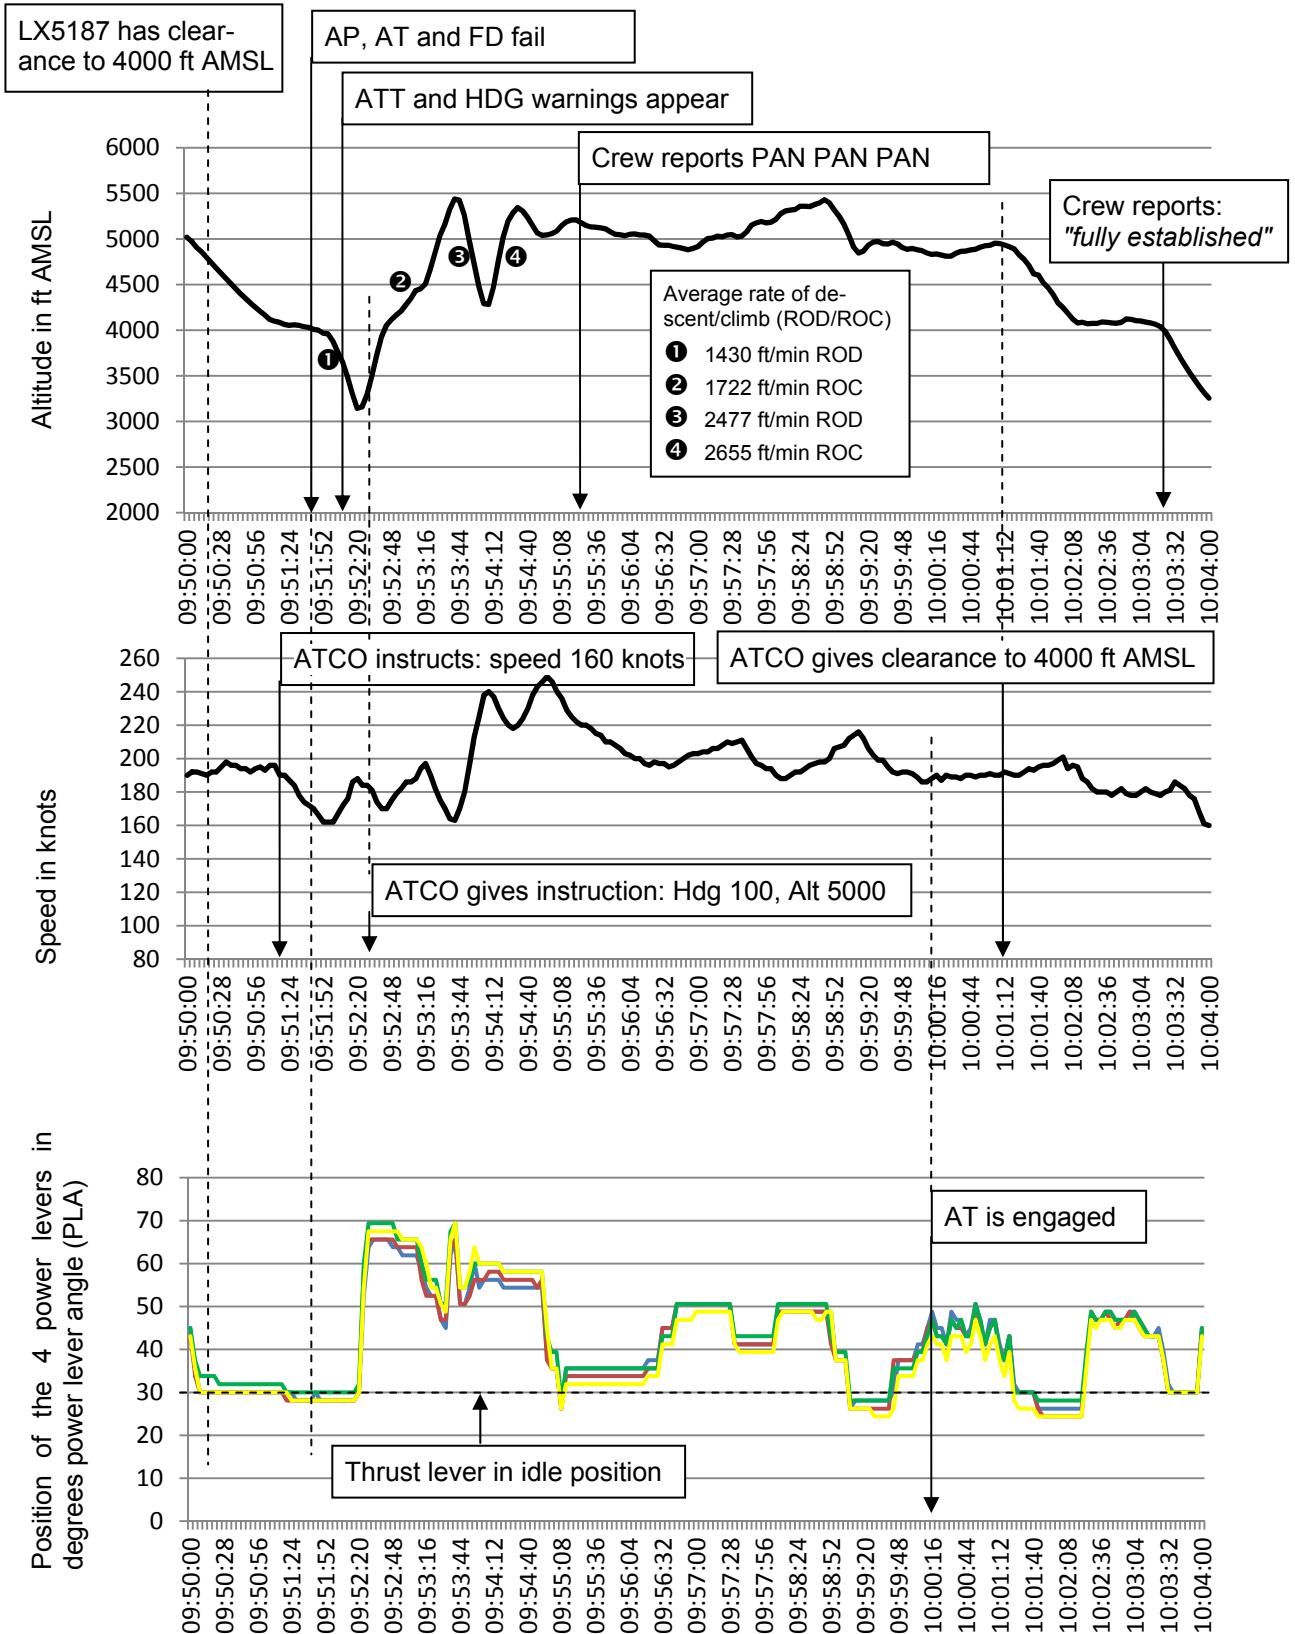
**Annex 2: Altitude, speed and thrust lever position**

The fact that the copilot did not make a consistent comparison of the available attitude indications led to a partial loss of situational awareness. This uncertainty meant that the copilot experienced difficulty in controlling the aircraft manually and was subsequently able to support the commander only inadequately. Too little correction was applied for the strong westerly wind and the aircraft drifted away to the east from the ILS localizer. The recorded altitude of this flight phase testifies to a changeable and unstable pitch attitude (cf. Annex 2).

The FDR (flight data recorder) only records flight attitude reference data of the IRU 1. Since these parameters were no longer available from 09:52:04 UTC, a representation of pitch and bank angle was omitted.
