# **Final Report No. 2160** **by the Swiss Accident** **Investigation Board SAIB**

concerning the accident involving the  
Piper PA-32R-300 aircraft,  
registration HB-PRE

on 26 August 2010

Oey, Saanen/BE municipality

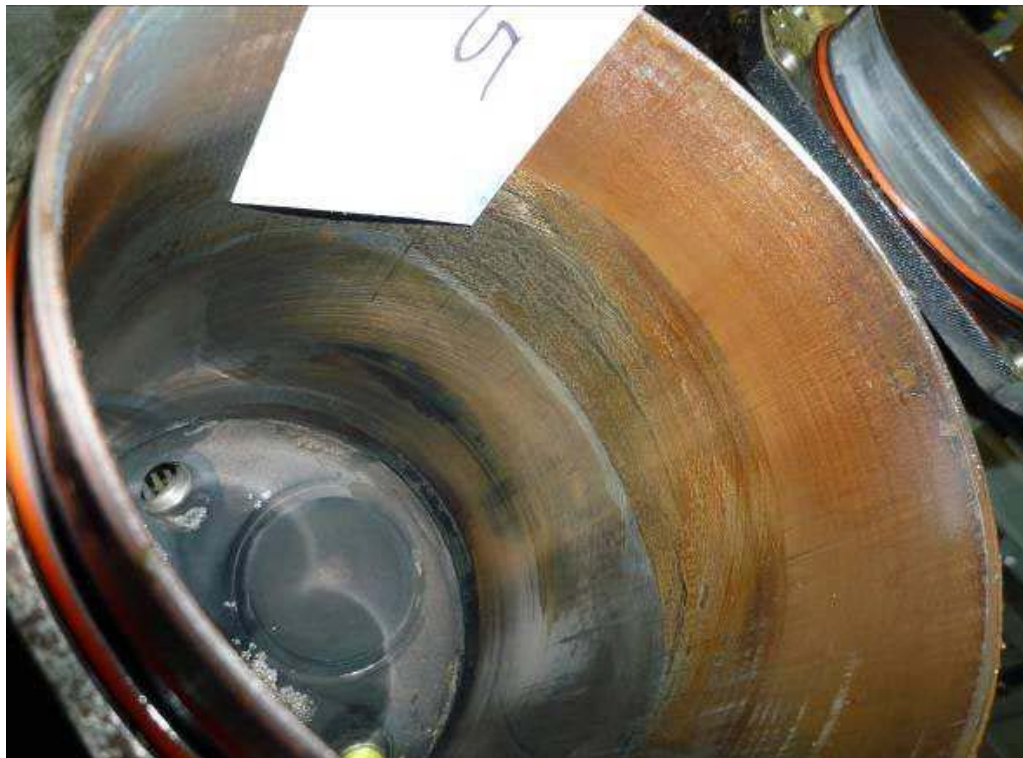
- The spark plugs of cylinders 5 and 6 were heavily sooted up. No defects were found during the functional testing of all twelve spark plugs.
- When the cylinders were dismantled, it was found that cylinder no. 2 had already been dismantled, repaired and re-installed previously. This work was attested on 30 March 2006. The operating time of cylinder no. 2 since this repair up to the time of the accident was 98:27 hours.
- A repair was detectable on cylinder no. 1.
- Serious corrosion was visible on the inner wall of cylinders no. 3, 4, 5 and 6. The incidence of rust on the cylinder surfaces was striking. It was also found that the usual fine oil-film on the surfaces of the pistons and cylinders was missing; this may possibly be due to the fire.

**Figure 3:** Cylinders 5 and 6 exhibit pronounced corrosion on the cylinder wall

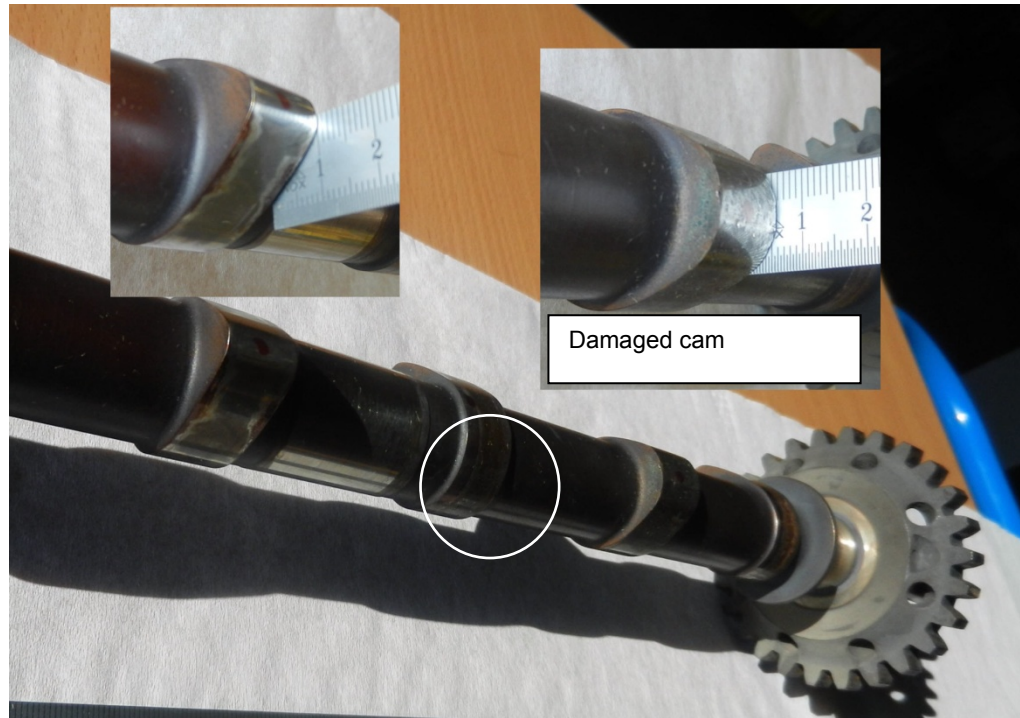
- The inner tubes of exhaust tubes 4, 5 and 6 were heavily blackened.
- Residual fuel was found in the inside of the inlet line to cylinder 5, near the injector nozzle aperture.
- With the exception of cylinders 1 and 2, all pistons exhibited considerable deposits of a mixture consisting of rust and oil on their bottom piston rings.
- On the camshaft, a wear of approximately 4 mm was found on the cam which actuates the inlet valves of cylinders 5 and 6.

**Figure 4:** Camshaft with damaged cam  
(beschädigter Nocken=Damaged cam)

The hardness of the camshaft was measured at 15 points using the "Vickers" method<sup>9</sup>. The results at all measurement points, with the exception of those on the damaged cam, are between 600 and 700 HV. The damaged cam exhibited with 400HV a significant deviation.

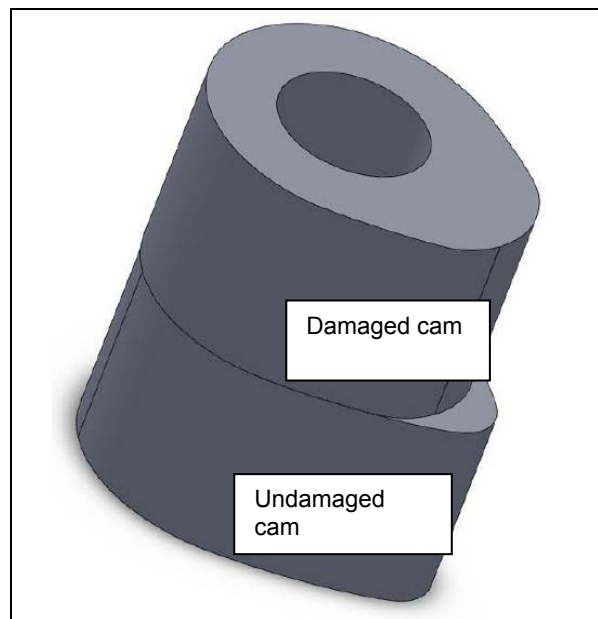
**Figure 5:** Comparison of the damaged cam with an undamaged cam

The damaged cam exhibited a difference of 3.87 mm in comparison with the undamaged cam, i.e. the inlet valves of cylinders 5 and 6 were opened 3.87 mm less as a result of the worn shape of the cam.

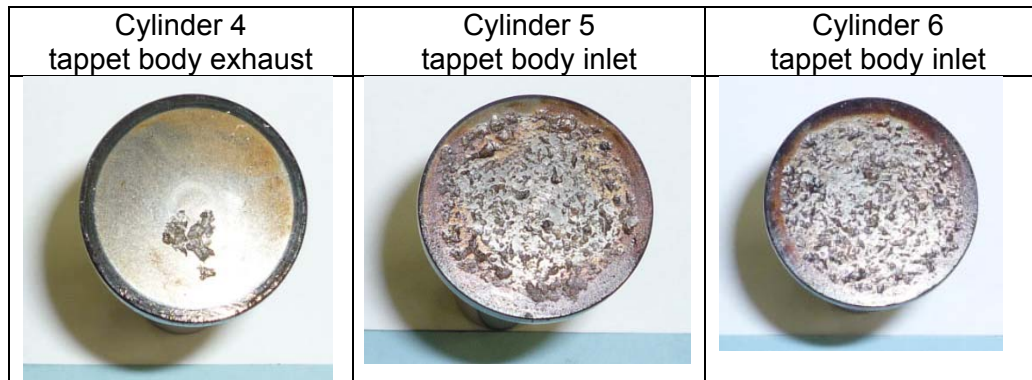
- The tappet bodies operated by the damaged cam to control the inlet valves of cylinders 5 and 6 were very badly corroded on the contact surface. In addition, the tappet body of the cylinder 4 exhaust valve was badly corroded.

**Figure 6:** Corrosion on tappet bodies

There is no doubt this cam lobe and tappet wear was caused by periods of non-use, not doing regular oil changes, and not doing good inspections of the oil filters or screens."
